HOUSTON INSPECTIONS

TREC Inspection

PROPERTY INSPECTION REPORT FORM

John Doe <i>Name of Client</i>	09/06/2022 <i>Date of Inspection</i>
123 Main St, Houston, TX <i>Address of Inspected Property</i>	
Shawn Emerick <i>Name of Inspector</i>	#4623 <i>TREC License #</i>
R. Shawn Emerick <i>Name of Sponsor (if applicable)</i>	#4623 <i>TREC License #</i>

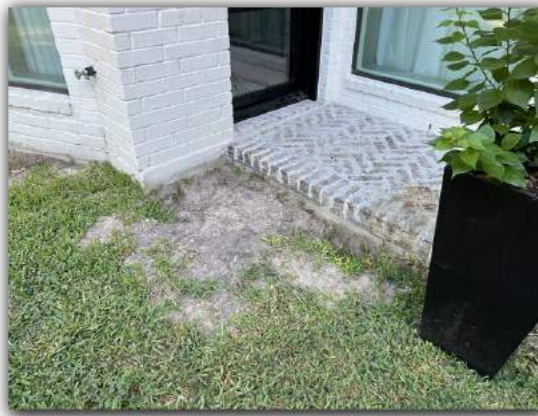
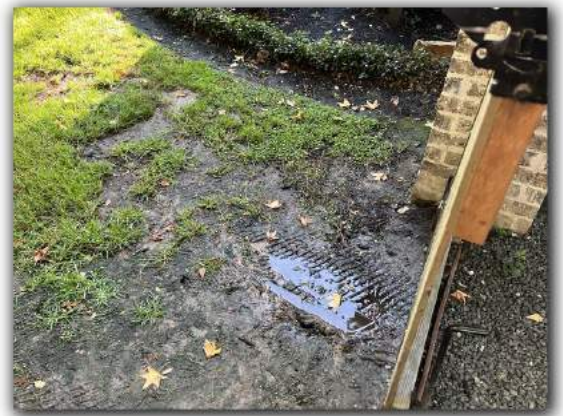
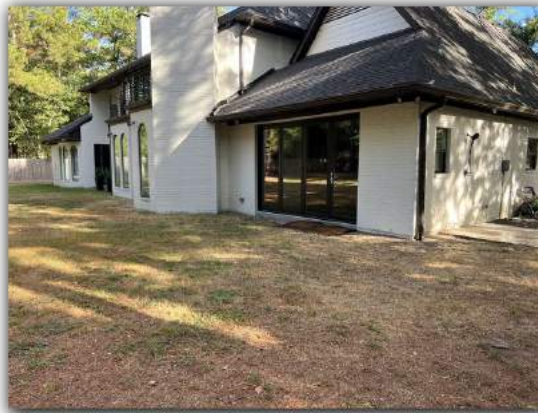
The existing grade at the slab perimeter is not adequate for shedding water away from the structure(s) on all sides. The ground should slope away from the structure at a rate 6" in the first ten feet. Where lot lines, walls, slopes or other physical barriers prohibit 6" of fall within the first 10', drains or swales should be provided to ensure drainage away from the structure. Ideally, at least eight (8) inches of clearance should be maintained between soil level and the top of the foundation walls.

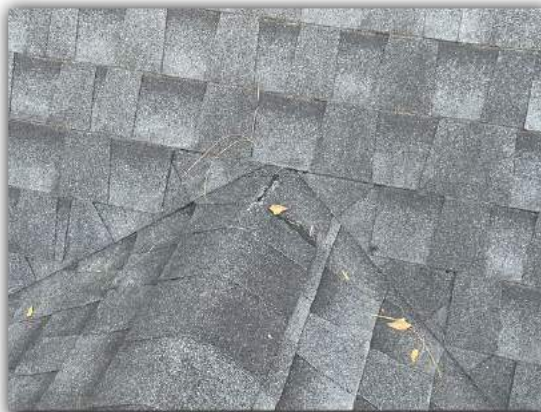
A damaged shingle was found during the inspection of the roof covering (left side above garage). Recommend repairs by a qualified tradesman.

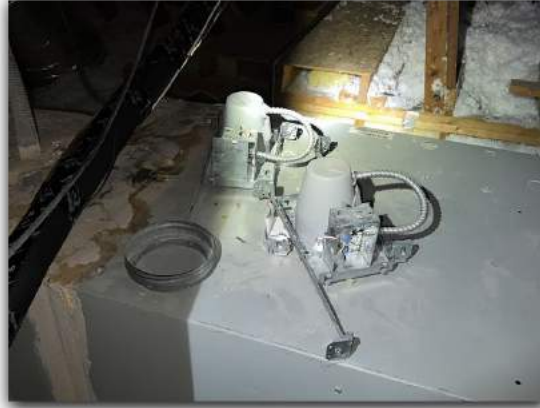
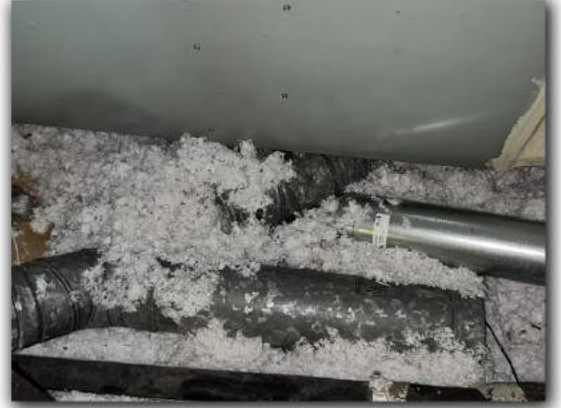
Trash and debris were found in the attic.

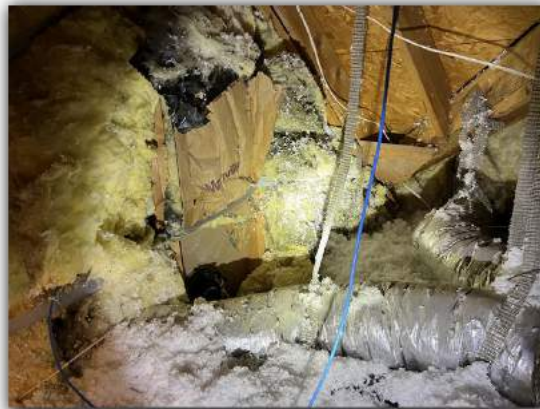
The level / depth of insulation in the attic is considered less than normal in some areas of the attic. The installation of additional insulation or the rearranging of the insulation is recommended to improve the energy efficiency of the building.

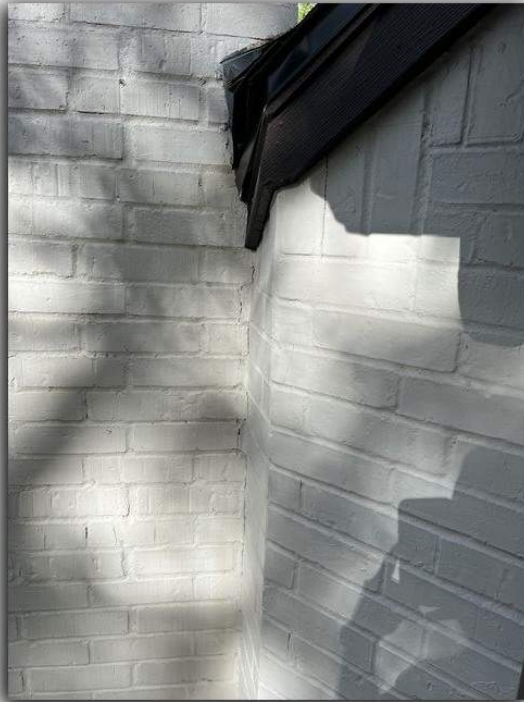
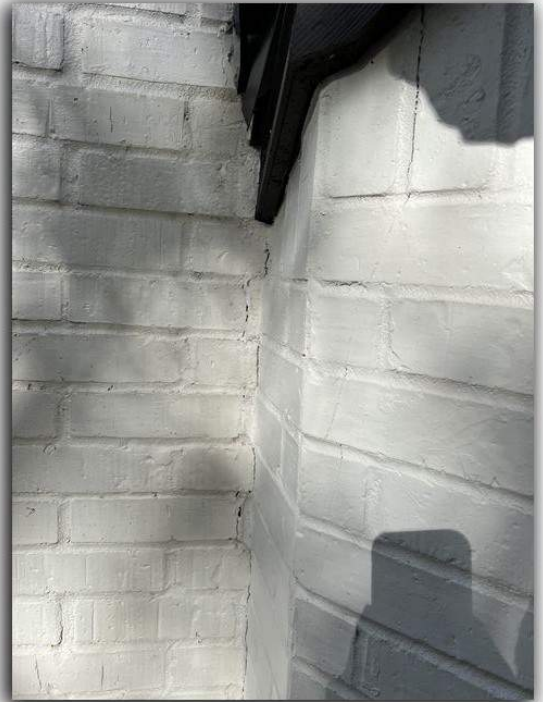
Brick / mortar cracks were found on the exterior of the structure as evidence of settlement of the structure.

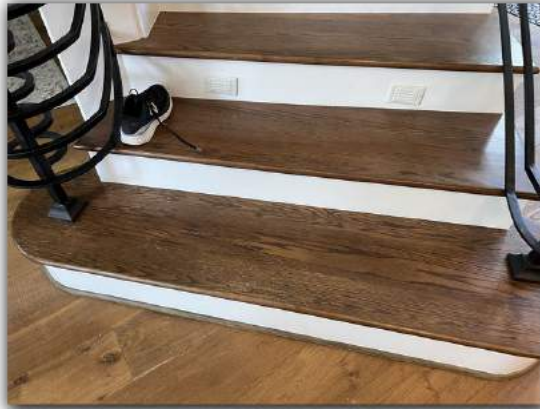
The wood floors are showing signs of wear and tear (ding's, scratches, etc.).

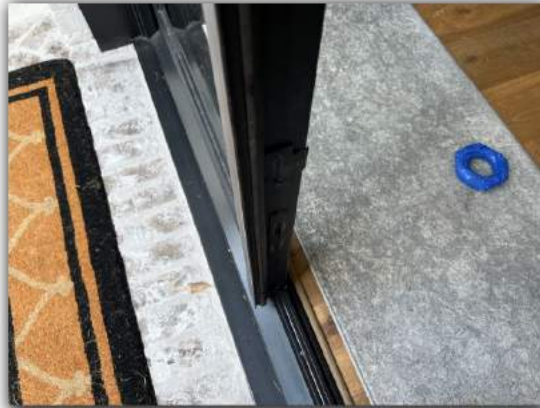
The lower lock at the secondary front door does not engage the striker plate.

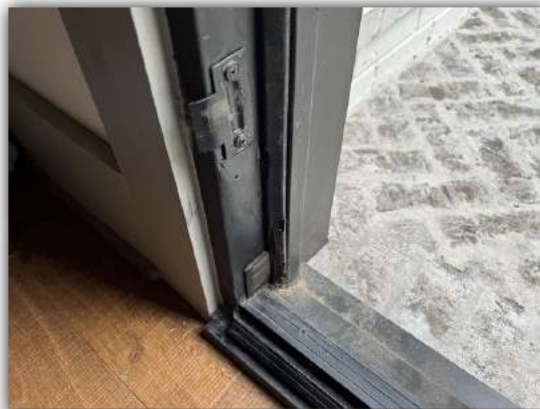
Damaged and missing weather stripping was noted at the master bedroom exterior door. The weather stripping should be replaced.

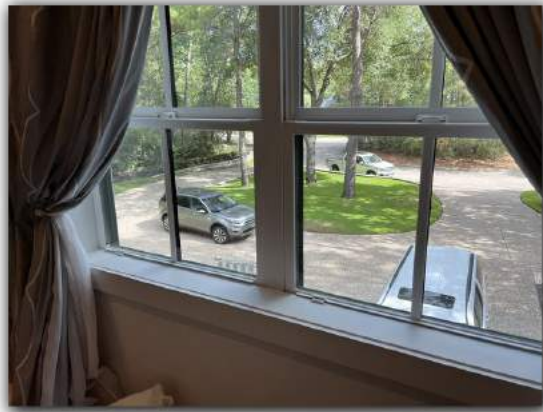
Improper dimension of windows in sleeping rooms for use as secondary emergency egress. The clear opening at the some of the bedroom windows are smaller than allowed by current codes at windows that will be used as a secondary means of egress in the event of an emergency. Steps should be taken to improve the condition.

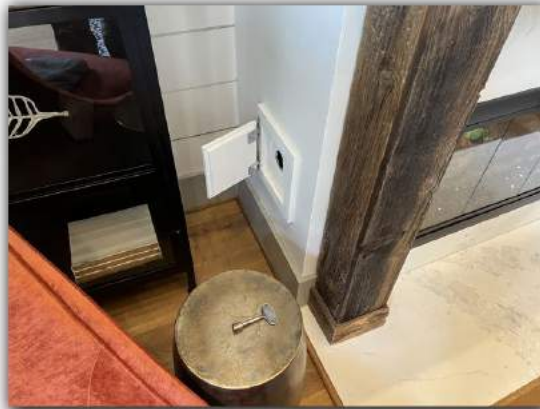
The gas valve could not be turned on at the formal living room fireplace.

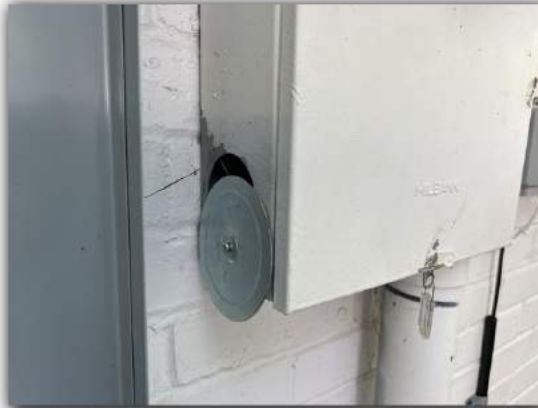
The knockout plate is loose at the main service meter.

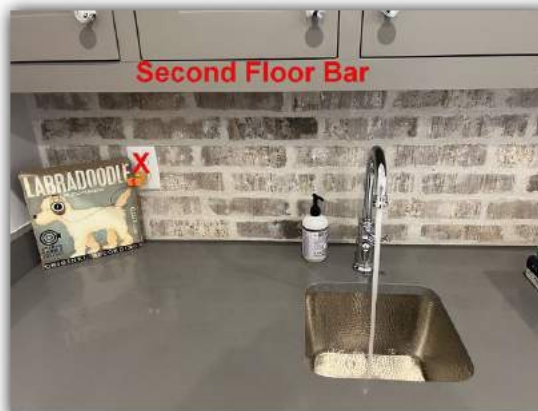
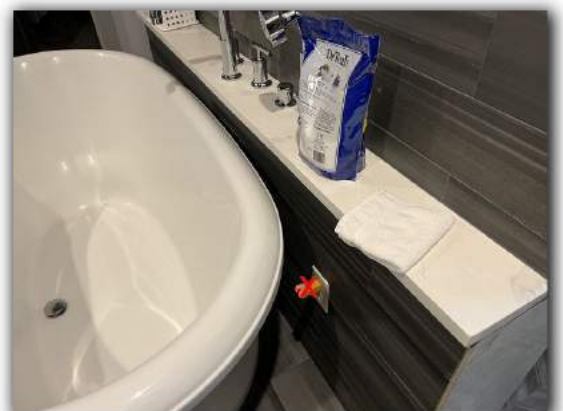
The installation of a ground fault circuit interrupter (GFCI) is currently recommended at all kitchen receptacles (countertops, dishwasher, disposal, etc.), all bathroom receptacles (including receptacles within 6' of tub and shower enclosures), all receptacles in the laundry room (including washer & dryer), all receptacles in the garage (including the ceiling), and all receptacles on the exterior of the property. A ground fault circuit interrupter (GFCI) offers protection from shock or electrocution. The installation of this safety device is recommended at the areas noted above lacking GFCI protection.

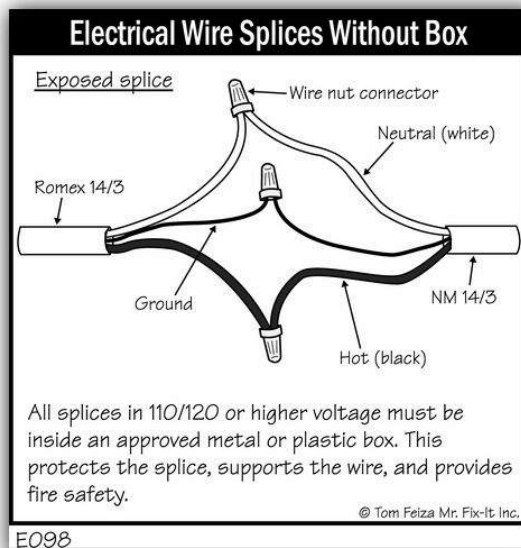
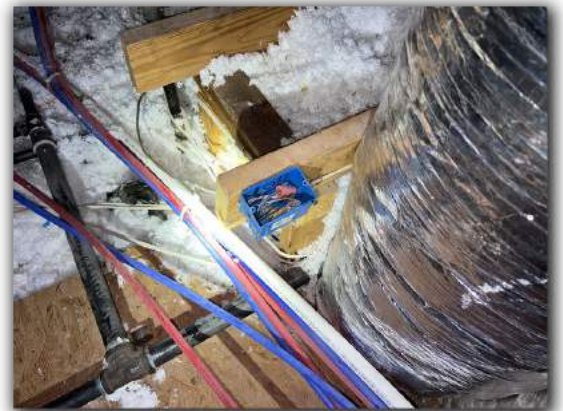
Exposed electrical connections were noted in the attic. Improper electrical connections should be improved. All electrical connections should be made inside junction boxes fitted with cover plates.

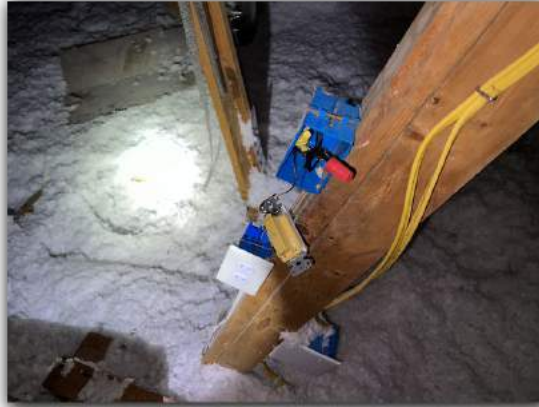
A loose switch was found in the upper attic.

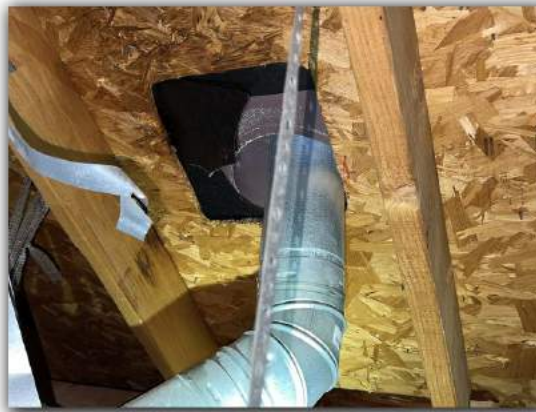
Furnace flue pipe(s) does not have sufficient clearance from combustible materials. There is insufficient clearance between the heater exhaust flue and combustible materials. *This is a fire hazard.* A qualified licensed heating technician should be consulted to correct this situation.

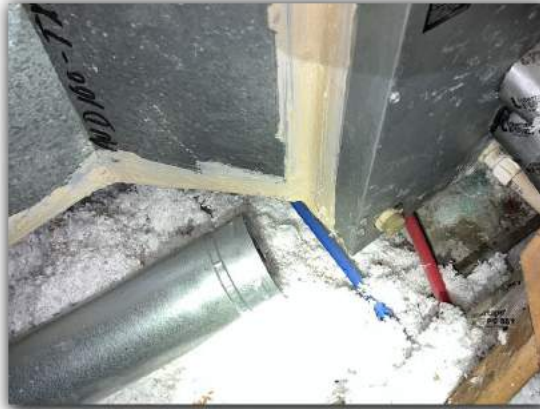
The debris in the emergency drain pan below the evaporator of unit(s) # 1 should be removed.

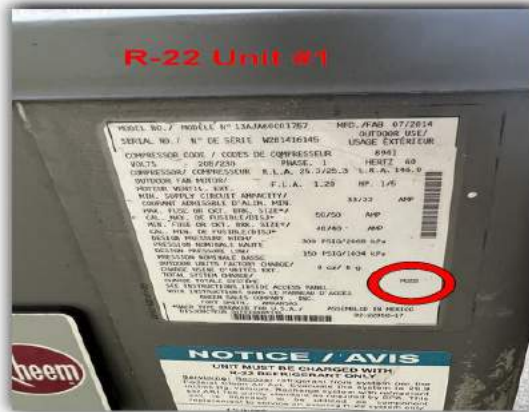
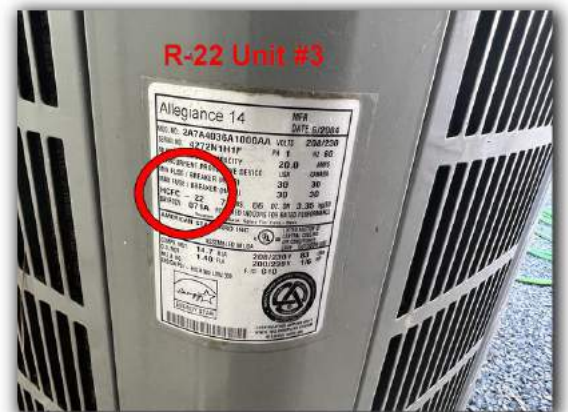
During the inspection of the cooling equipment labeling was found that indicates the system has been charged with R22. As of January 1, 2020 R22 is no longer manufacturer, installed (new systems), or imported in the US. This will create financial obstacles when servicing this unit and will eventually create a situation where the system cannot be re-charged or repaired. The client is urged to take this into consideration and discuss this situation in more detail with a licensed HVAC contractor.

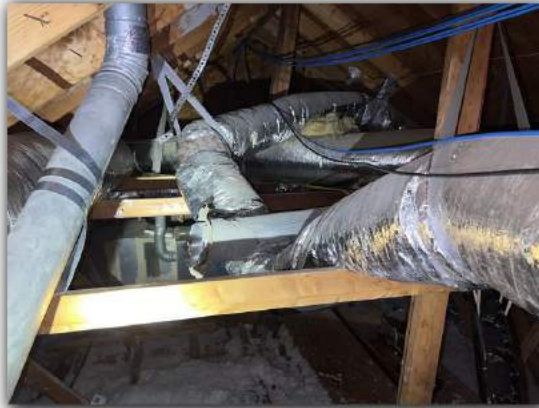
A metal vent pipe is laying across a supply air duct in the attic, which has caused an excessive bend. Recommend to improve for air flow.

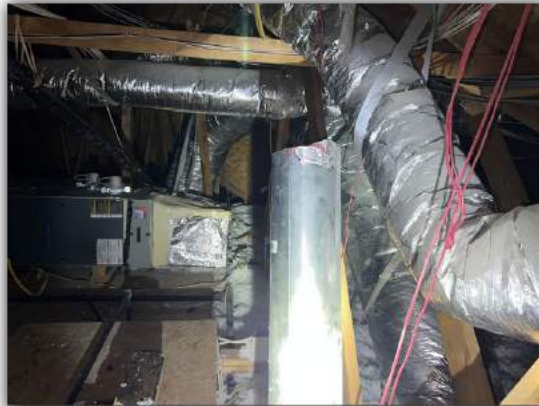
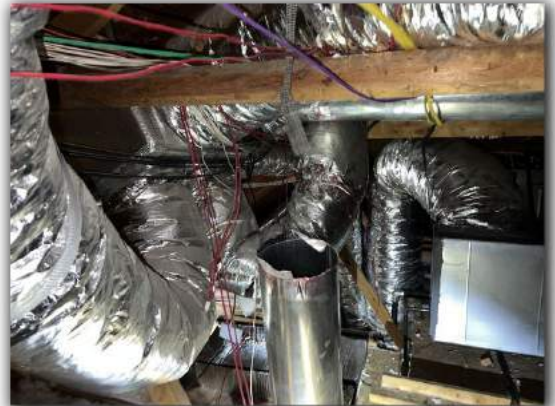
A disconnected vent pipe was found in the upper attic. It appears that this vent is not in use. However, it is recommended that it be verified that this vent is no longer in use or needed as I cannot locate the point of termination.

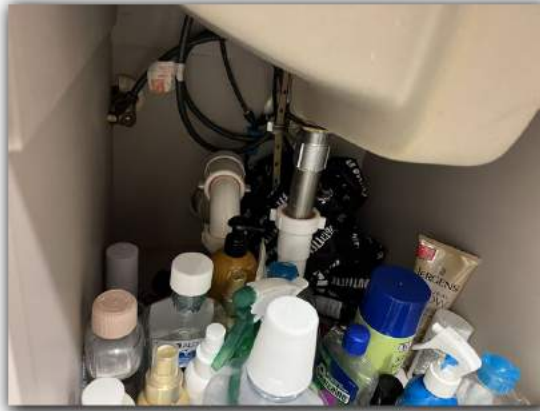
- Improper type of traps installed at fixtures, i.e. "S" trap - Kitchen Sink

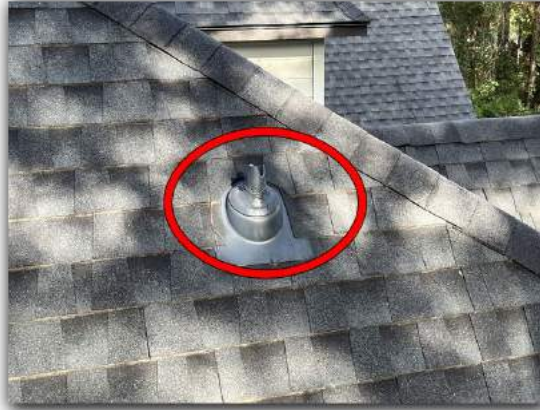
A damaged plumbing vent was found on the left side of the roof covering.

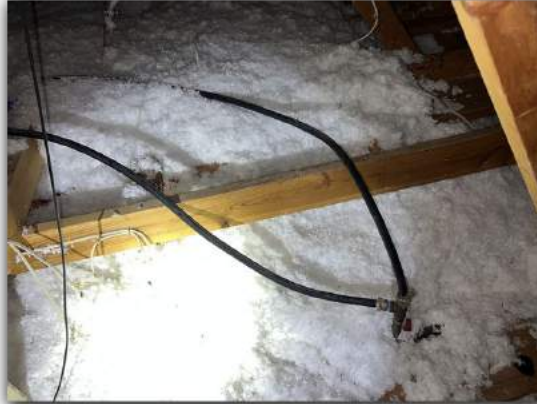
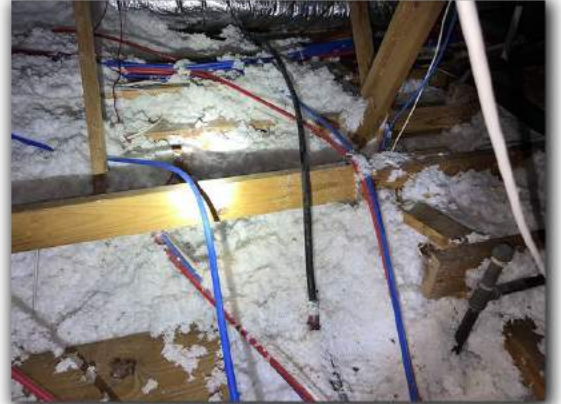
Corrugated Stainless Steel Tubing (CSST) is being utilized as the gas supply system at this property. Recent events have led the state fire marshal's office to make certain recommendations in regards to the bonding of the type of gas supply line. Information regarding installation and safety of this material may be referenced at <http://www.csstsafety.com> . All modifications and / or repairs of this system should be conducted by an approved / licensed / qualified tradesman.

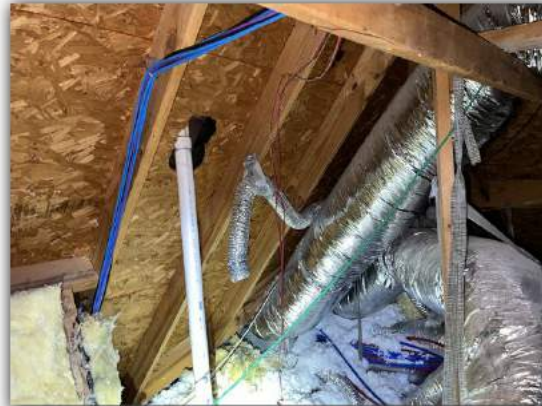
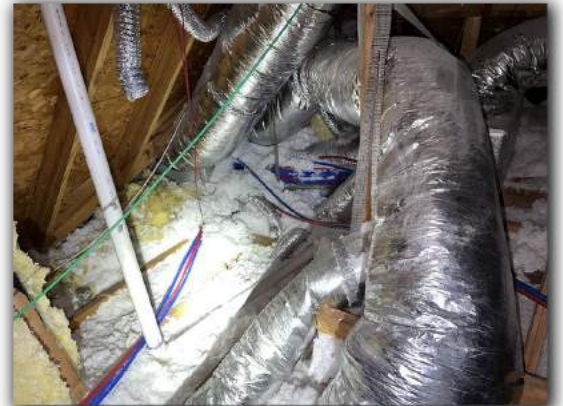
A disconnect bathroom exhaust vent was found in the upper attic.
