CONSTRUCTION / PHASE INSPECTION REPORT

Prepared For:	Jane Doe (Name of Client)	
Concerning:	123 Main Street, Houston, TX 77777 (Address or Other Identification of Inspected Property)	
By:	Chris Stoffer, Lic #20695 (Name and License Number of Inspector)	10/24/2018 (Date)

Report Identification: CS20181024-01, 123 Main Street, Houston, TX

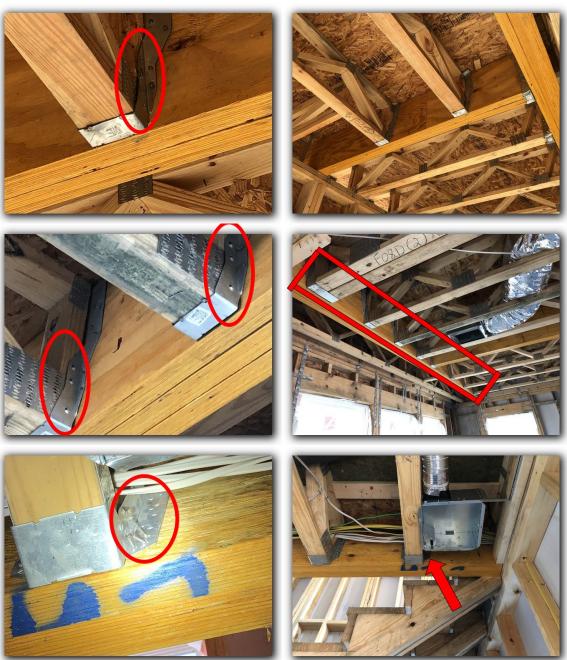
Ceiling joist hanger straps missing nails or nailed improperly in several areas throughout the home.
