PROPERTY INSPECTION REPORT

Prepared For: John Doe
(Name of Client)

Concerning: 1234 Anywhere Street, Anywhere, TX 77777
(Address or Other Identification of Inspected Property)

By: Shawn Emerick, Lic #4623 06/19/2017
(Name and License Number of Inspector) (Date)

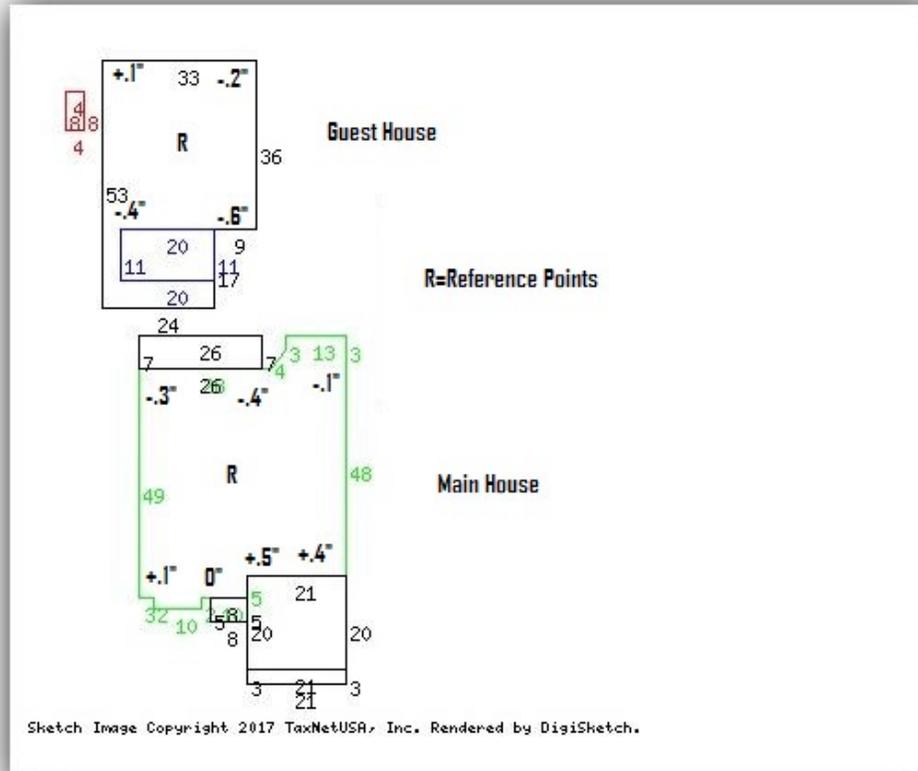
The below graph reflects measurements taken during the inspection to assist with determining the performance of the foundation. The outline / drawing is not to scale and does not accurately reflect every detail of the foundation walls.

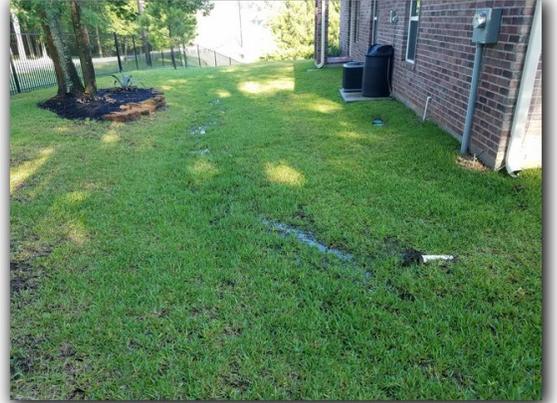
The drainage swale at the front and right of the guest house is holding water. The lot should be graded to allow storm water to drain to the street. If grading improvements cannot be made the installation of underground drainage systems should be considered.

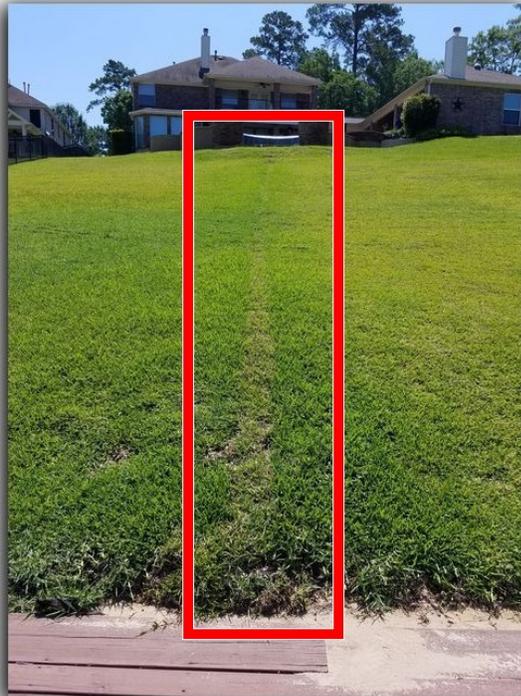
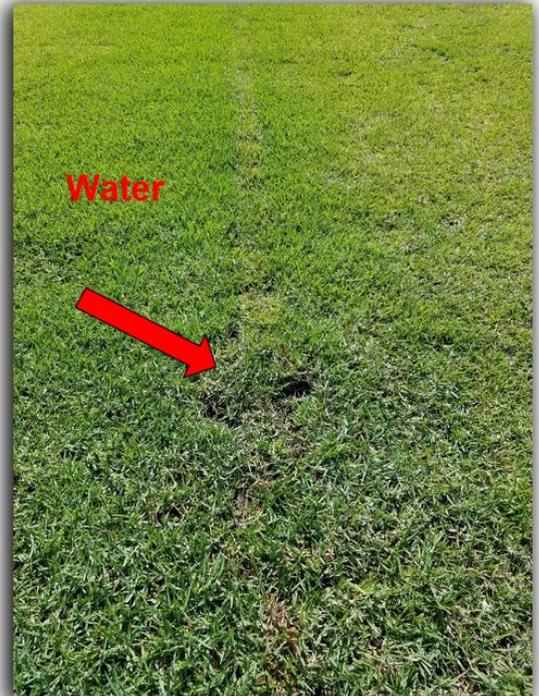
Water was found running from a the ground / pipe at the rear of the property. It appears that this area had been recently excavated as evident by the displaced soil / sod. I could not determine what the source of the water. Recommend further inquiries and investigation if needed to determine the source of the water and the reason for the recent repairs.

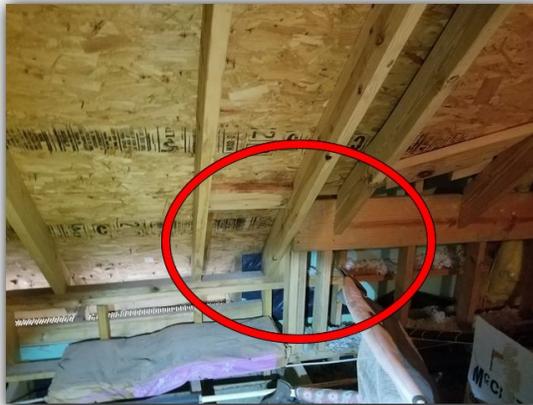
Staining was found at sections of the roof decking as evidence of active roof leaks (main house garage attic). A qualified tradesman should further evaluate the roof and make the necessary repairs to repair the leaks.

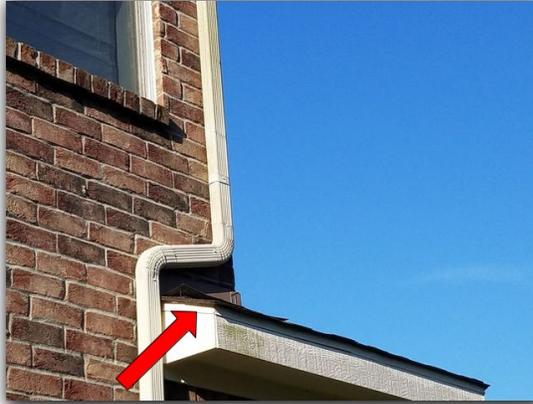
Sections of the roof flashing are raised which could lead to water penetrations. Recommend repairs.

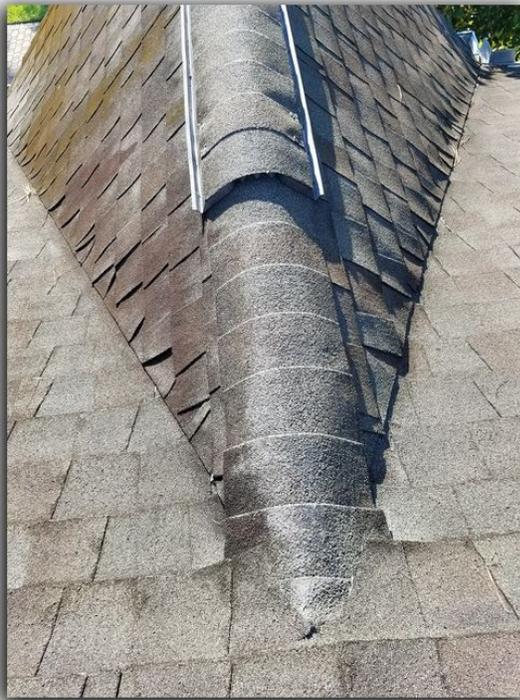
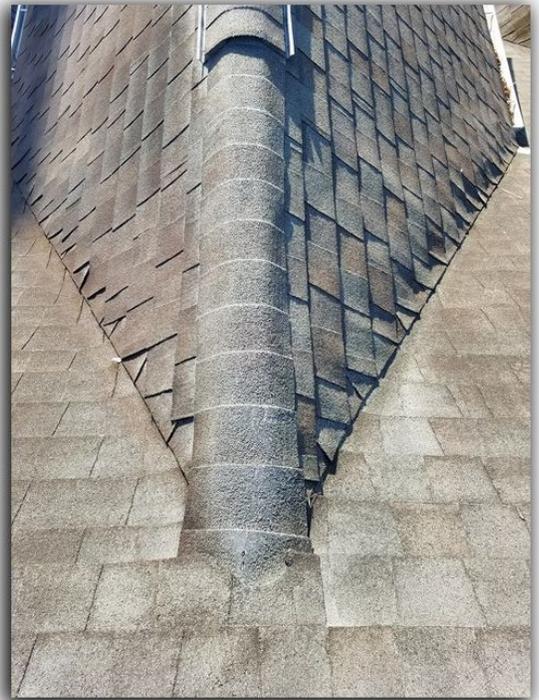
The hip and ridge shingles have reached the end of their serviceable life's as evident by excessive loss of aggregate and damage at many locations. This commonly occurs when these shingles are a different quality than the main body. Recommend contacting a qualified tradesman to evaluate the roof and make the necessary repairs.

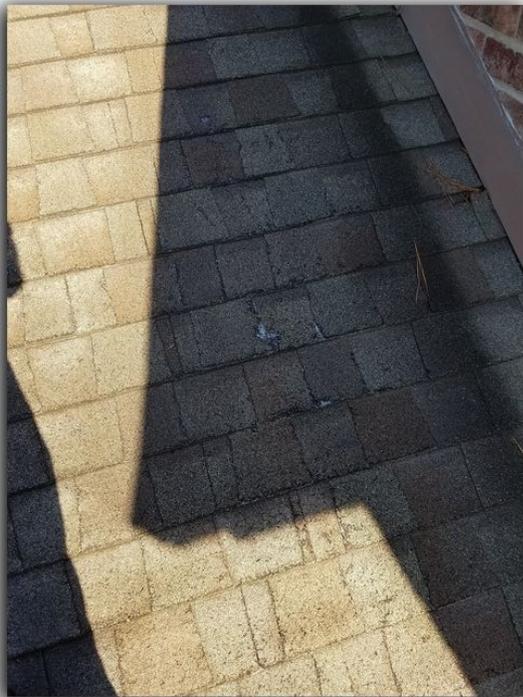
Damaged and / or missing shingles were found during the inspection of the roof covering. Recommend repairs by a qualified tradesman.

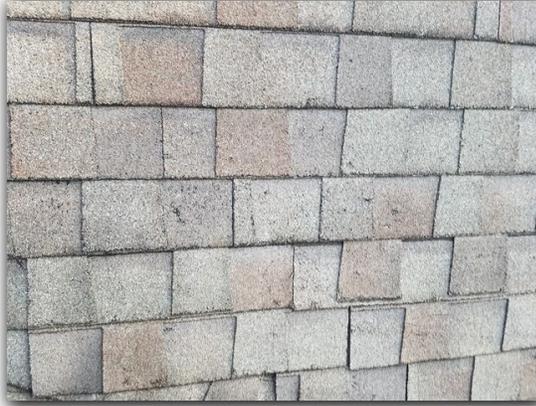
Evidence of loss of aggregate was noted during the inspection of the roof covering as evidence of aging.

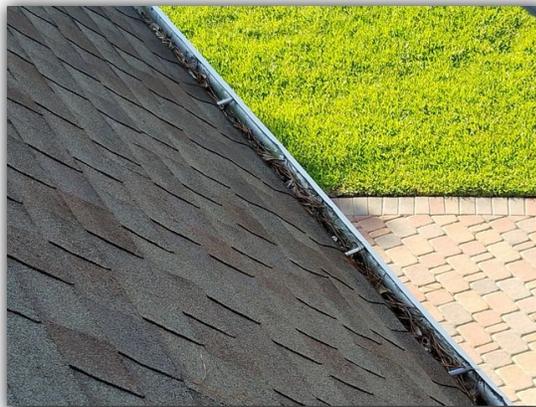
The debris should be cleaned from the gutters to allow proper drainage of rainwater from the roof covering.

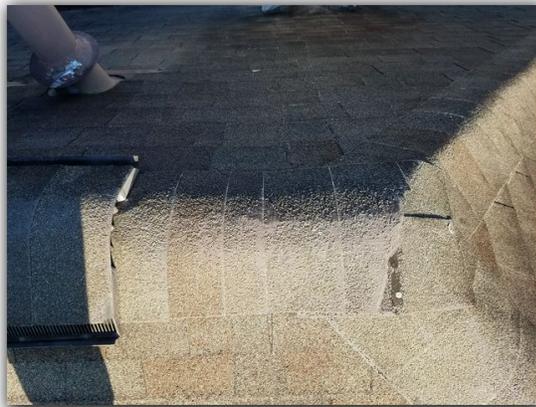
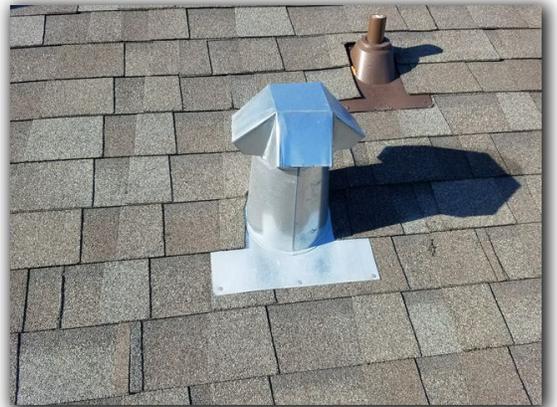
Exposed nail heads were found at roof jacks and / or sections of the flashing. All exposed nail heads should be sealed to prevent water penetrations.

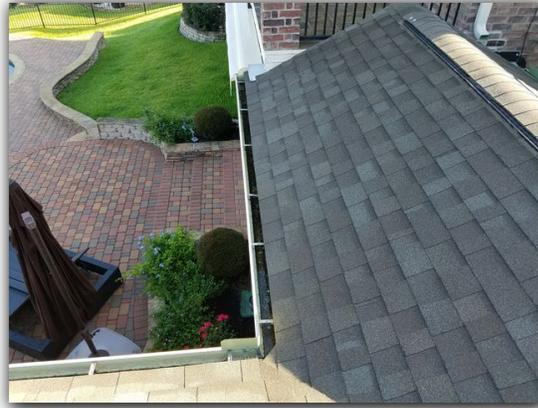
Evidence of improper sloping of the gutter was found as evident by a standing water in sections of the gutters. This problem can lead to future leaks.

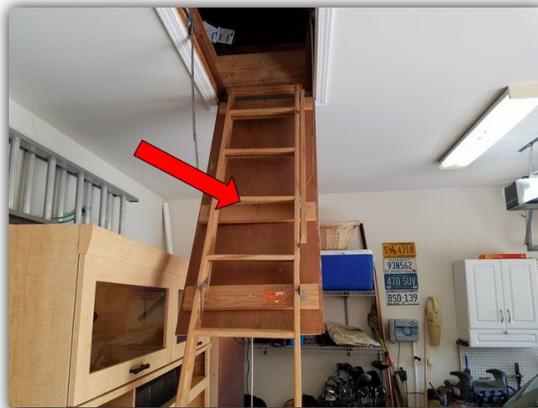
The panel is loose at the main house garage attic ladder.

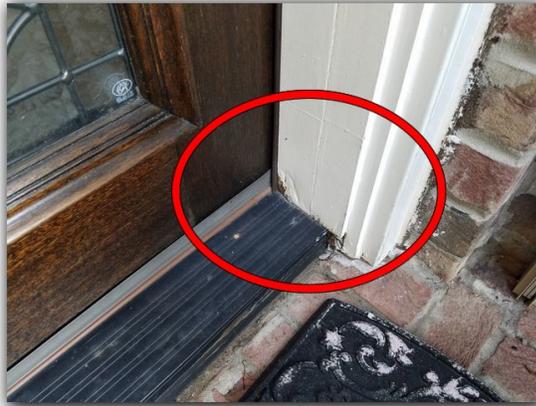
Recommend repairs / replacement of the affected areas. In addition, areas where decay is present should be removed, exposing underlying materials for inspection prior to repair by a qualified tradesman.

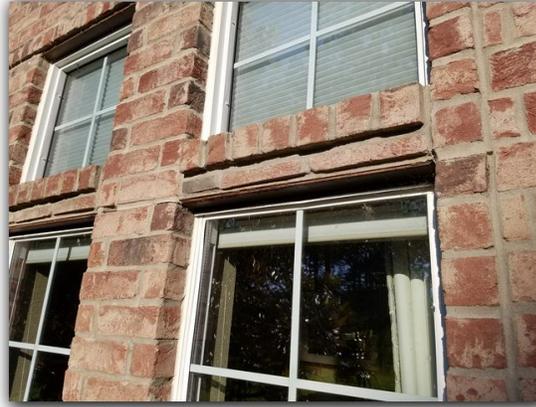
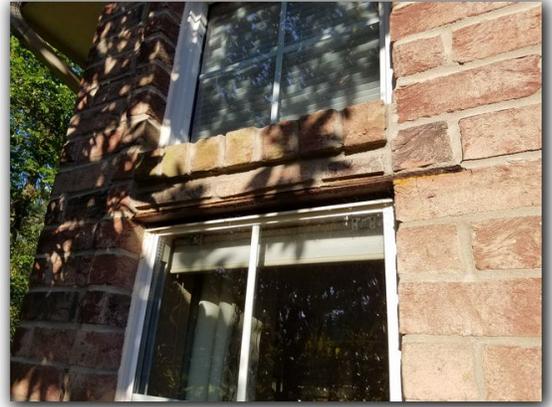
The metal lintels on the exterior of the structure are rusted. Lintels are metal that is installed over openings in the brick veneers (doors, windows, etc). Further evaluations and repairs by a qualified tradesman.

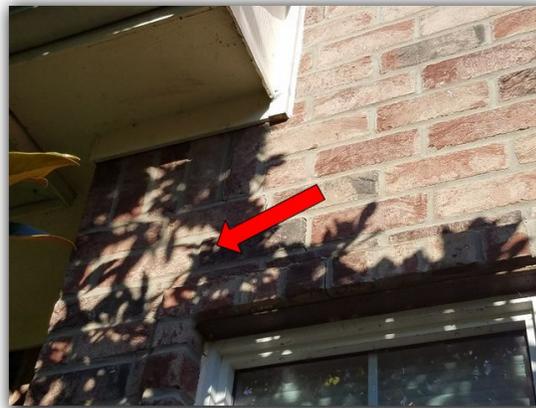
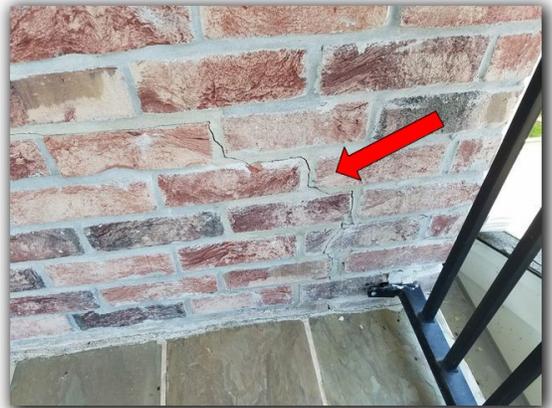
Brick / mortar cracks were found on the exterior of the structure as evidence of settlement of the structure.

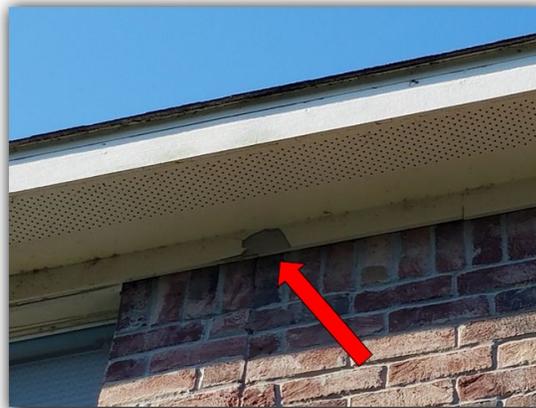
The paint appears to be wearing down on the exterior of the structure as evident by fading and flaking.

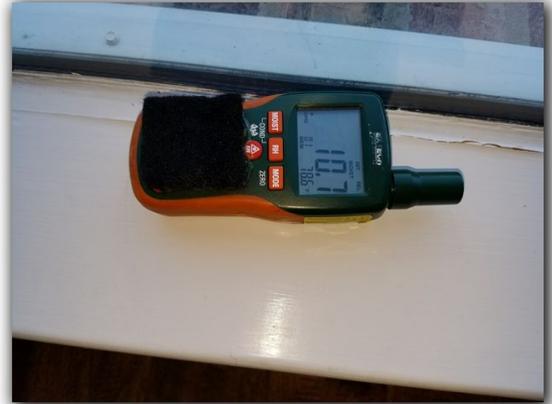
Staining and discoloration was found at the windowsills in the master bedroom. Sealing on the exterior of the windows can sometimes correct this problem. At a minimum these areas should be monitored and repaired as needed. No moisture was found present at the inspection.

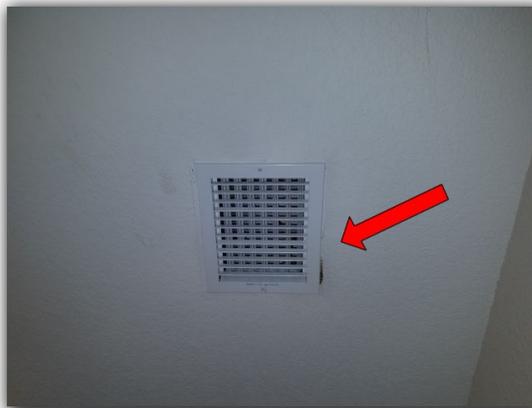
A small amount of discoloration was noted at the ceiling near a supply register in the downstairs guest bedroom.

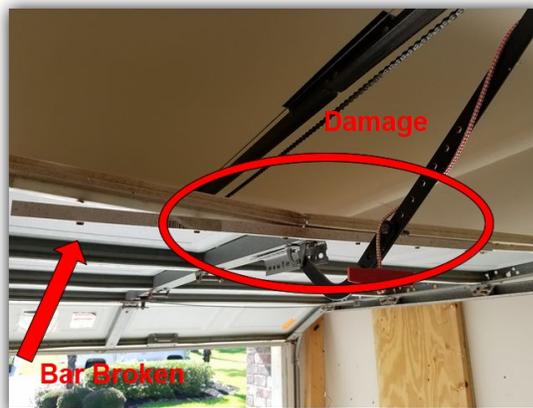
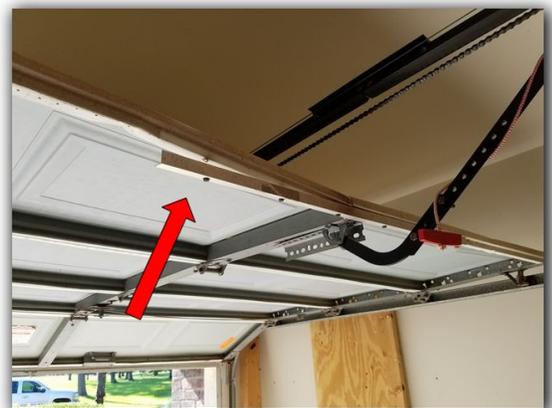
Damage was found at the left garage door panel. It appears repairs were previously attempted, but the reinforcement bar has broken off the panel. Recommend repairs prior to use by a qualified tradesman.

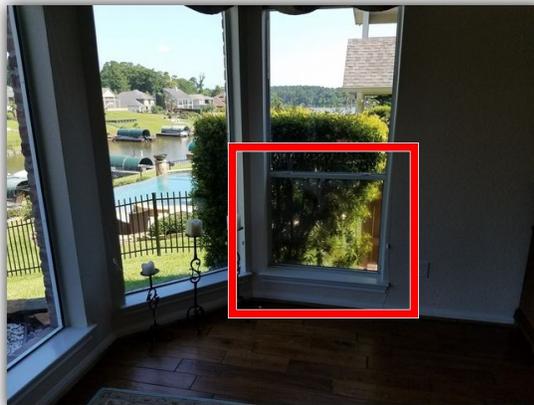
This was evident by the build up of condensation and / or discoloration between the two window panes. A qualified tradesman should be consulted to repair or replace the windows found deficient and evaluate the other windows in the property for additional lost seals.

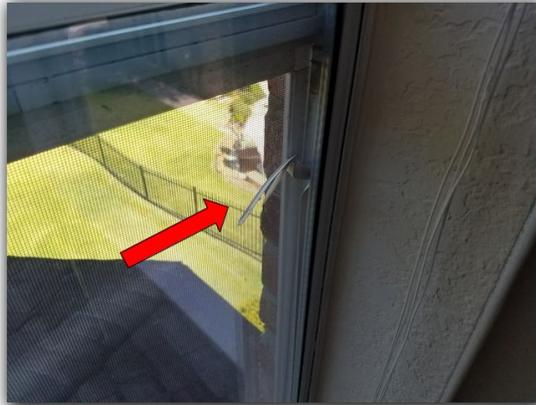
Damaged weather stripping on the exterior of the glass was found at windows in the back right second floor guest bedroom and in the second floor game room. These problems interfere with operation of the windows.

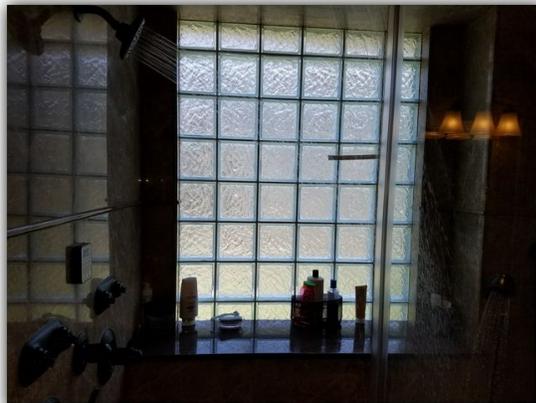
Window(s) were found installed in the bathroom shower enclosure(s). These openings will be vulnerable for water penetrations and should be inspected / sealed regularly.

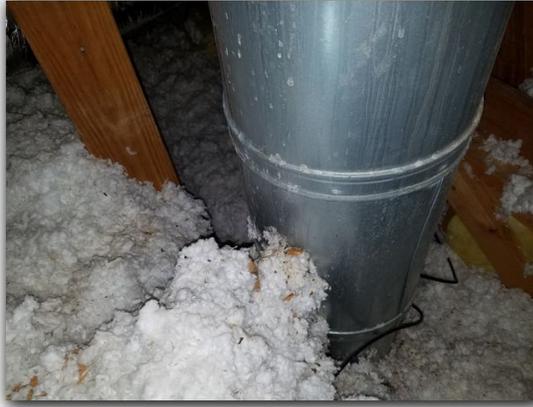
Evidence of leakage at the main house chimney cap was noted in the attic. Recommend sealing at the cap.

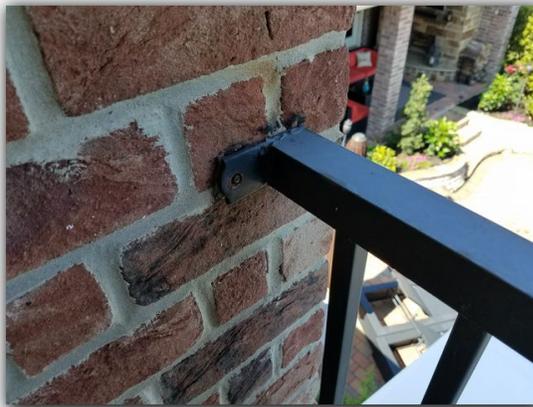
Loose railings were found at the second floor balcony.

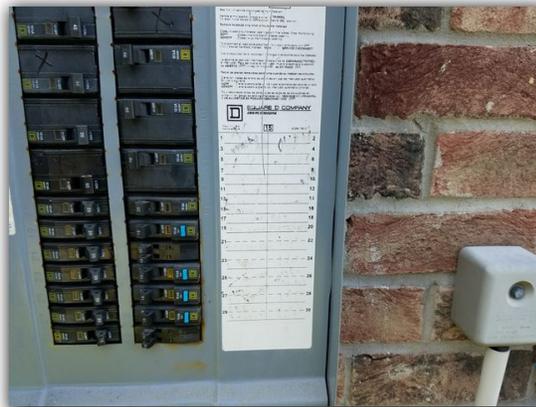
The main electrical panel should be relabeled as the original markings are beginning the fade.

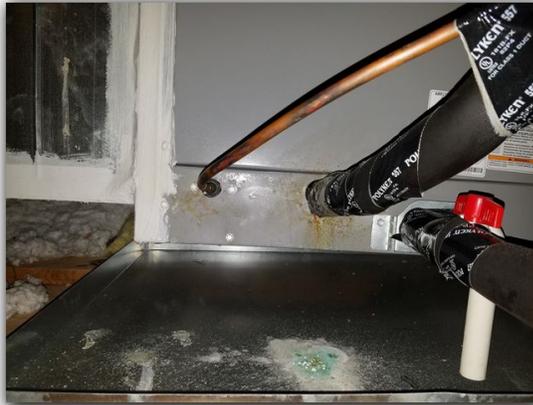
Condensation was found on the exterior of the evaporator coil housing for unit #1 in the attic. This has led to moisture related problems, i.e. mildew, rust & corrosion, etc. Recommend further evaluation by a licensed HVAC contractor to determine the needed repairs to correct this problem.

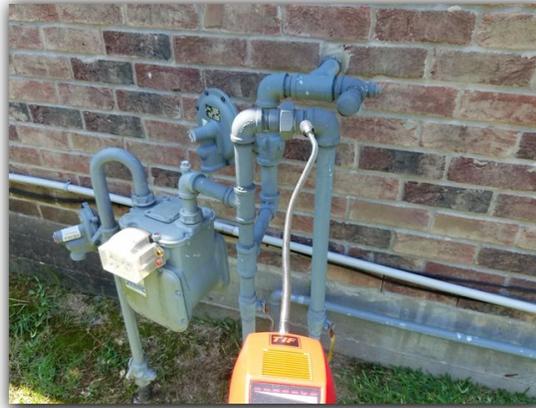
A gas leak was detected at the piping near the gas meter on the right exterior of the home. Recommend repairs by a licensed plumber as soon as possible. The buyer agent was notified and agreed to contact the selling agent about this hazard.

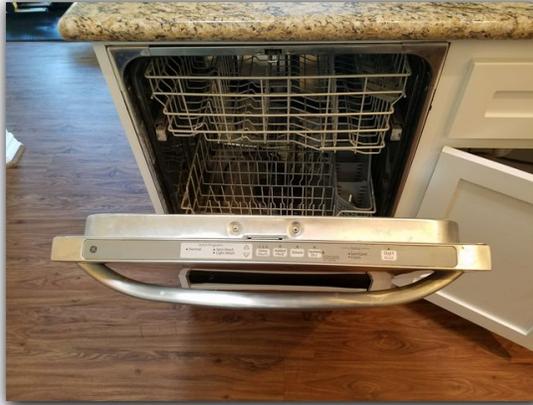
The dishwasher at the guest house would not operate (all disconnects on that could be located). Recommend further investigation and repairs.

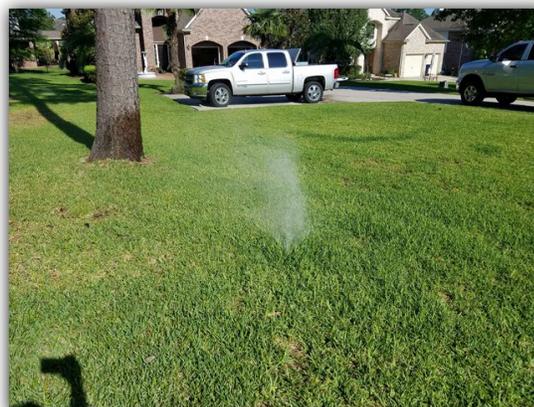
Heads were found in zone #3 that need to be raised due to the height of the grass and other vegetation. This problem is preventing the heads from properly watering the designated area.

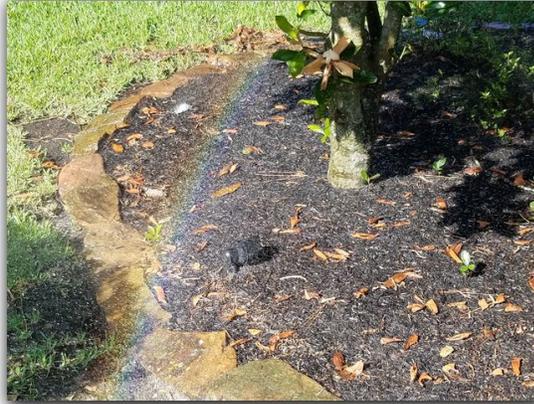
Broken sprinkler heads were found in zone(s) #1 (main). A qualified tradesman should be consulted to perform all necessary repairs.

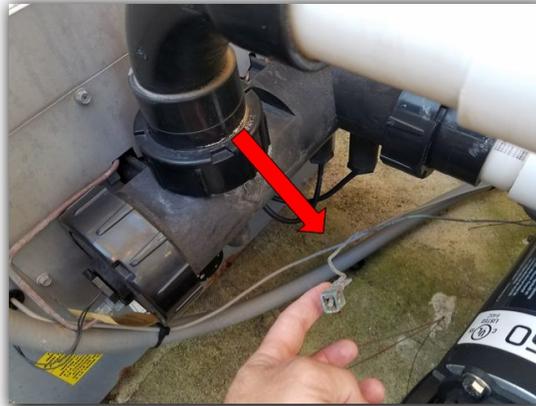
The bonding conductor is detached from the pool heater. Recommend repairs.

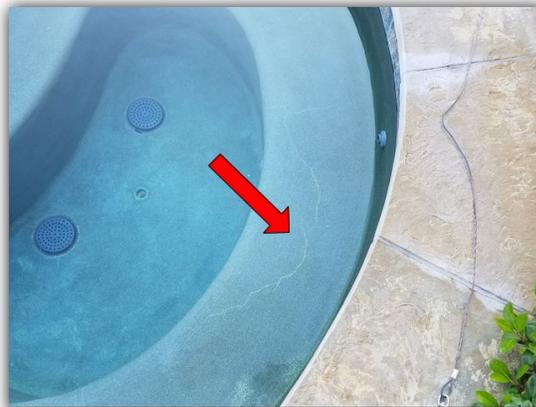
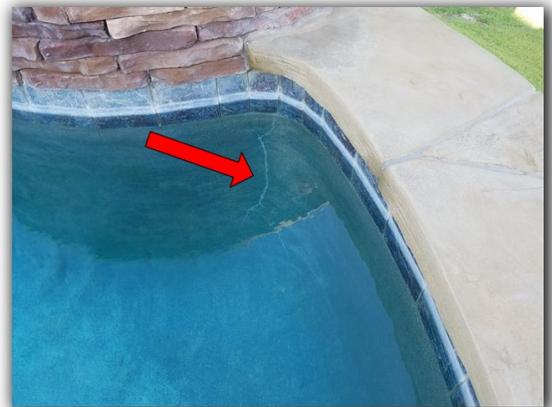
Surface cracks were noted at the spa and pool's surface. These cracks do not appear to be a result of structural problems. The cracks can be repaired by a qualified tradesman.

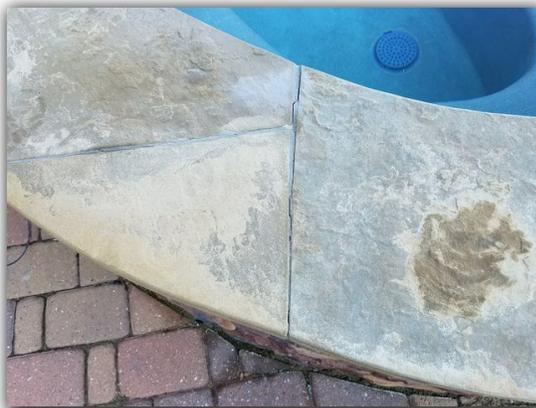
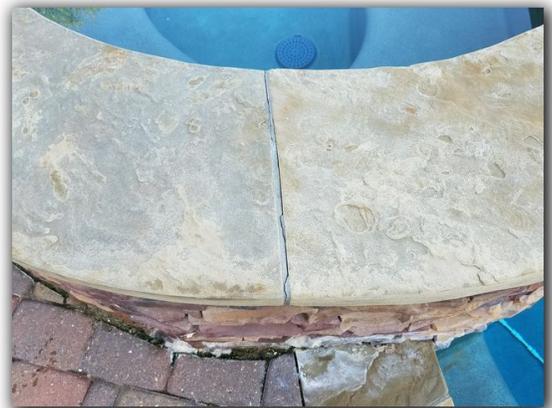
Missing grout / mortar was found at some locations of the coping. Recommend sealing.

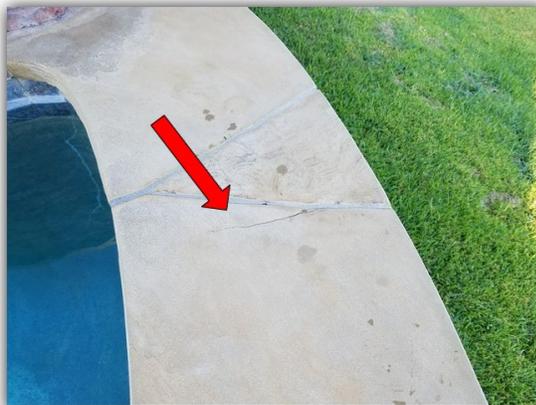
Cracking was noted at one section of the pool coping.

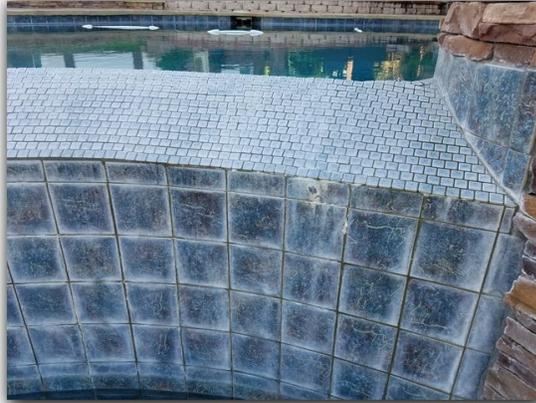
Some mineral build up was noted at the overflow side walls.

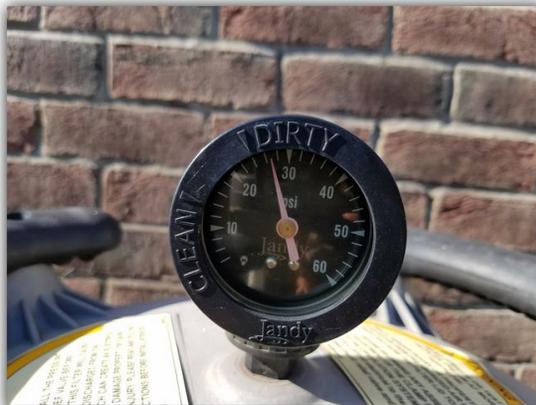
The main pool filter should be cleaned by a qualified tradesman as evident by a elevated pressure at the filter gauge.

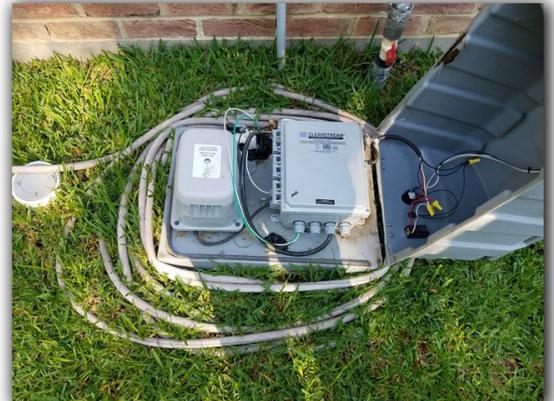
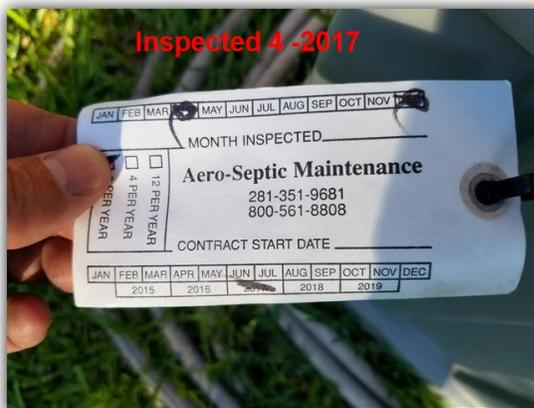
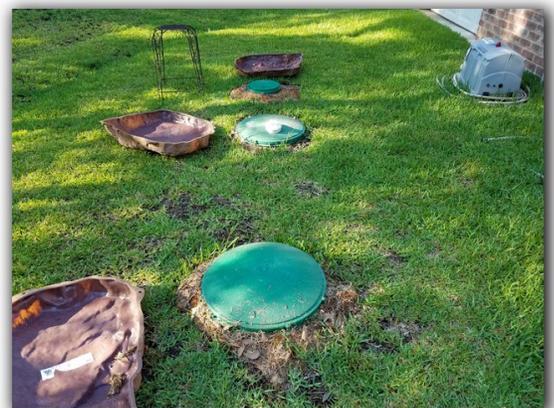
The private sewage disposal (septic) system and related components do not appear to be operating adequately at the time of this inspection. The system is not achieving an operation, function, or configuration consistent with accepted industry practices for its age. It is recommended further evaluation by a qualified tradesman.

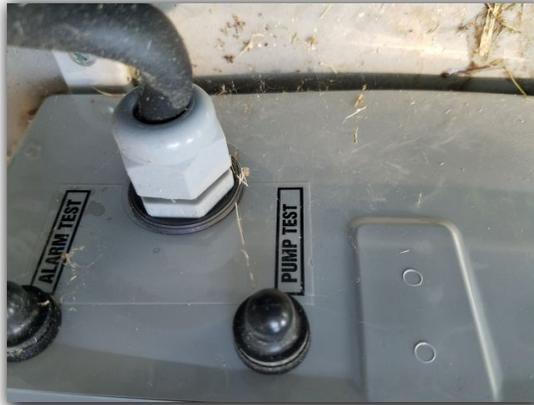
During testing of the guest house the system the pump would not function. I could not get the pump to turn on during testing (both with button pushed and after filling system). This prevented me from locating the spray field for the system. Recommend further evaluation and repairs by a licensed contractor.
