John Doe 123 Main Houston, TX

August 27, 2020

PROPERTY INSPECTION REPORT

Prepared For:	John Doe			
	(Name of Client)			
Concerning:	123 Main, Houston, TX			
C	(Address or Other Identification of Inspected Property)			
By:	Shawn Emerick, Lic ##4623	08/27/2020		
•	(Name and License Number of Inspector)	(Date)		
	Shawn Emerick Lic #4623 (Name, License Number of Sponsoring Inspector)

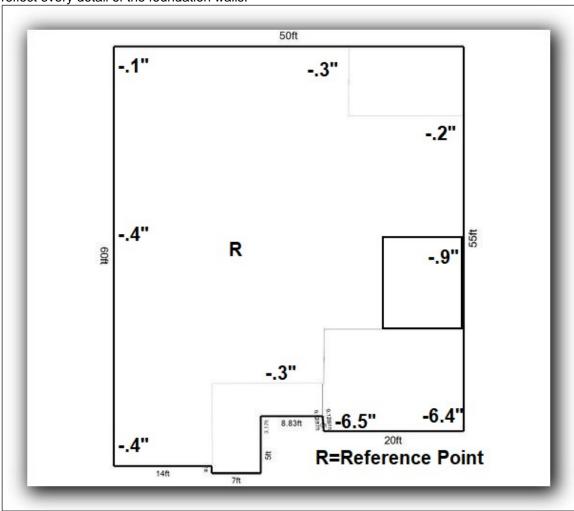
The below graph reflects measurements taken during the inspection to assist with determining the performance of the foundation. The outline / drawing is not to scale and does not accurately reflect every detail of the foundation walls.

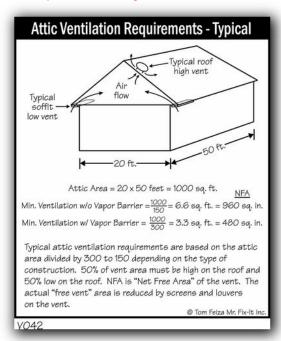
The level of ventilation should be improved in the lower roof structure / attic (above garage and front lower rooms). It is generally recommended that one (1) square foot of free vent area be provided for every one hundred and fifty (150) square feet of ceiling area. Proper ventilation will help extend the life of roofing materials and could (if over living space) assist with the energy efficiency of the building.
