HOUSTON INSPECTIONS

PROPERTY CONDITION REPORT

Concerning: 1234 Any Street, Houston, TX
(Address of Inspected Property)

By: Dennis Inman, Lic #20664 10/31/2018
(Name and License Number of Inspector) (Date)

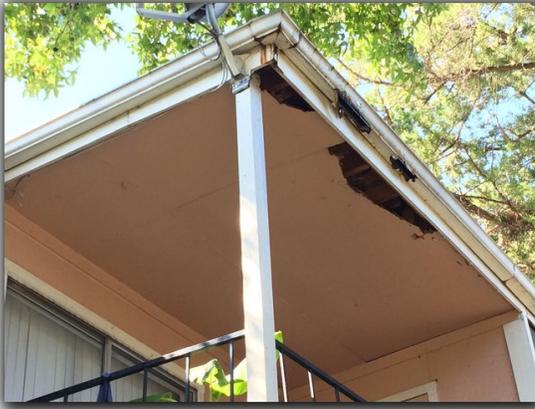
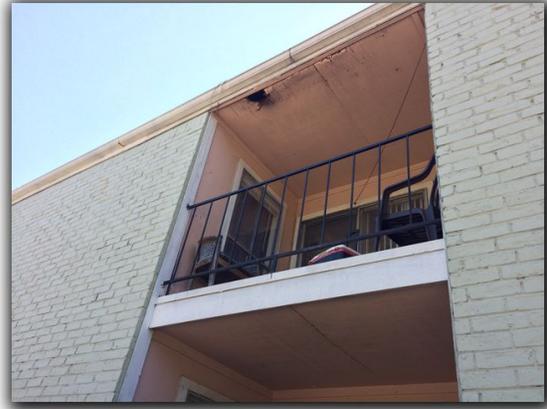
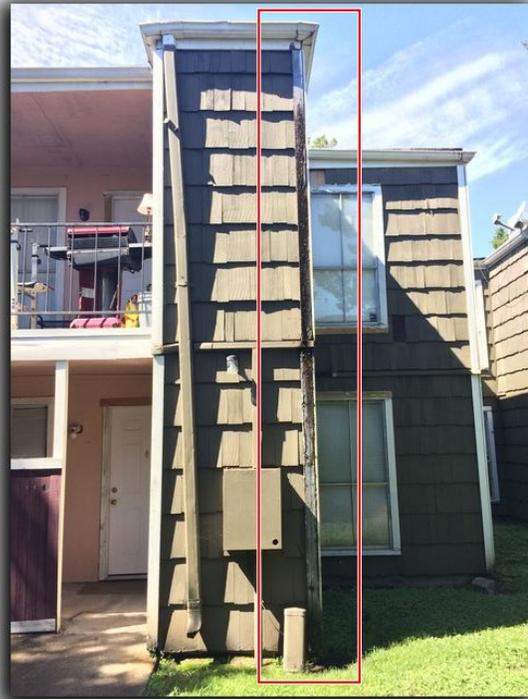
Sections of the roof flashings are raised which could lead to water penetrations. Recommend repairs.

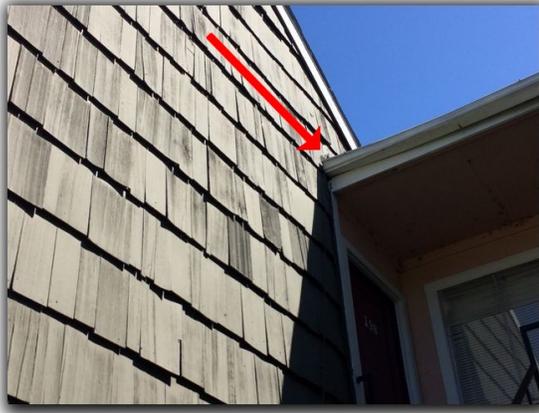
- "Z" flashing missing at exterior wall openings, i.e. projecting trim, doors, windows, etc.
- Kickout / diverter flashing is not installed at the wall & roof Intersections. This creates an opening that could allow moisture to enter the wall cavity and create damage.

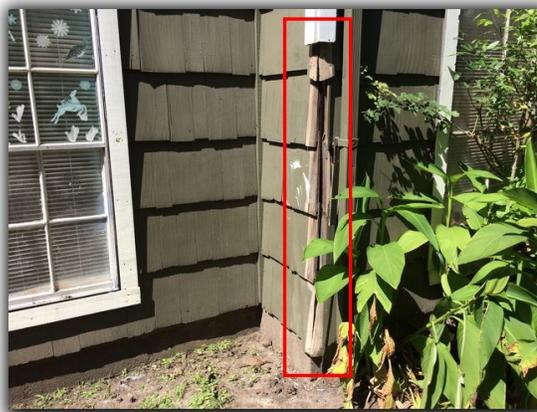
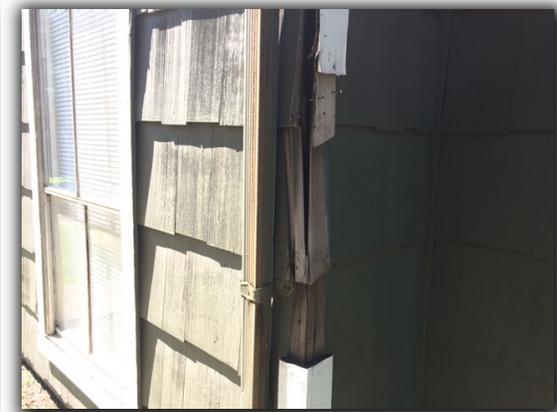
Damaged and / or missing items were found on the exterior of the property. Recommend repairs / replacement of the affected areas. In addition, areas where decay is present should be removed, exposing underlying materials for inspection prior to repair by a qualified tradesman.

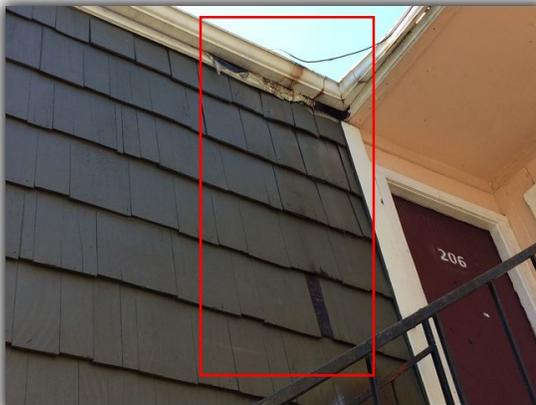
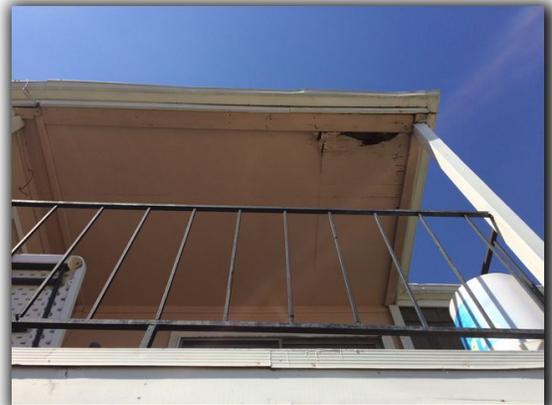
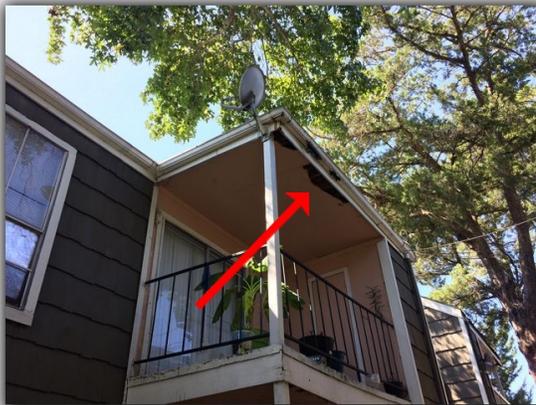
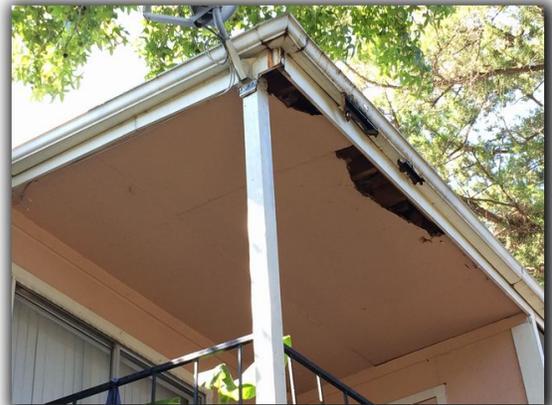
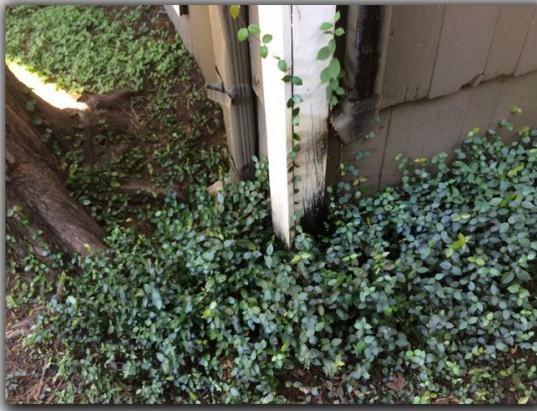
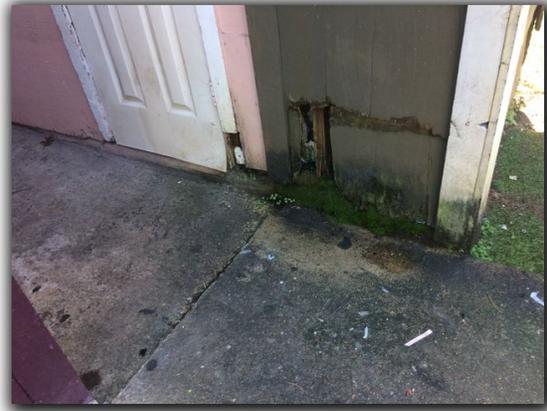
Moisture damaged wooden components were found at many locations. The vast majority of these extensive damages appear to have originated from improper clearances to soil/flatwork as well as moisture accumulation predominantly caused by improper, damaged, and incomplete gutter system. Underlying damages affecting the interior of these areas should be anticipated.

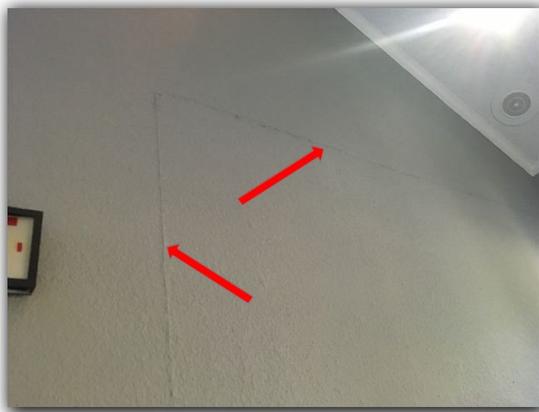
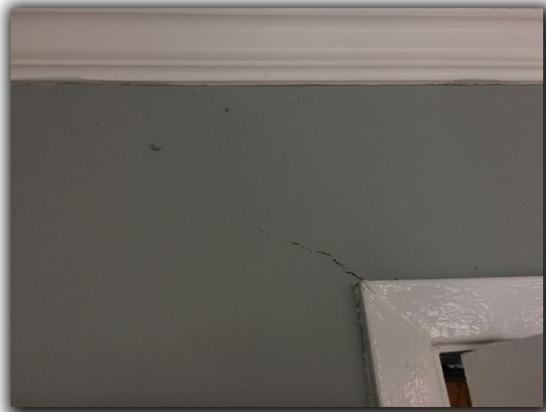
Drywall cracks were found on the interior of the property as evidence of settlement. The cracks can be repaired if desired for cosmetic purposes.

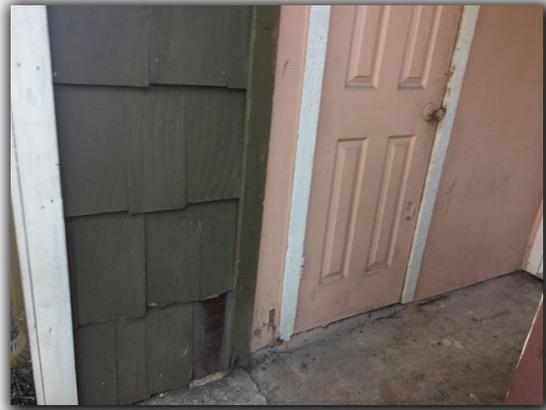
Multiple damaged doors were noted at the interior and exterior during the inspection. Recommend evaluation for repair by a qualified tradesman

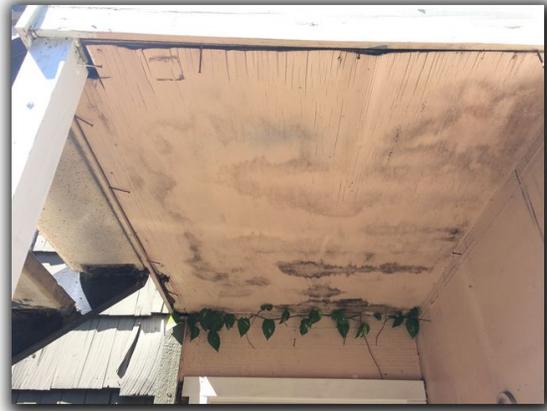
Damaged components were found at balconies as evidence of moisture intrusion/accumulation. Repair by a

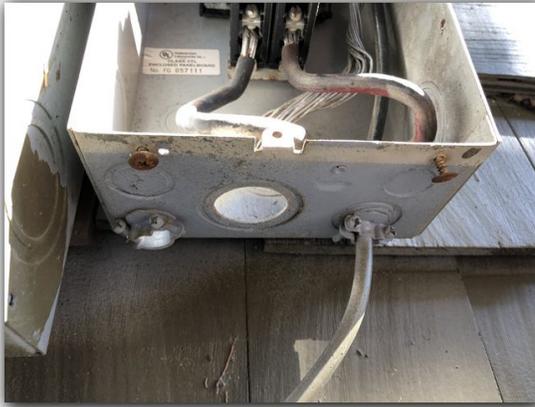
Missing internal knockouts were found on the interior of many of the panels.

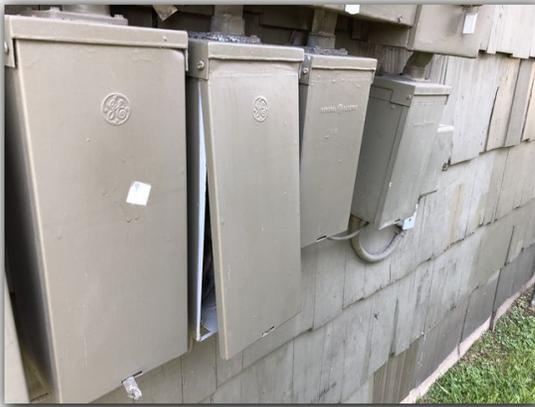
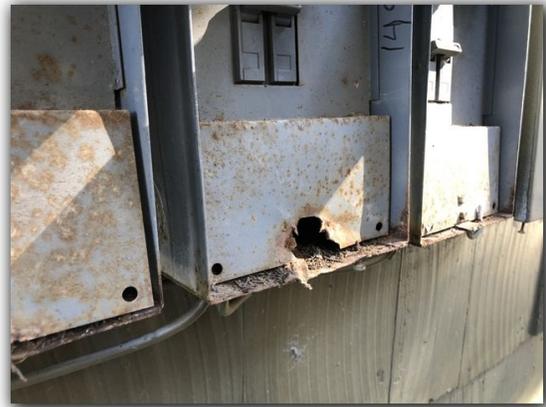
Many of the panel covers are bent, damaged, and loose. Recommend repairs or replacement by a licensed electrician.

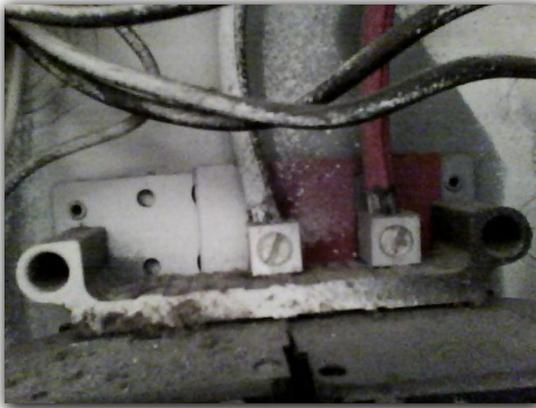
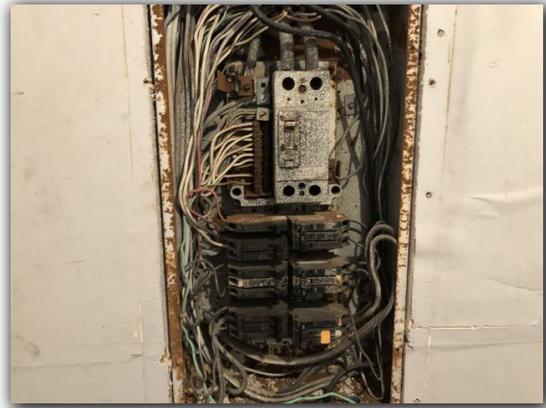
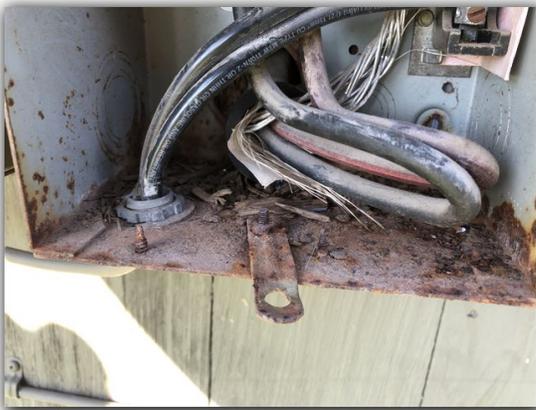
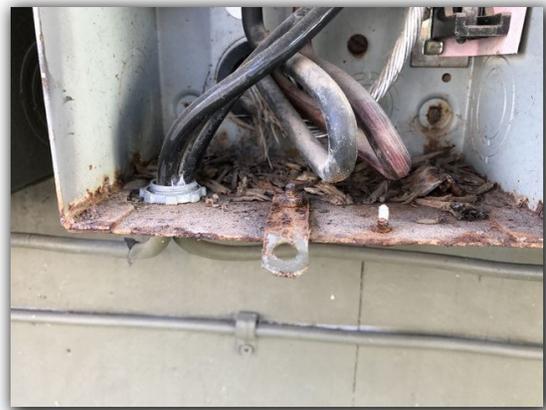
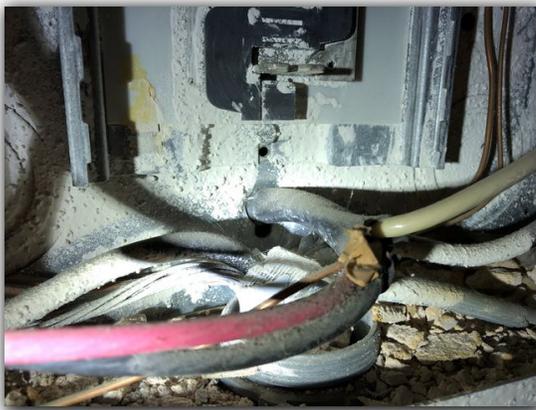
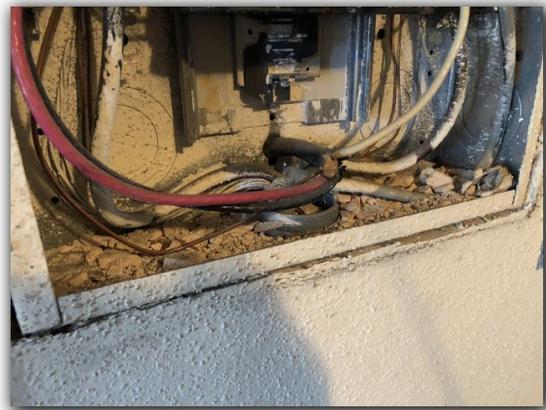
Debris (paint/texture, wood shavings, panel parts, etc.) was found within many of the electrical sub-panels, main panels, and on various conductors. The interior of the panel and conductors in the panel should be cleaned as required by code.

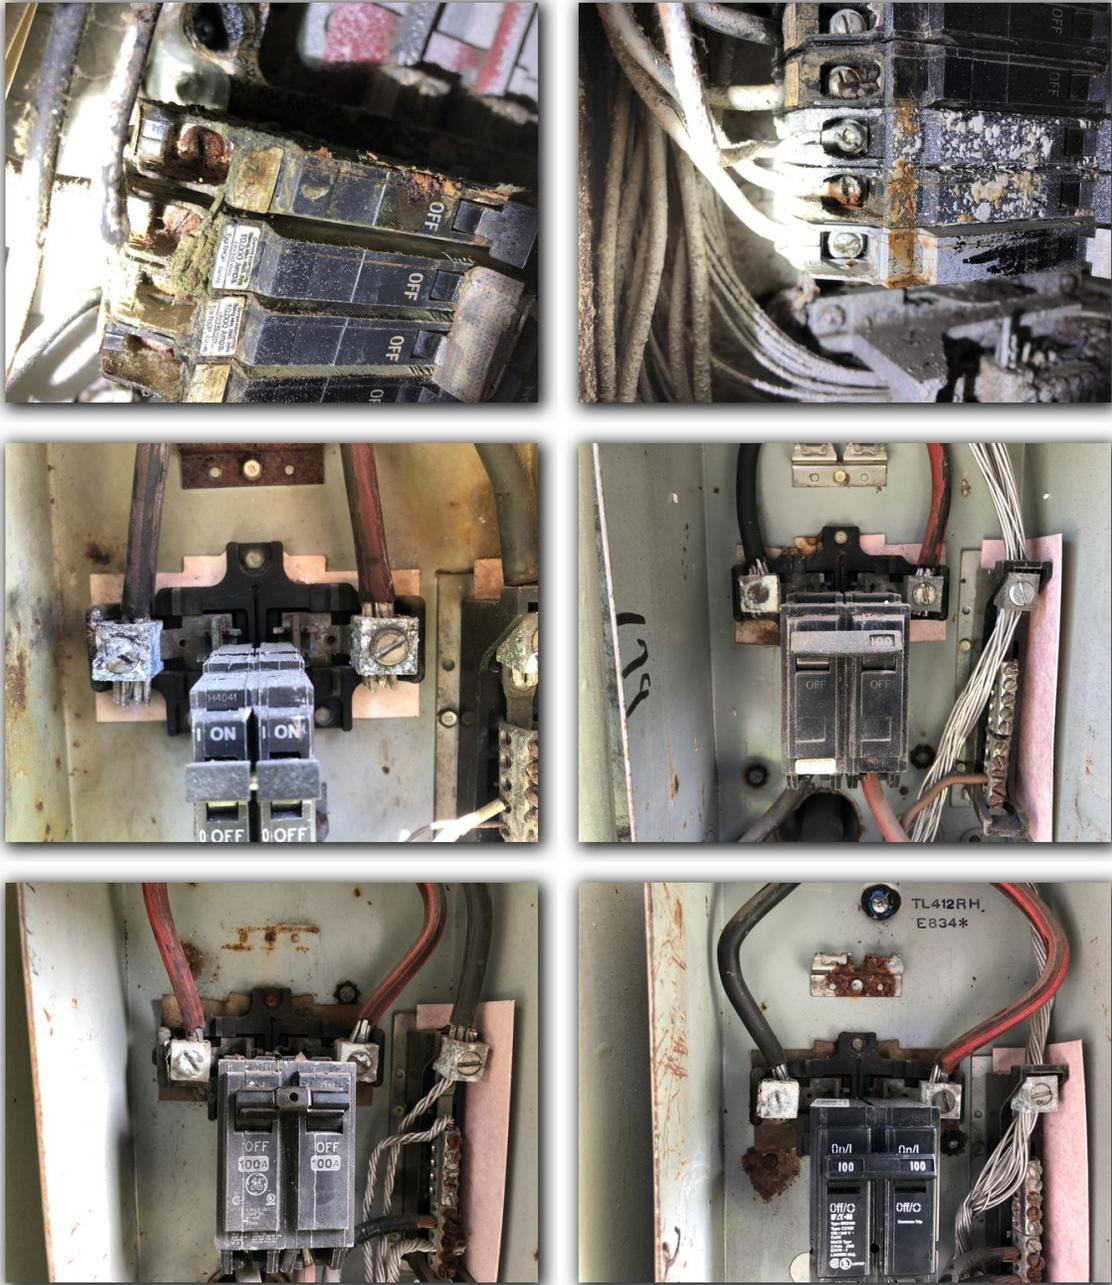
Corrosion was found at several conductors within the service panels indicating water/moisture penetrations. A licensed electrician should be consulted to correct these problems.

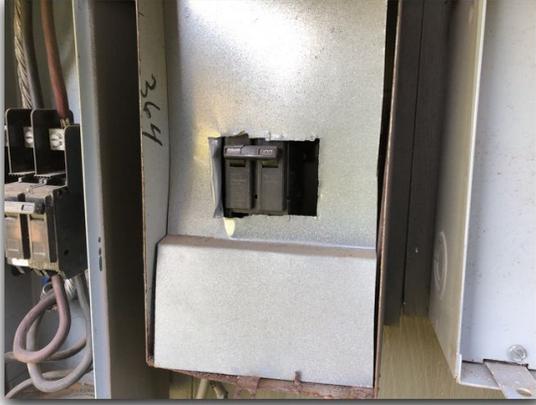
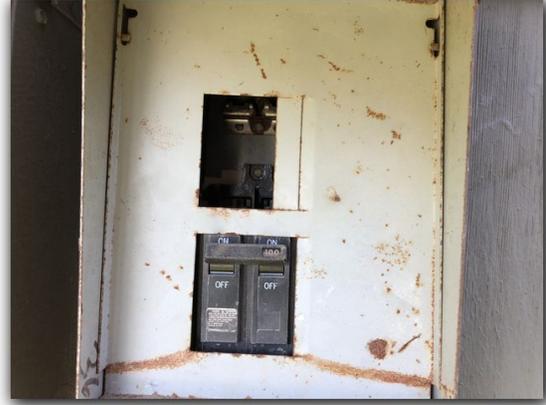
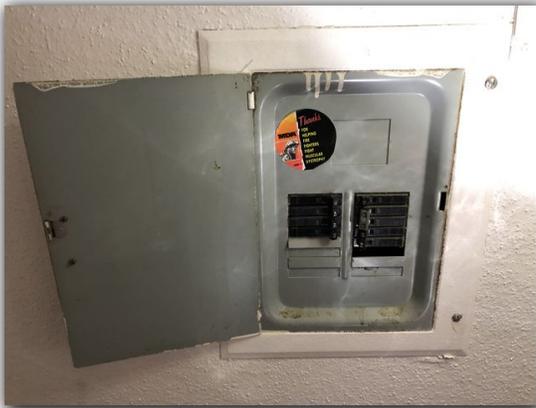
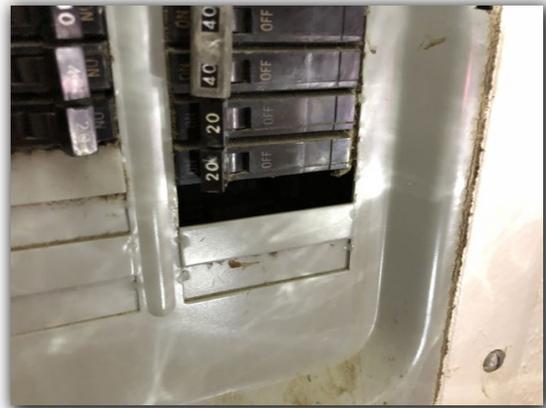
Missing knockout tabs were found at many of the electrical panels. Knockouts are spaces in the panel where breakers either were previously installed or the tabs were removed in anticipation of a breaker that was never installed. These openings pose a safety hazard to the occupant if objects are placed in this area and contact the electrical supply. Recommend filling the knockout openings with an approved device as soon as possible.

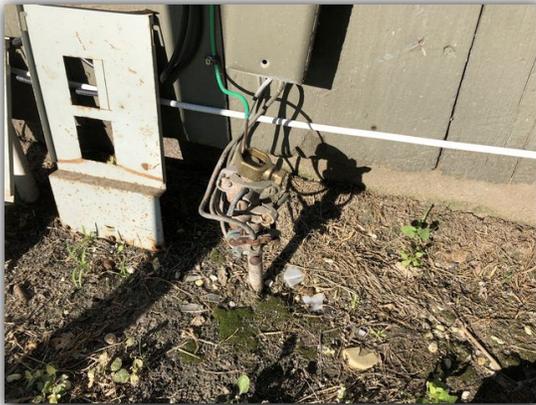
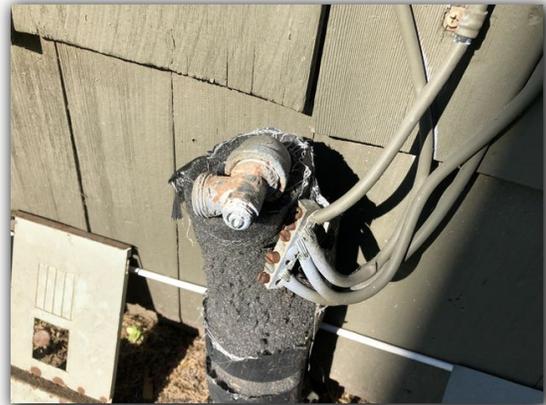
The grounding wire/clamp is loose at several of the ground rods. Recommend tightening the two screws at the clamp.

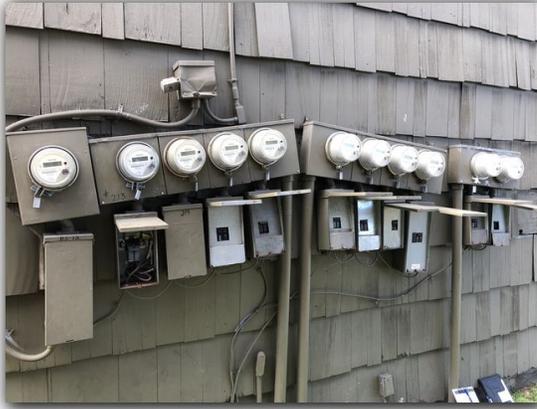
Many of the electrical meters are loose on the exterior wall of the buildings. The meter should be re-secured by a licensed electrician.

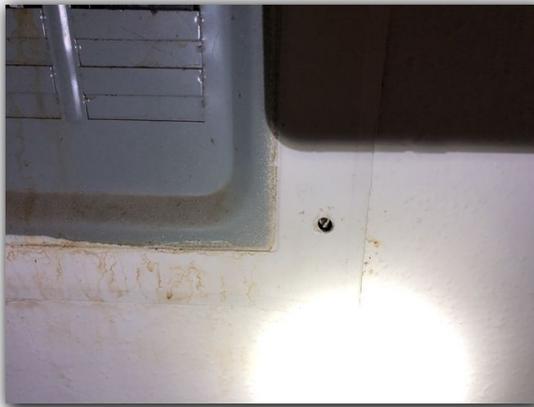
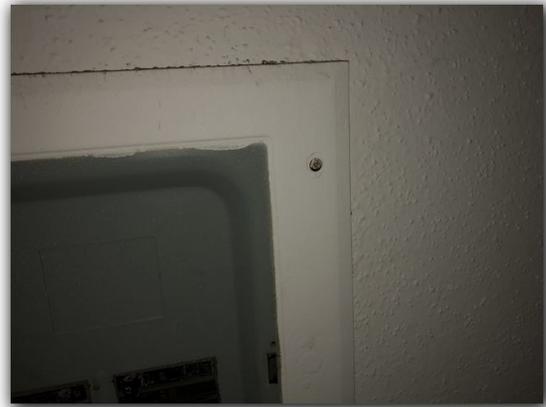
Many missing screws were found at the dead front cover located at the main service panel. Approved screws should be installed at the dead front to properly secure the cover.

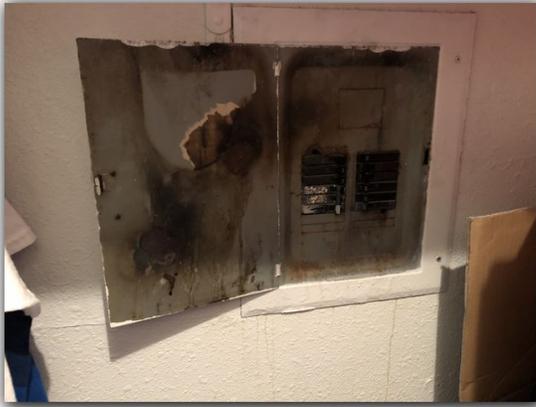
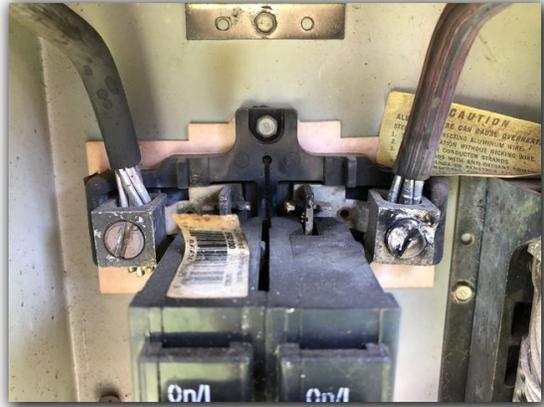
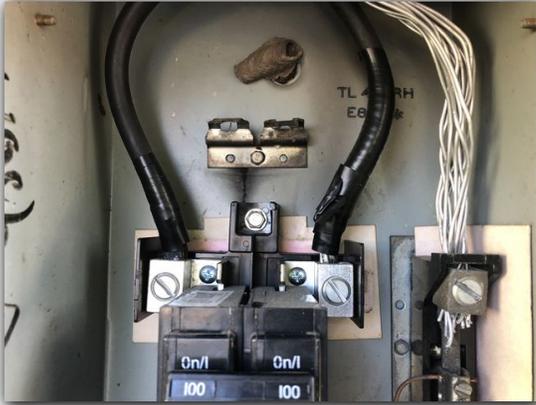
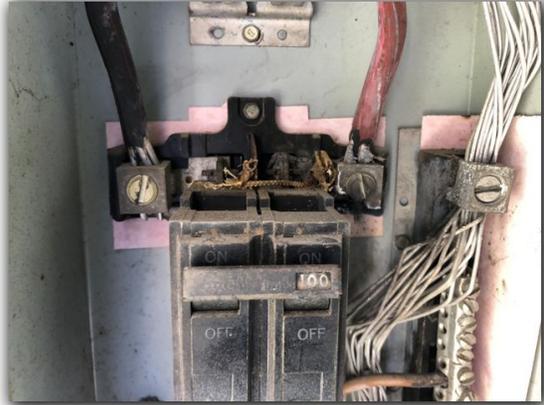
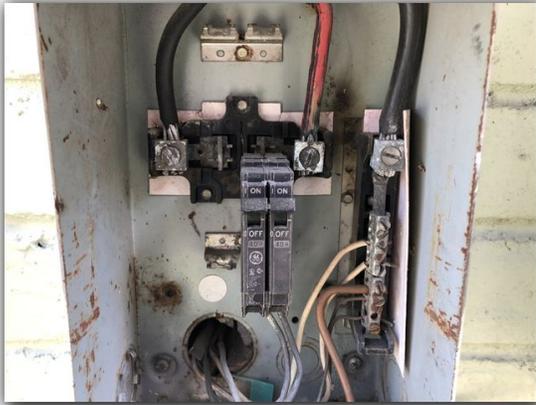
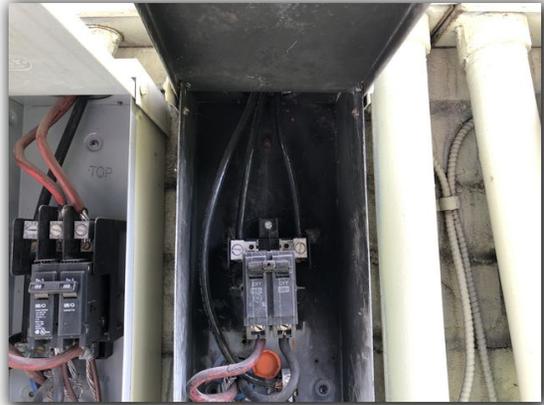
Evidence of previous overheating/arcng was noted within the panel as evident by discoloration on the interior of the box.

1. Bdle 9 Unit (not labeled)
2. Interior Sub panel Unit 143 and 277
3. Bdle 14 Washer Room
4. Bdle 17 Unit 175
5. Bdle 17 Unit 176
6. Bdle 17 Unit 174
7. Bdle 19 Unit not labeled

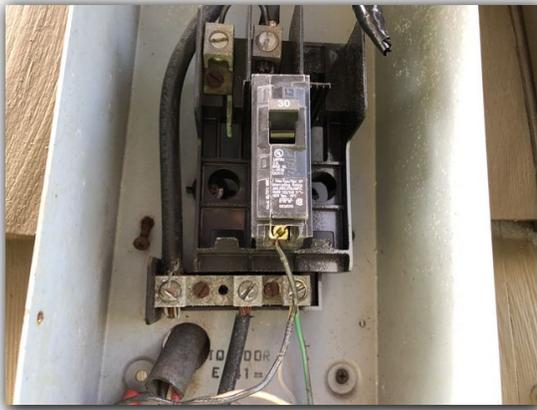
An improperly wire main service panel was found in building #12. Recommend further evaluation by a licensed electrician.

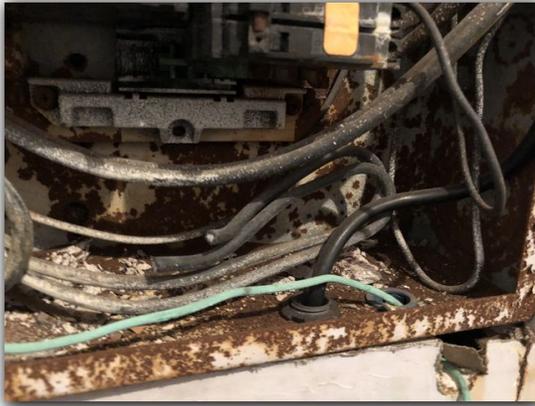
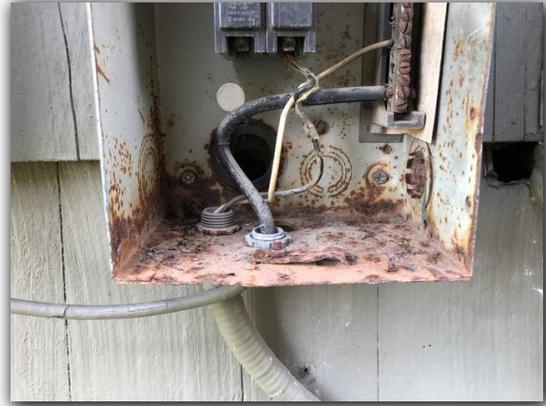
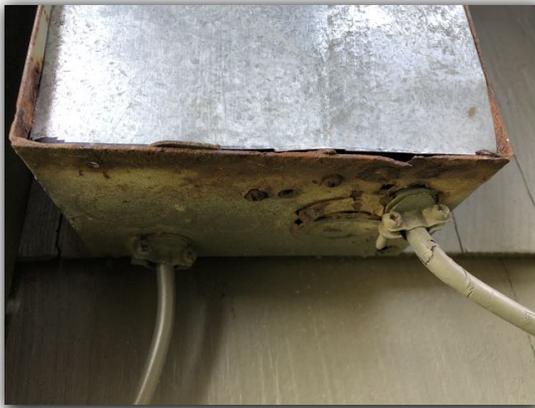
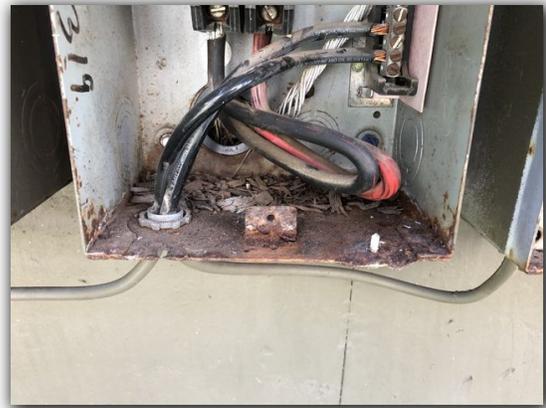
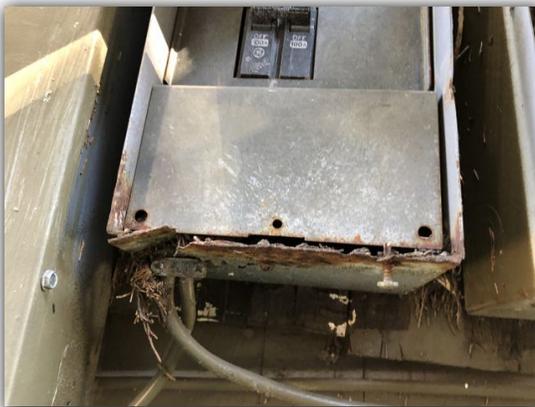
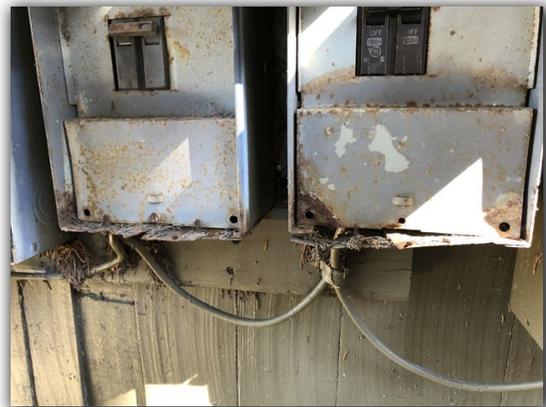
Most of the service box shows evidence of rusting, suggesting the presence of moisture. Many of the main electrical boxes are possible in need of replacement. Recommend further evaluation / replacement by a licensed electrician.

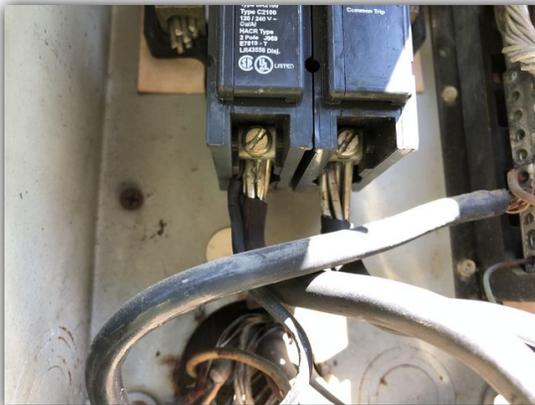
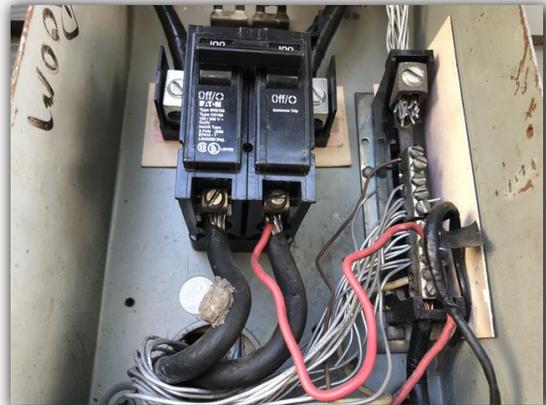
Double-lugged breakers within the service panels. Each conductor and circuit must have its own overcurrent protection.

1. Bdle 9 Unit not labeled
2. Bdle 14 Washer Room

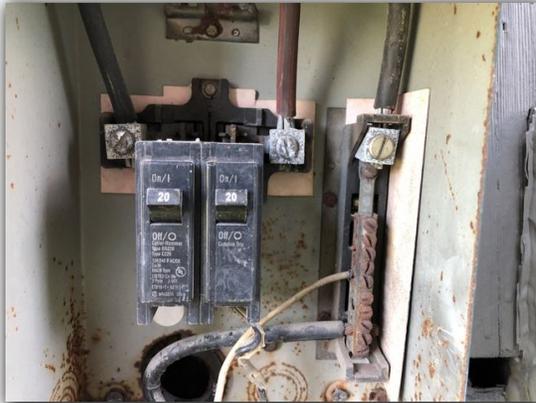
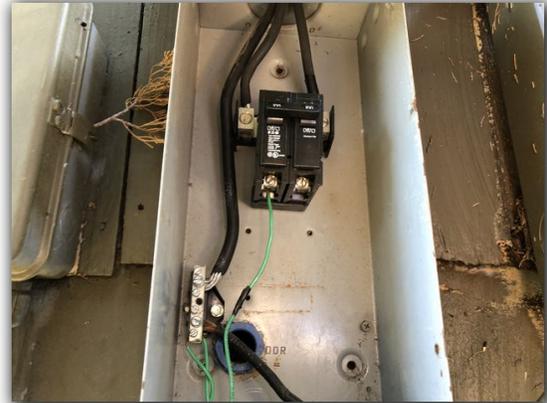
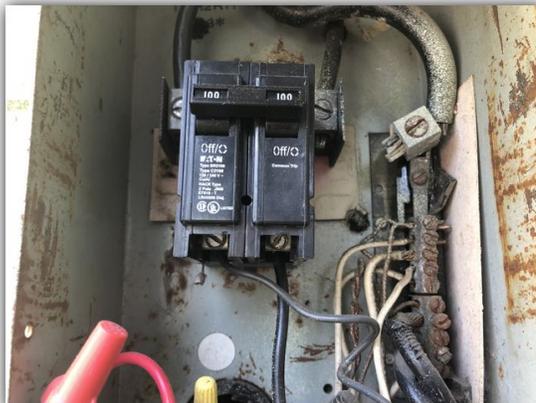
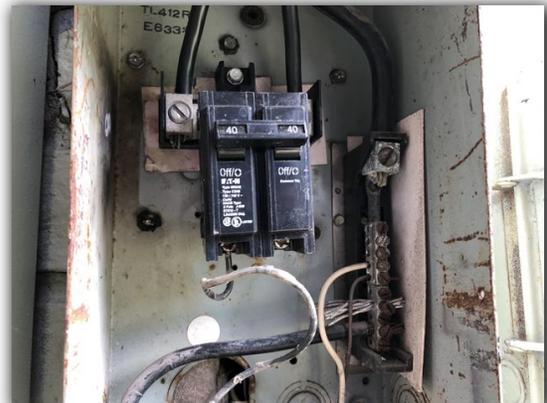
Oversized breakers were found within the electrical panel. Each breaker is rated for a specific size conductor. Ideally, these breakers should be re-sized by a licensed electrician.

1. Bdle 2 Unit not labeled
2. Bdle 16 Unit not labeled
3. Bdle 15 Unit not labeled
4. Bdle 10 Unit not labeled

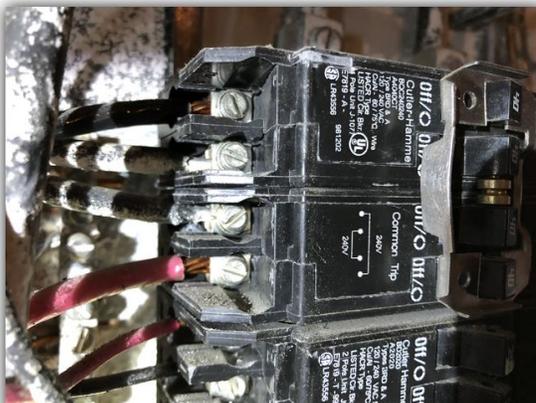
Aluminum wiring was observed at appliance breakers in several of the main service panels. The breakers are labeled for aluminum wiring but the connections at the receptacles for the appliances were not accessible to be inspected. Aluminum wiring must be fitted/connected with the special connectors and outlets to ensure safe operation of these circuits. Further investigation is recommended by a licensed electrician to verify that the aluminum connections are proper and perform repairs as needed.

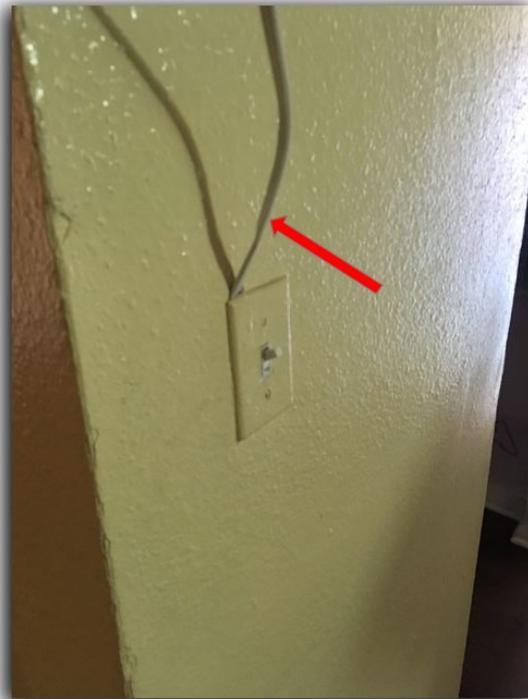
Missing conduit and improperly secured electrical conductors were noted in multiple units. Recommend evaluation for repair by a qualified tradesman

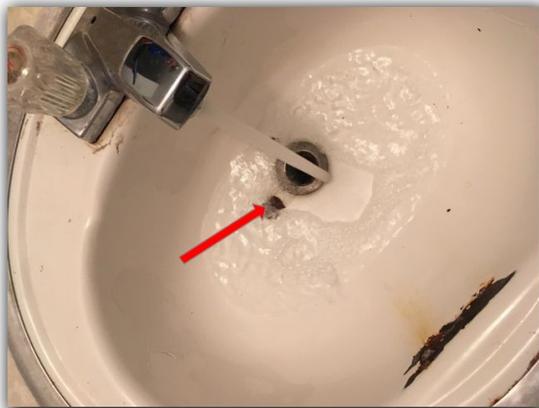
Surface damage was found at many of the sinks/tubs. The damage should be repaired to prevent the damage from extending to through the fixture.

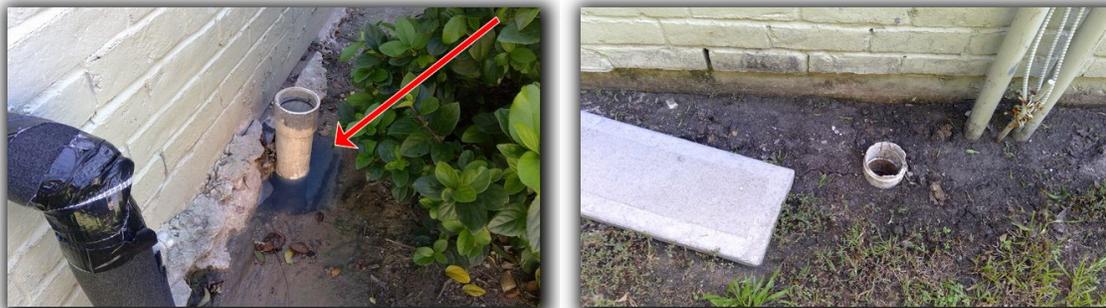
Many of the cleanout caps are loose or missing at the exterior of the property as evidence of possible drainage issues and/or increased maintenance level requirements for proper function.

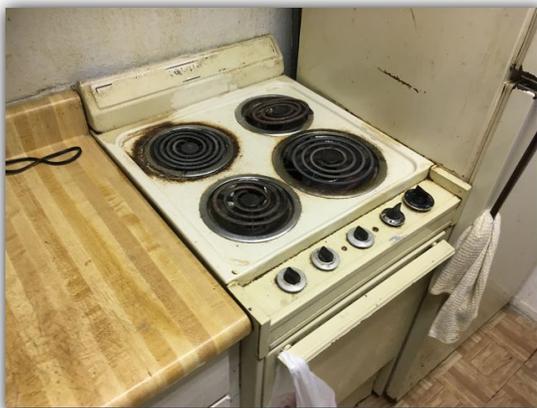
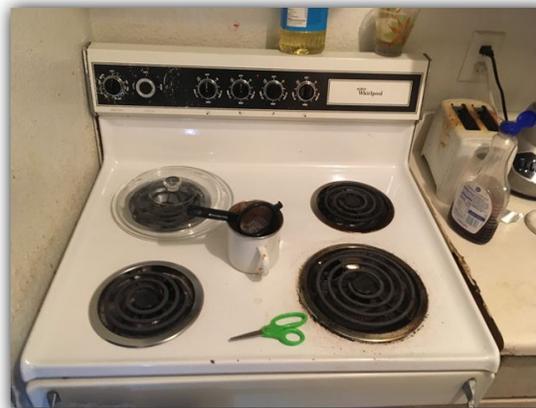
Many of the ranges/ovens appeared to be older with surface damage and visibly worn components/controls.
