HOUSTON INSPECTIONS

Stucco Inspection

Jane Doe
123 Main
Houston, TX 77001

August 14, 2018

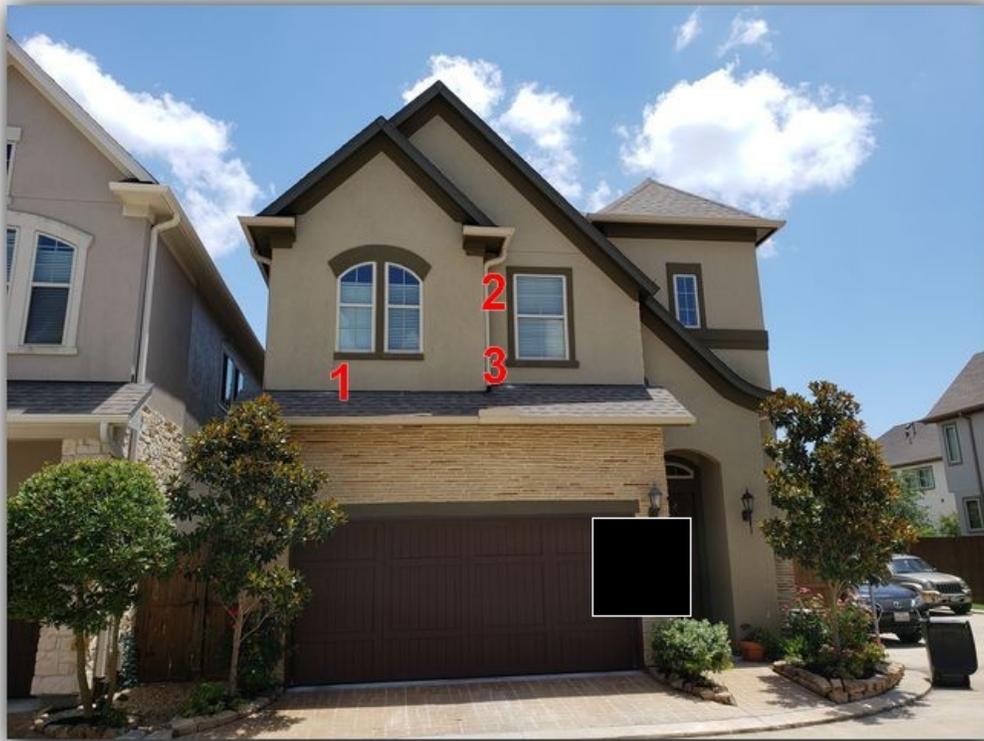
Front Elevation

Grid Site	Moisture Reading	Substrate Condition	Observations / Comments
1	23.3%	Firm	
2	36.9%	Soft	See details of problems below.
3	33.1%	Soft	See Below

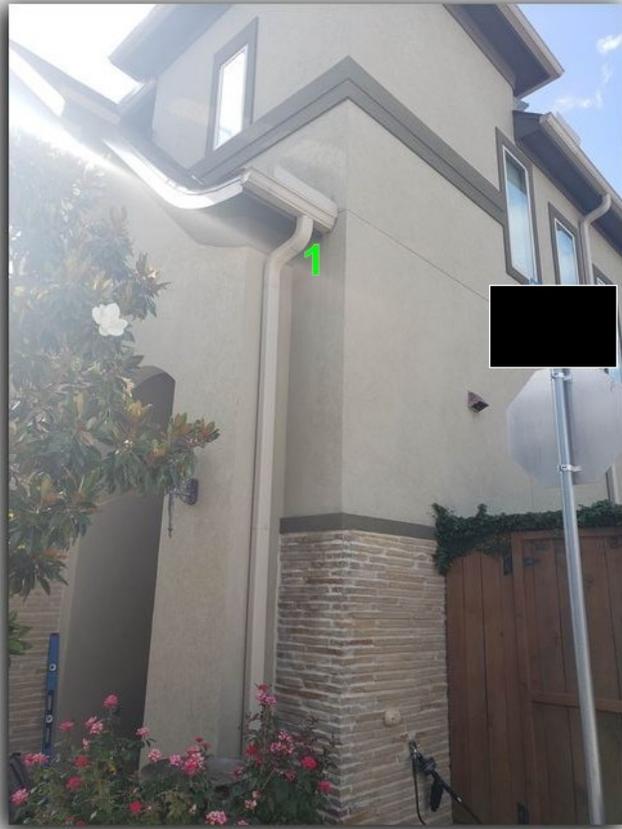
Front Elevation

Grid Site	Moisture Reading	Substrate Condition	Observations / Comments
1	14.7%	Firm	Seal Kickout Flashing

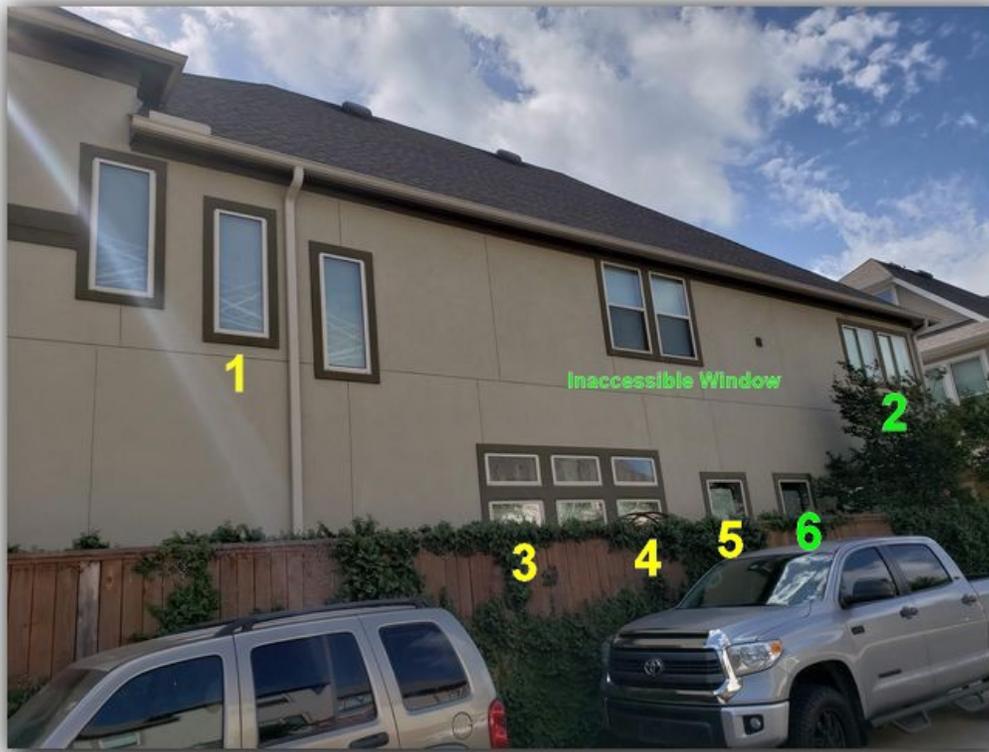
Right Elevation

Grid Site	Moisture Reading	Substrate Condition	Observations / Comments
1	17.1%	Firm	
2	11.4%	Firm	
3	18.5%	Firm	
4	16.8%	Firm	
5	15.5%	Firm	
6	11.3%	Firm

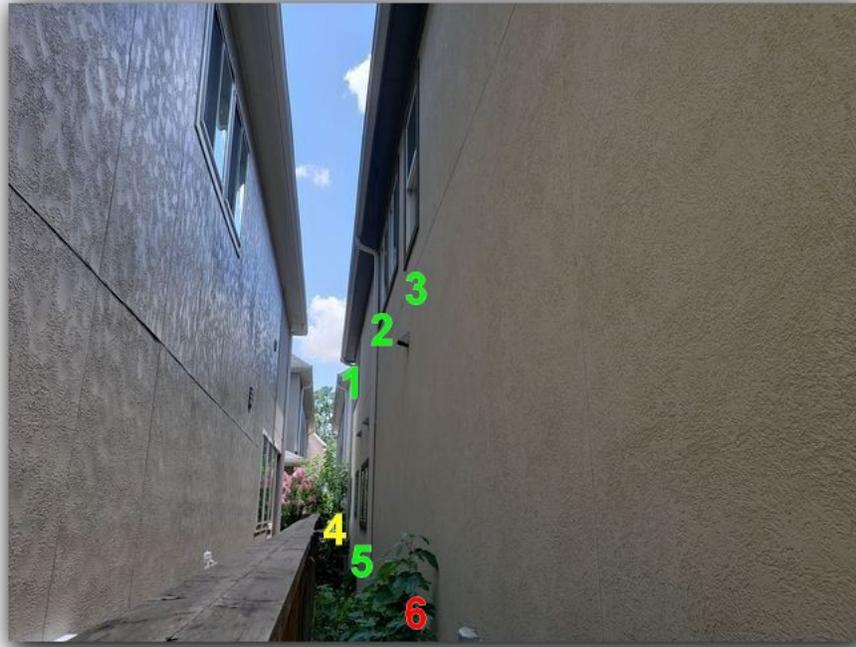
Left Elevation

Grid Site	Moisture Reading	Substrate Condition	Observations / Comments
1	13%	Firm	
2	11.3%	Firm	
3	12.1%	Firm	
4	17.5%	Firm	Improve vegetation
5	13.4%	Firm	
6	20.9%	Firm	Repair HVAC primary drain line

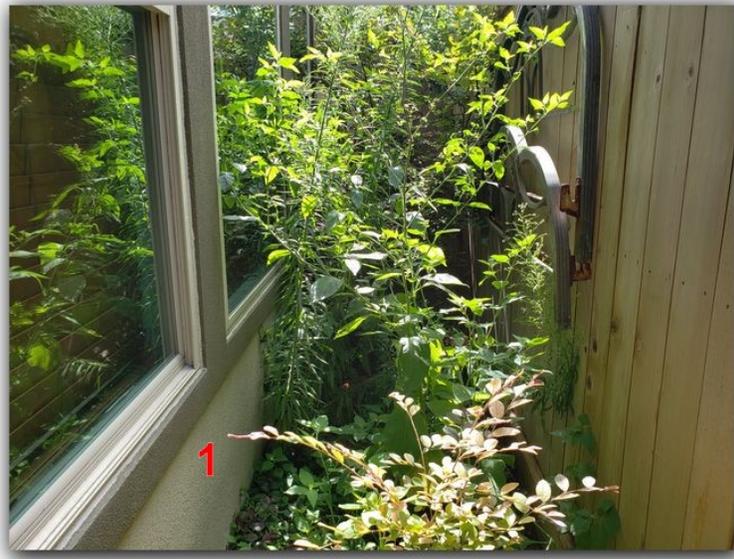
Rear Elevation

Grid Site	Moisture Reading	Substrate Condition	Observations / Comments
1	19.7	Firm	Improve vegetation

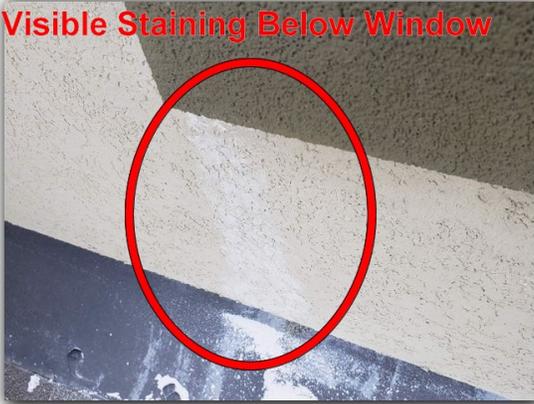
Evidence of significant damage was found at the exterior stucco walls located below the roof and wall termination located at the front middle of the home. Staining was found on the surface of the stucco. During the invasive probing of the wall cavities at two locations below the roof termination the substrate was found to be soft and elevated moisture readings were found. In addition, signs of prolonged water penetrations were found in this area as evidenced by the interior damage, bacteriological growth, staining, and other problems outlined below.

Visible Staining Below Window

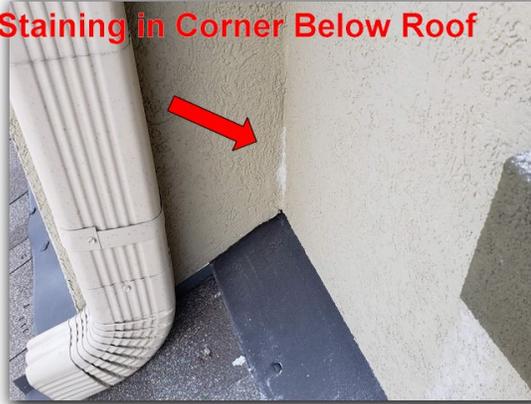
Staining in Corner Below Roof

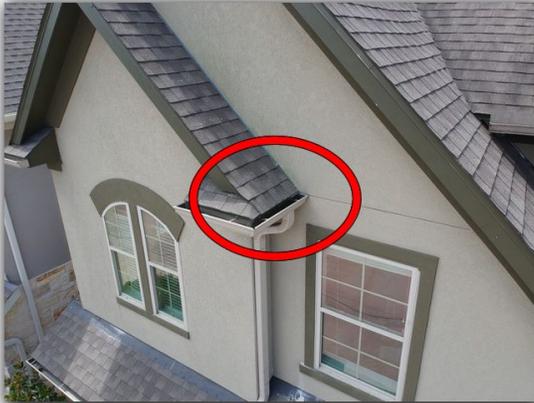
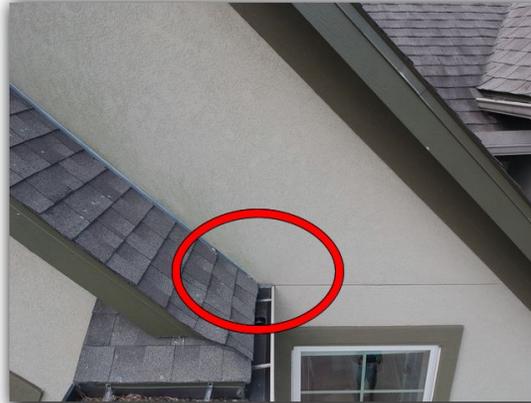
During the inspection of the wall and roof termination using a drone it was determined that kickout / diverter flashing had not been installed. It is suspected that this is one of the main causes of these extensive moisture problems.

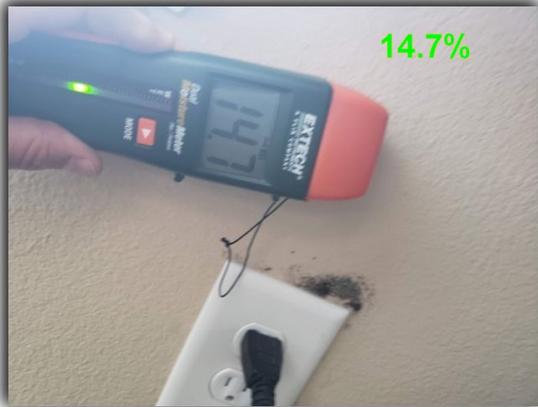
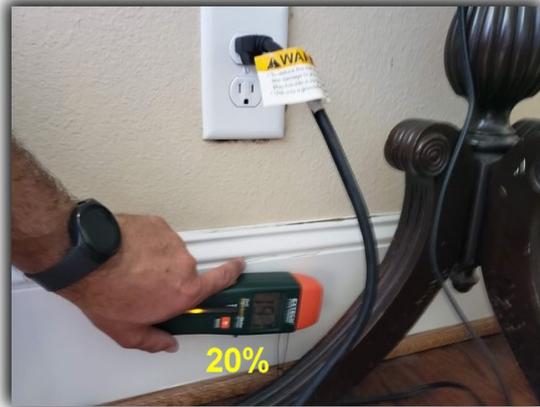
Elevated moisture readings were found below the window in the front game room on the second floor. Visible growth was observed in this same area. The readings measured in this area were between 14 - 15% all other areas in the home measured less than 9%. The elevated moisture readings are confirming the problems found at the stucco outside this area.

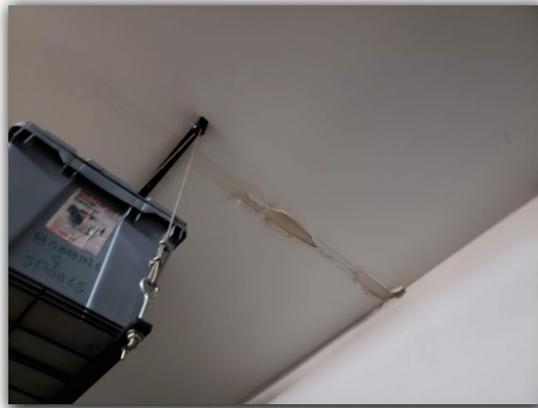
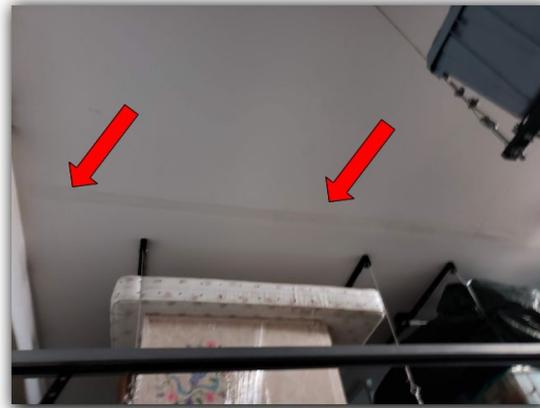
Damage and stained drywall was found at the ceiling located below the moisture problems found on the second floor at the stucco and interior walls. This is further evidence that active water penetrations exists.

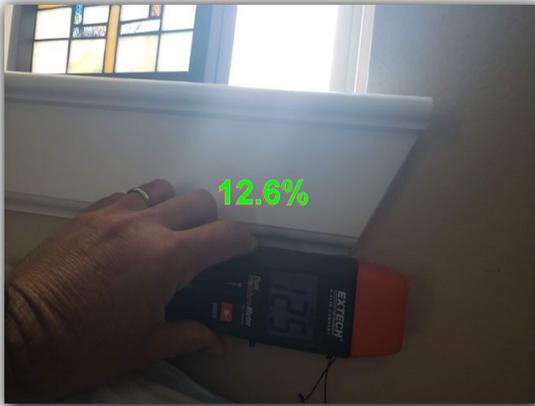
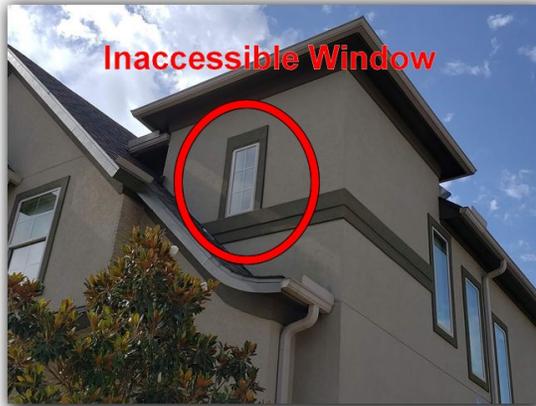
Slightly elevated moisture readings were found at the front right window on the interior. This area was inaccessible for invasive stucco probing. During repairs of the other areas this location should be evaluated and improved as needed.

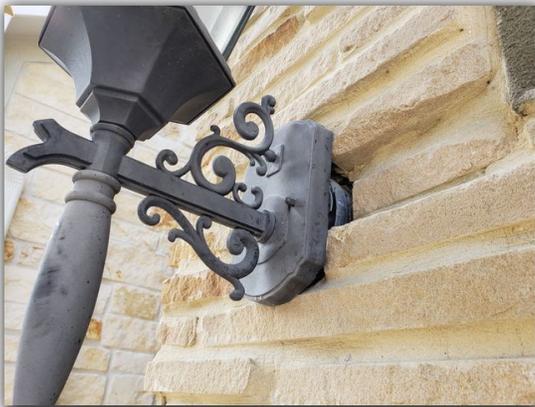
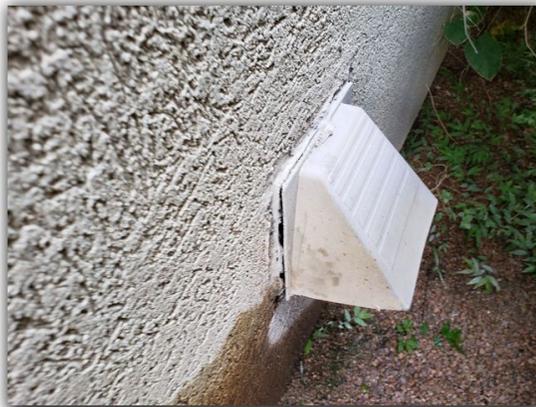
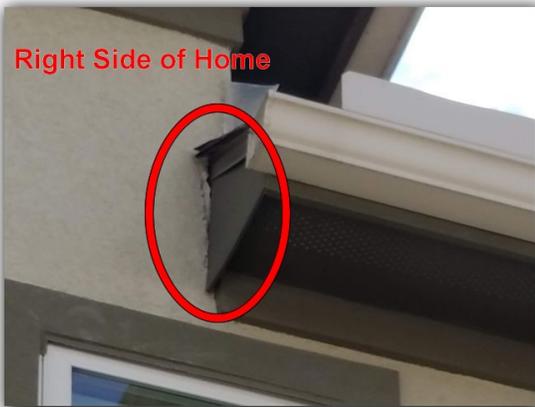
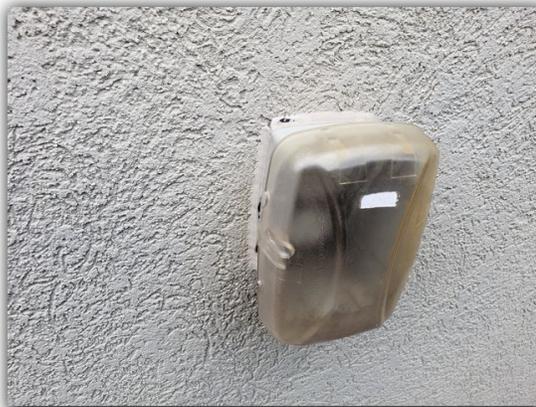
All exterior wall penetrations (electrical panels, electrical disconnects, light fixtures, etc.) and openings (expansion joints, windows, door thresholds, etc.) should be sealed with an approved material to prevent water penetrations into the wall cavities. Properly sealed exterior veneers help provide a barrier against the weather, insects, and enable environmental control of the interior spaces.

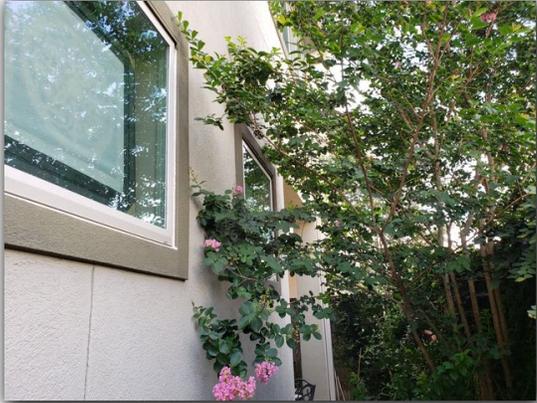
Tree limbs were noted in contact with the exterior walls. The tree limbs should be trimmed away from the walls to prevent future damage.

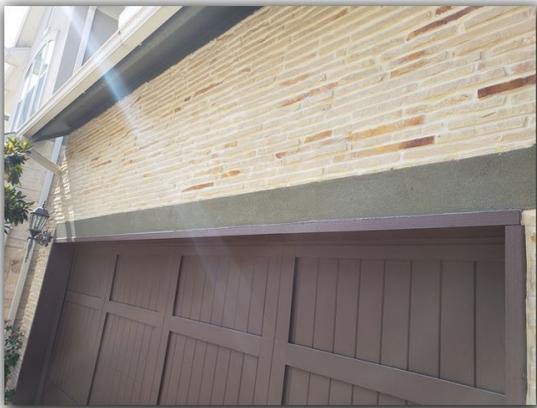
Missing head / "z" flashing was found at the garage door opening.

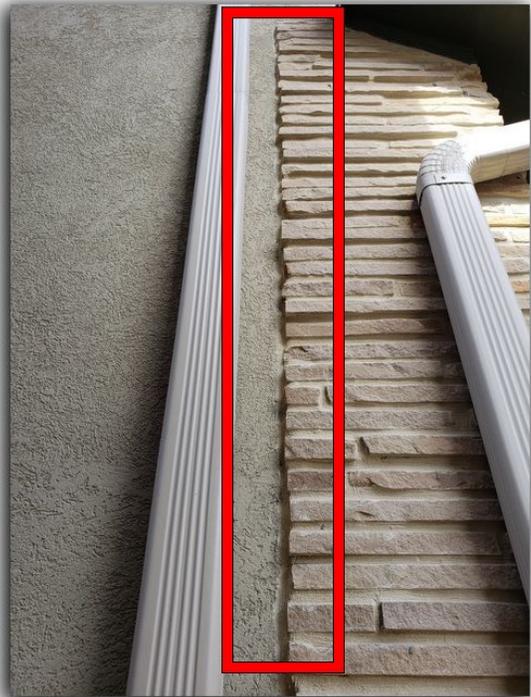
The transitions between differing materials have not been made properly. The transitions have been made with mortar which will eventually fail.

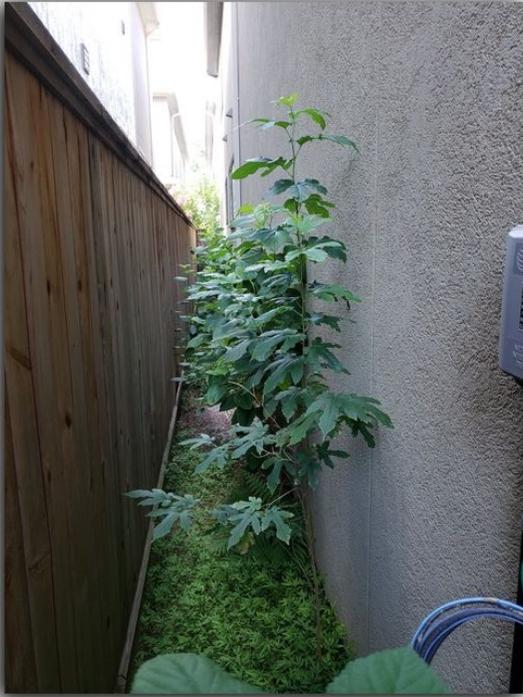
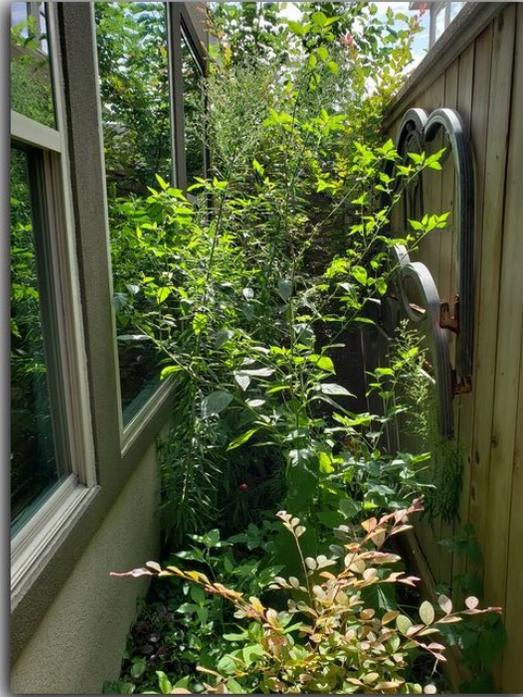
The overgrown vegetation around the sides and rear of the property should be improved to prevent moisture and insect problems at the walls.

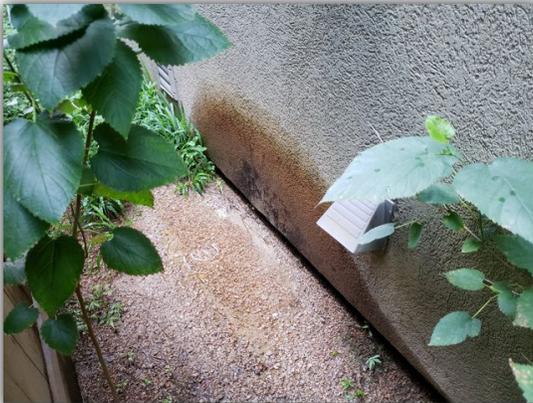
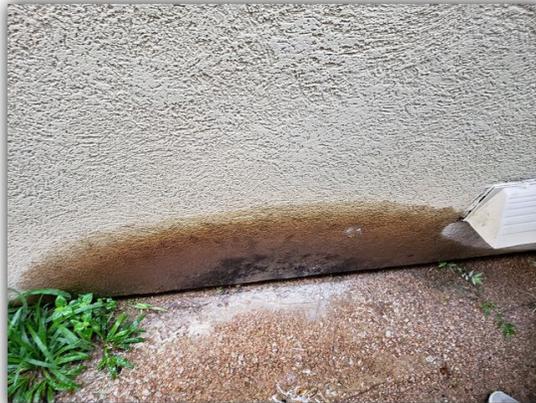
The primary drain line appears to be not functioning properly as evident by water dripping from the secondary drain line on the left exterior of the home. This has caused visible damage to the stucco. In addition, elevated moisture readings were found in this area.

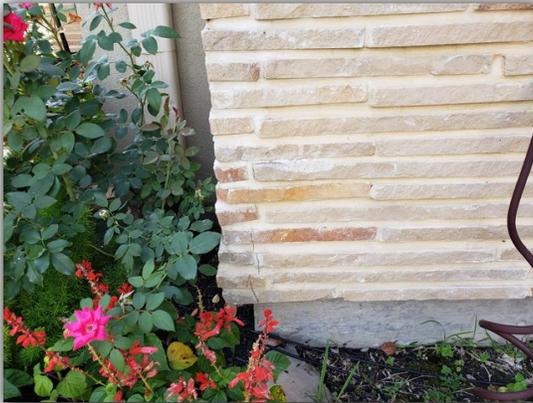
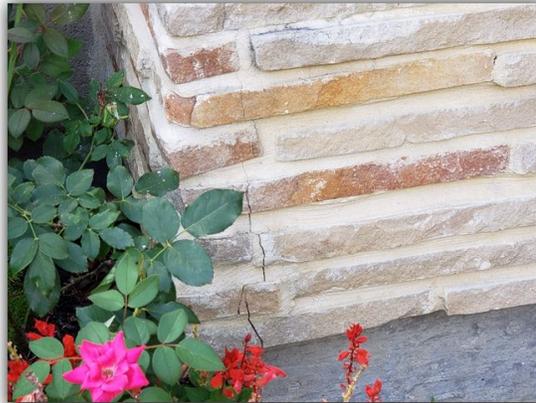
Mortar cracks were found on the exterior of the structure as evidence of settlement of the structure.

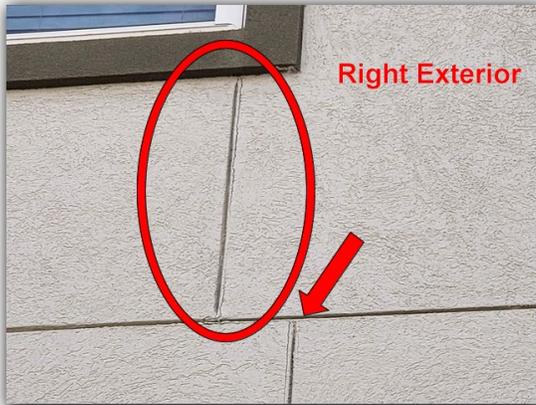
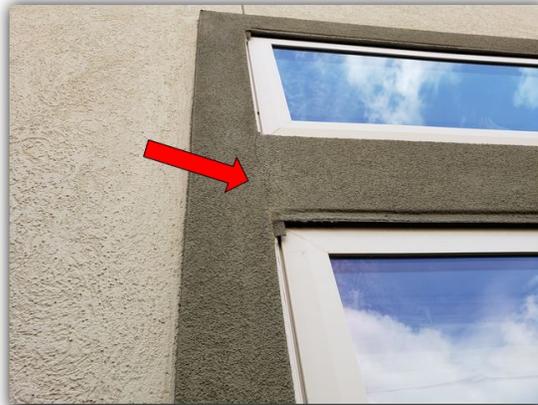
Cracks were found at the stucco walls. Recommend repairing / sealing these cracks.

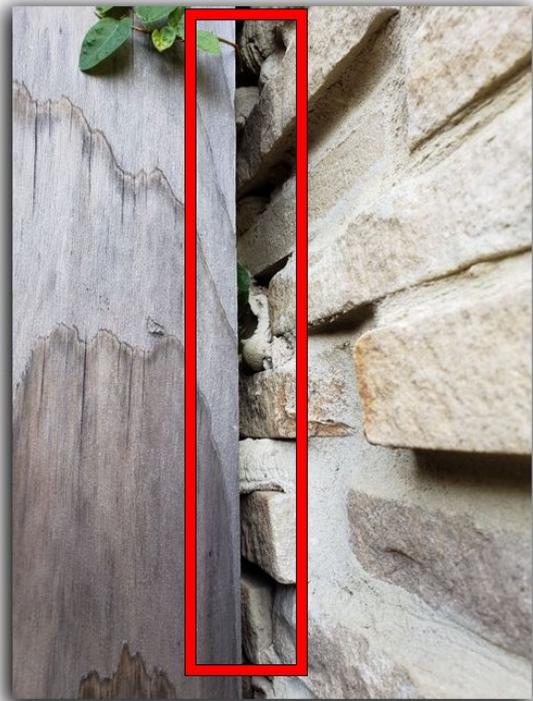
Missing mortar was found at the stone along the fence post on the right side of the home. This appears to have been not completed during construction.

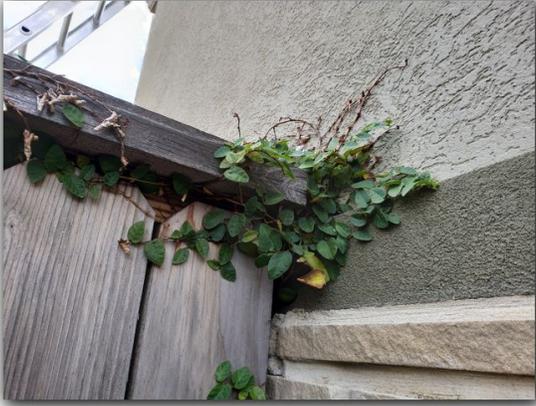
Vegetation was noted growing on the exterior walls of the structure. Vegetation on exterior walls promotes insect activity and moisture problems. The removal of the vegetation should be considered.

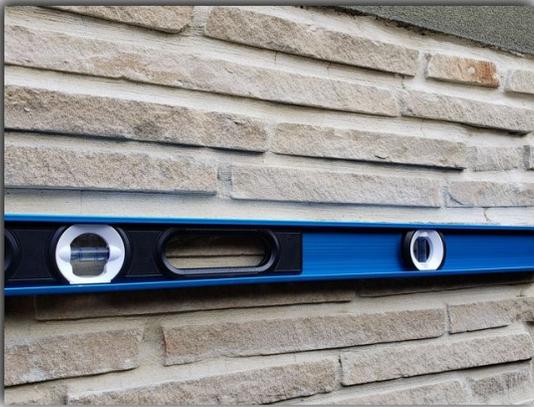
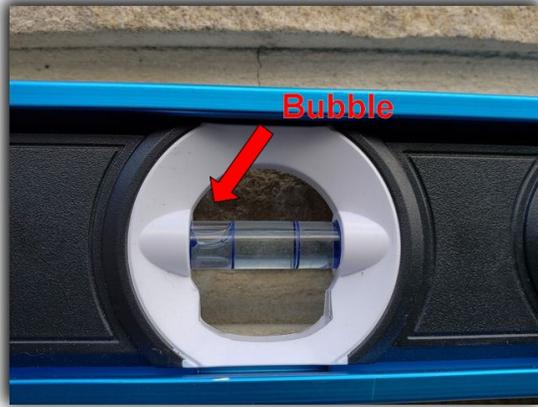
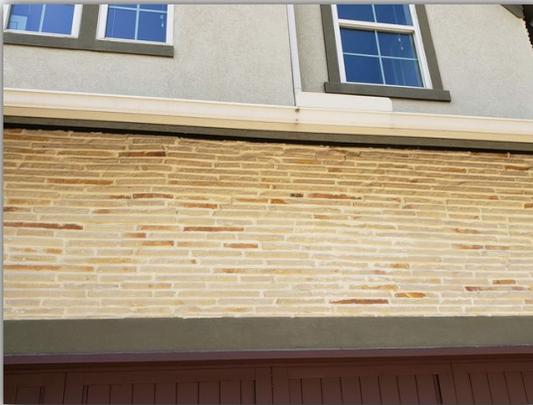
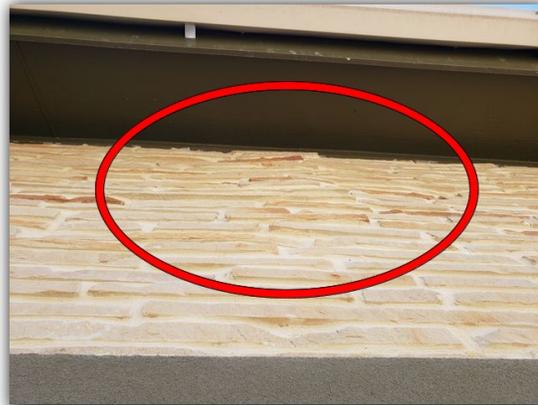
Poor workmanship was noted at the stone along the front above the garage door and on the right side of the home. The stone is not level at these areas.

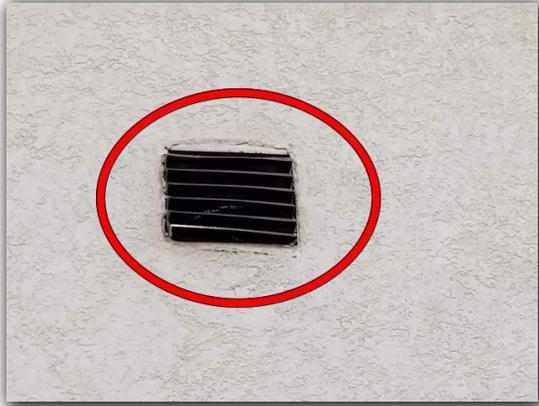
The outside air source cover on the right side of the home is recessed at the stucco wall. This could allow water to enter the cavity. Recommend improvements.

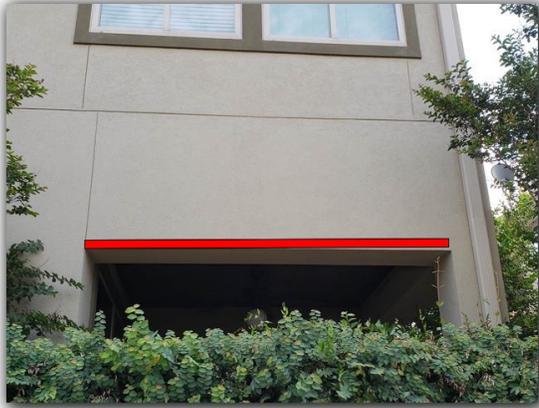
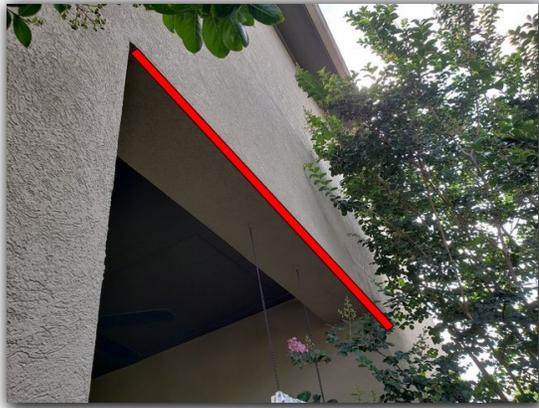
Weepscreeds / drainage openings missing at the stucco walls - This could lead to the build up of moisture / water in the wall cavities and create future problems.

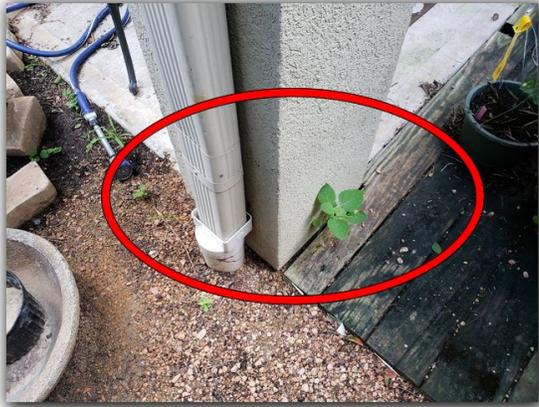
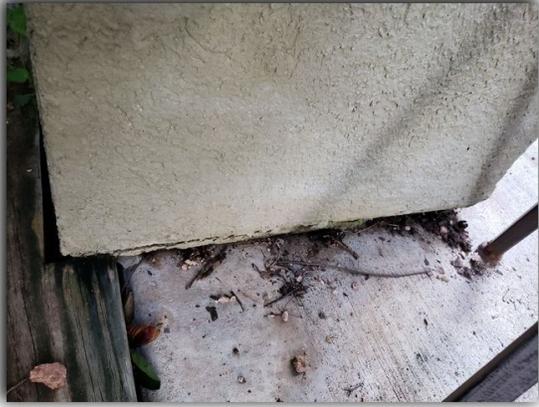
Improper clearance of the stucco was found at the back right porch column. Visible damage was found at this column.

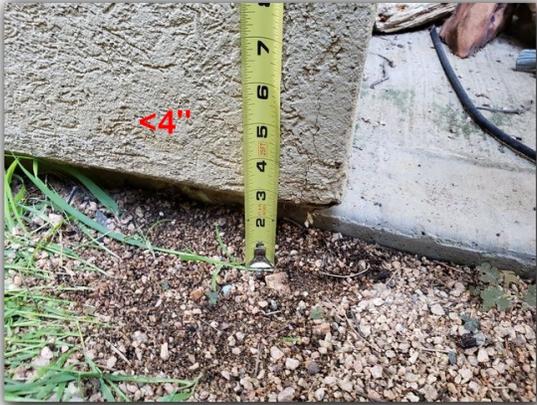
Improper clearance was found at the grade (soil), roof, and patio of flatwork.

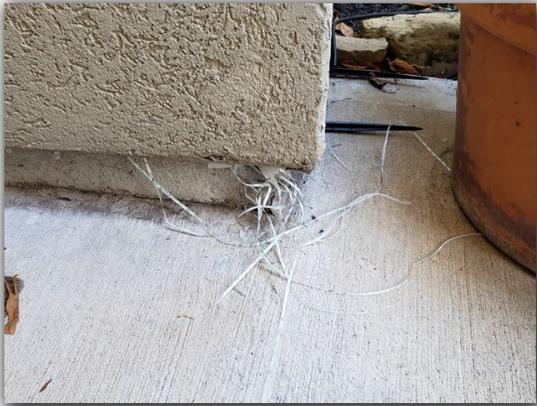
Portions of the underlying vapor barrier are hanging from the wall cavities.

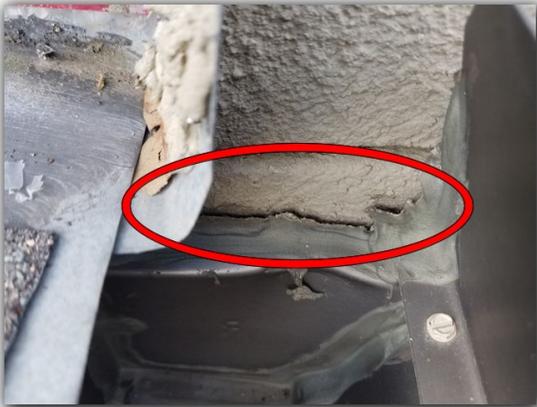
Failed sealant was found between the kickout / diverter flashing and the wall / roof termination.

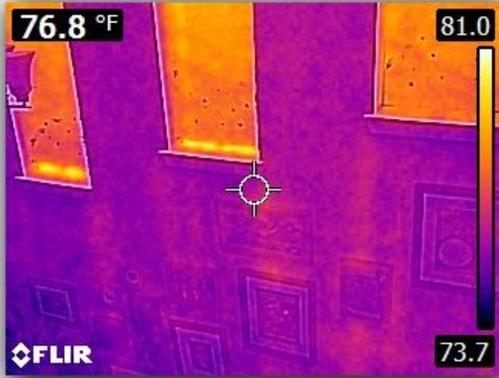
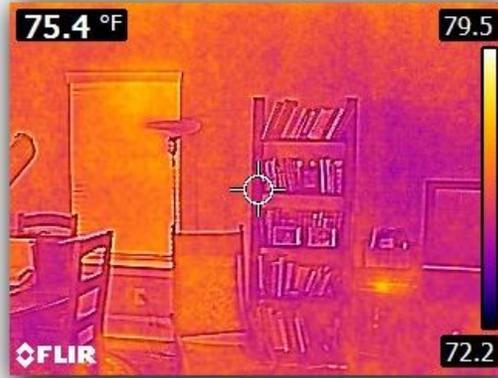
During the inspection of the walls on the interior of the structure with a infrared camera no abnormalities were noted. The picture(s) below are a sampling of some image(s) taken during the inspection.
