HOUSTON INSPECTIONS

**MUD District
Wastewater Treatment Plant
123 Street
Houston, TX 77094**

August 22, 2020

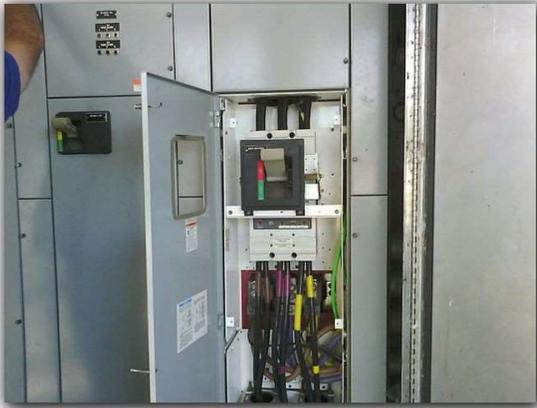
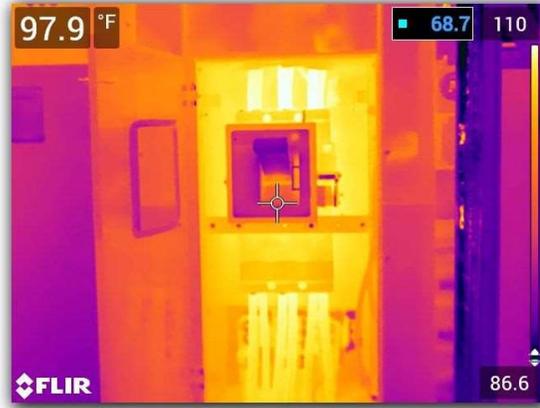
Equipment: Breaker

No deficiencies were noted during the inspection of this equipment.

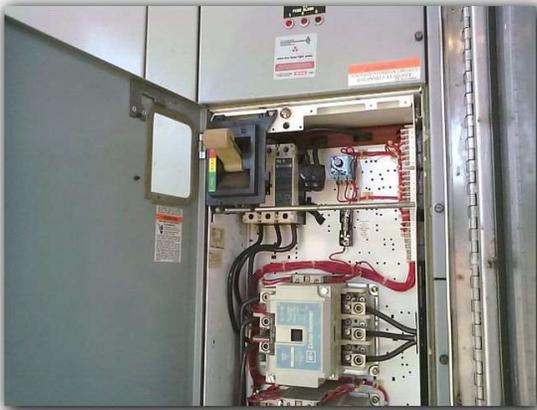
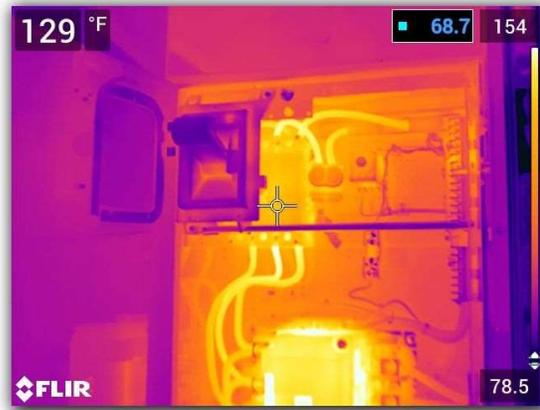
Equipment: Breaker

No deficiencies were noted during the inspection of this equipment.

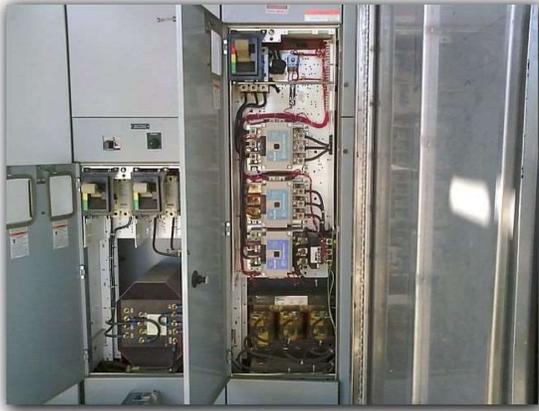
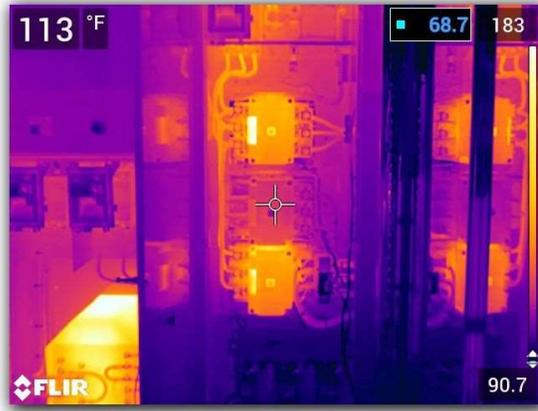
Equipment: Starter

No deficiencies were noted during the inspection of this equipment.

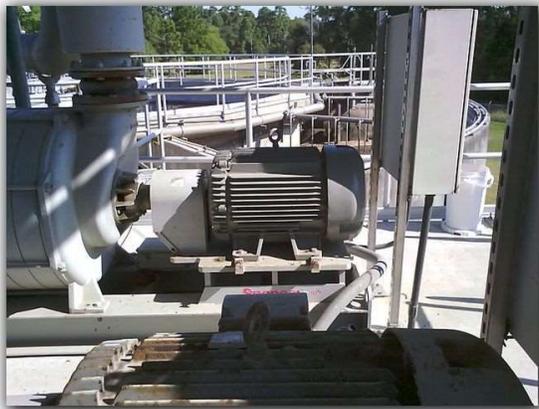
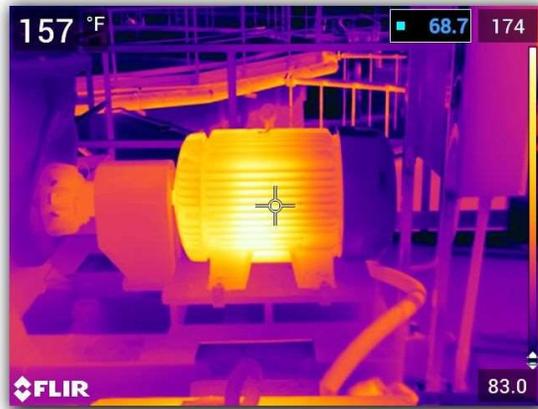
Equipment: Motor

No deficiencies were noted during the inspection of this equipment.

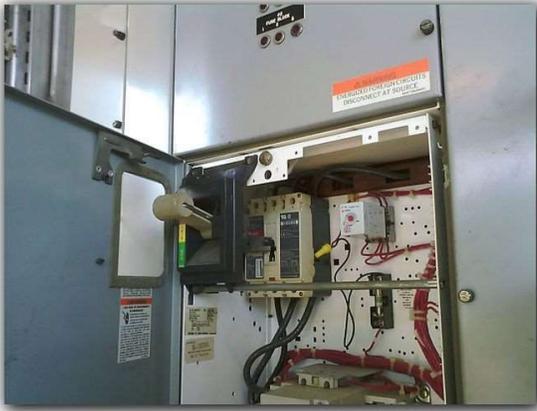
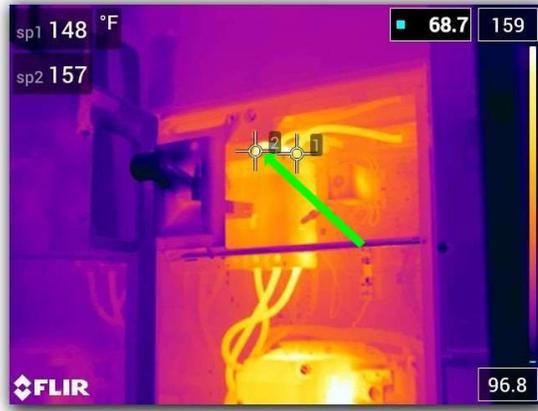
Equipment: Breaker

Abnormalities were found during the inspection. Recommend further evaluation and repairs if needed.

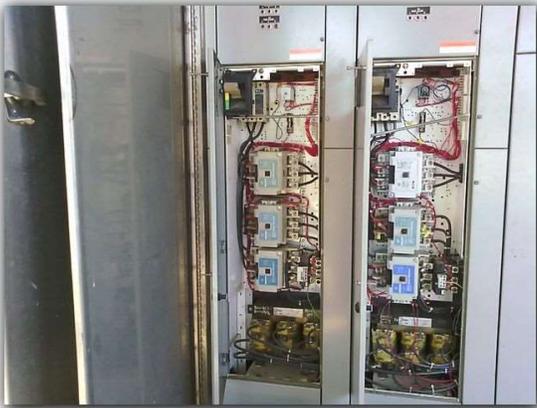
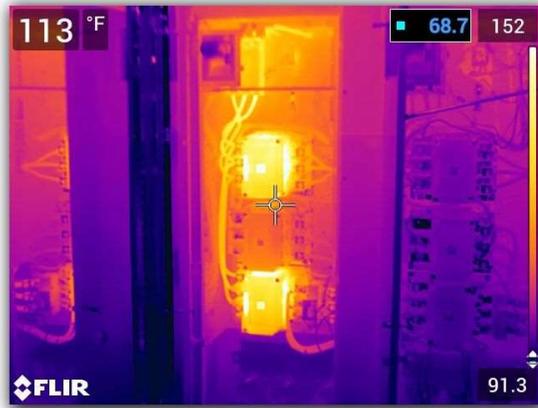
Equipment: Starter

No deficiencies were noted during the inspection of this equipment.

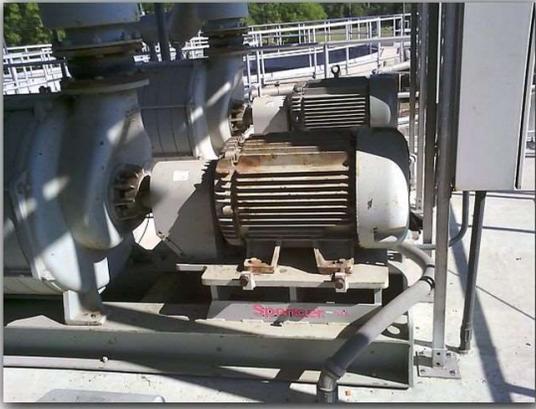
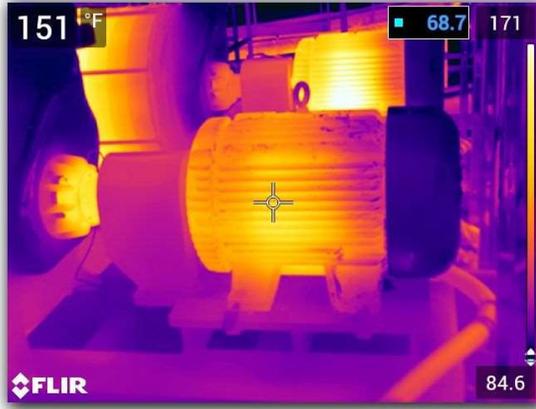
Equipment: Motor

Recommendations:
No deficiencies were noted during the inspection of this equipment.

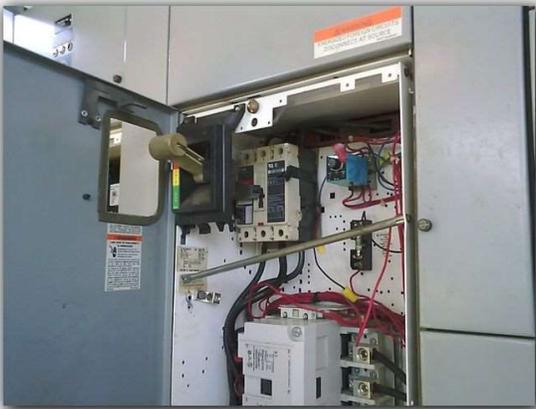
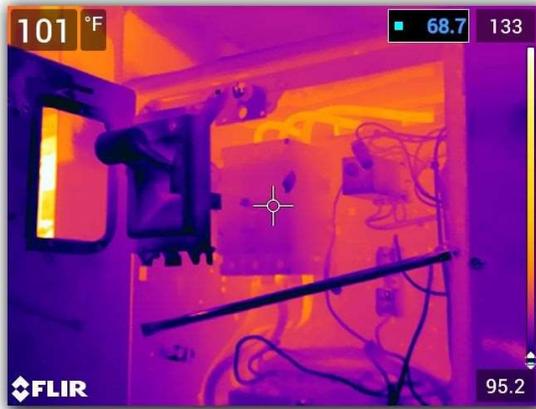
Equipment: Breaker

Recommendations:
No deficiencies were noted during the inspection of this equipment.

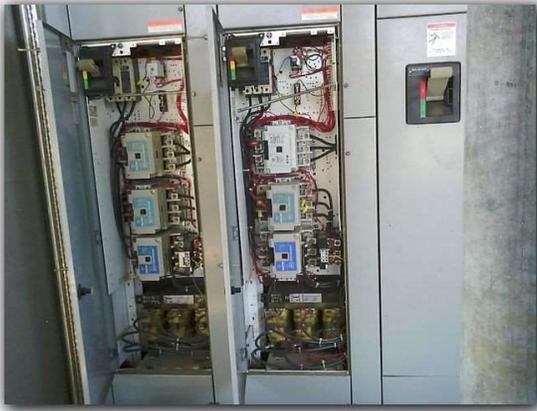
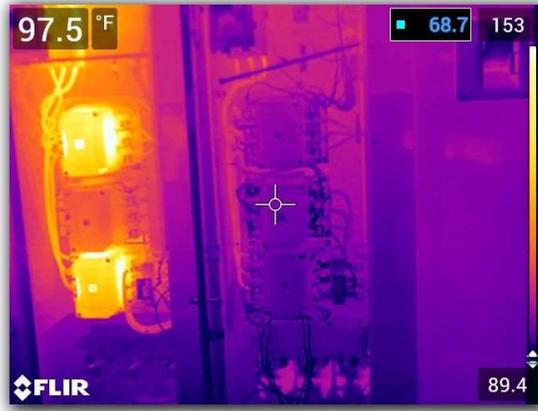
Equipment: Starter

No deficiencies were noted during the inspection of this equipment.

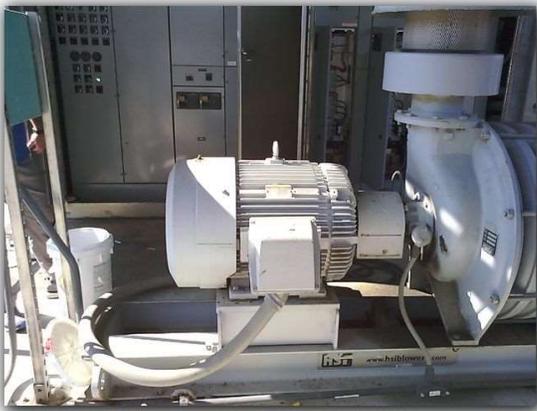
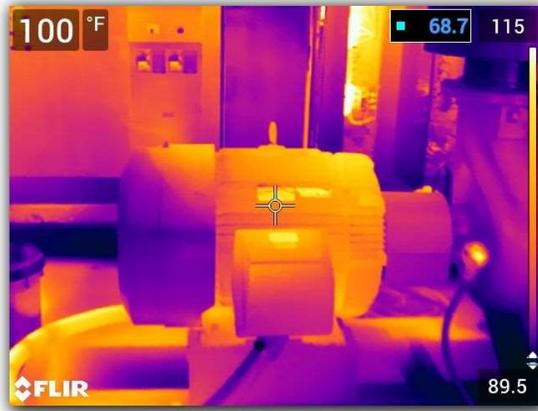
Equipment: Motor

No deficiencies were noted during the inspection of this equipment.

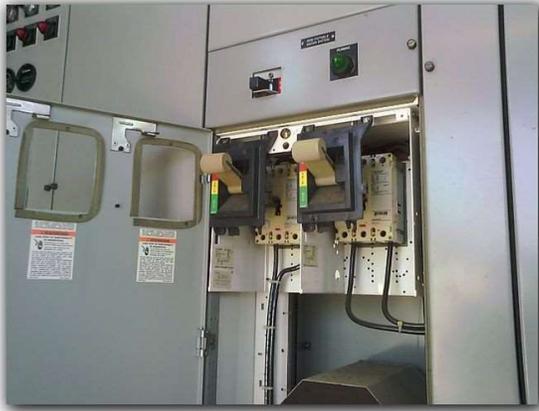
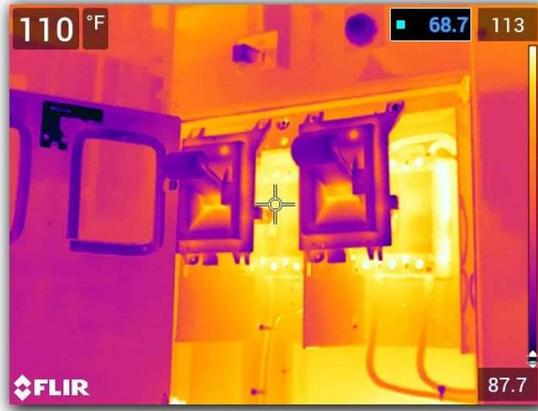
Equipment: Breaker

No deficiencies were noted during the inspection of this equipment.

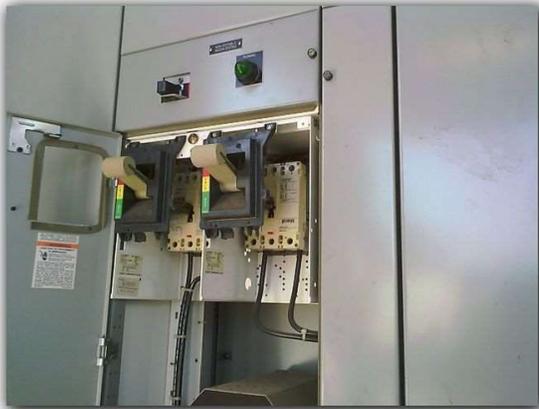
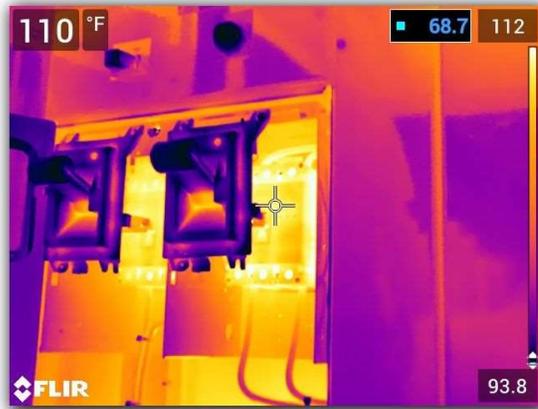
Equipment: Breaker

No deficiencies were noted during the inspection of this equipment.

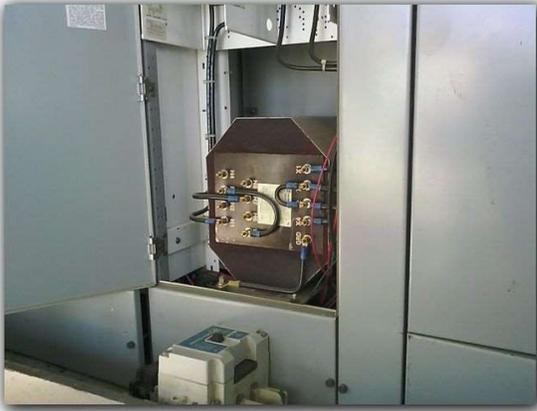
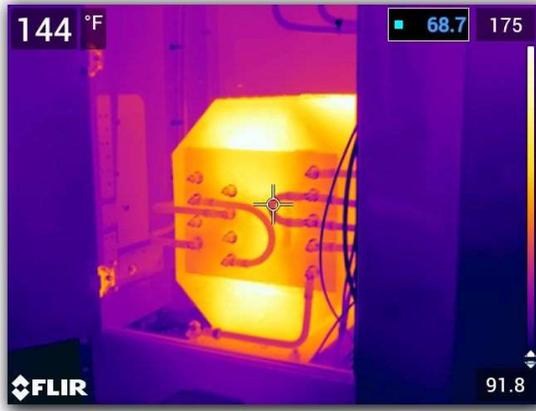
Equipment: Main Connections

No deficiencies were noted during the inspection of this equipment.

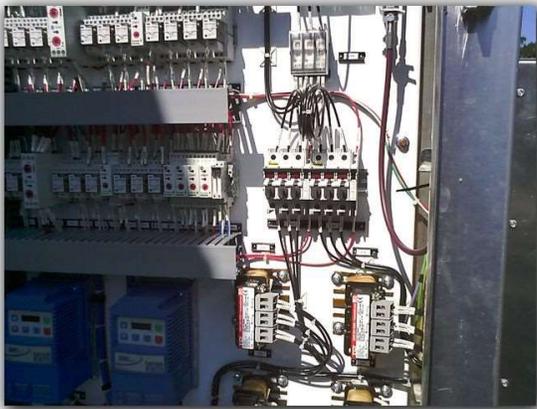
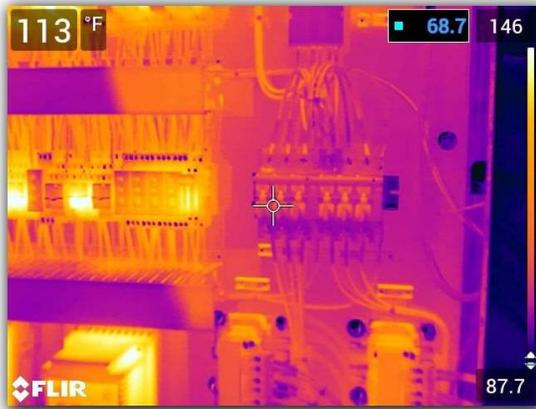
Equipment: Breaker

No deficiencies were noted during the inspection of this equipment.

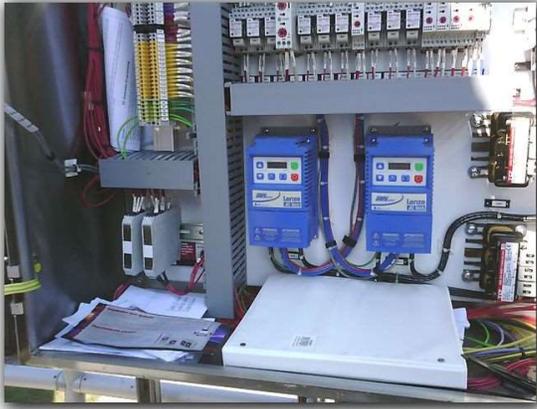
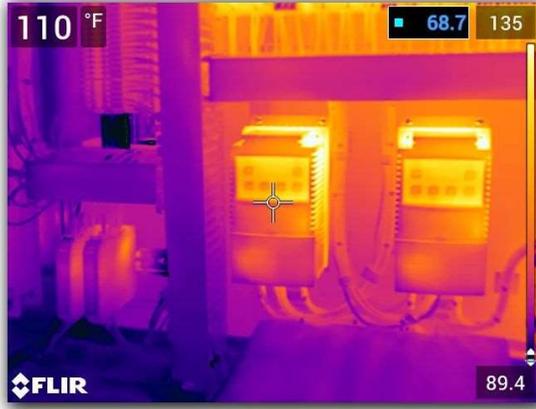
Equipment: Starter

Recommendations:
No deficiencies were noted during the inspection of this equipment.

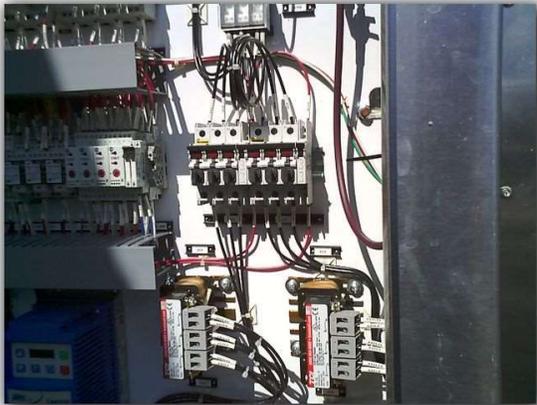
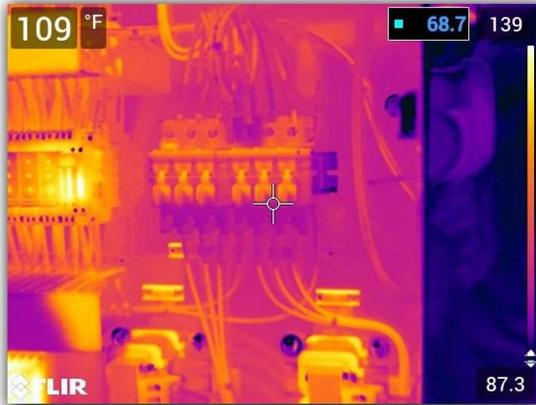
Equipment: Breaker

Recommendations:
No deficiencies were noted during the inspection of this equipment.

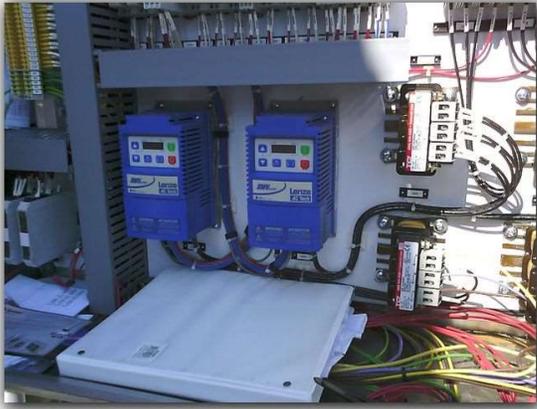
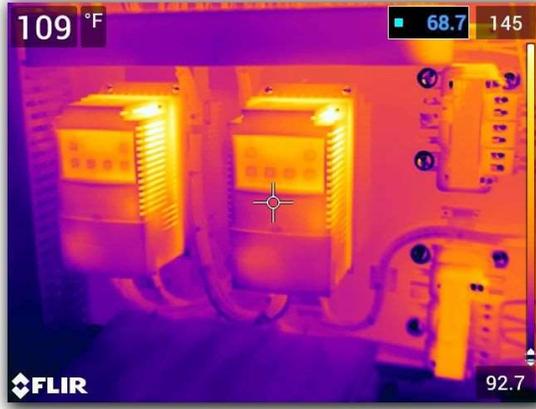
Equipment: Starter

No deficiencies were noted during the inspection of this equipment.

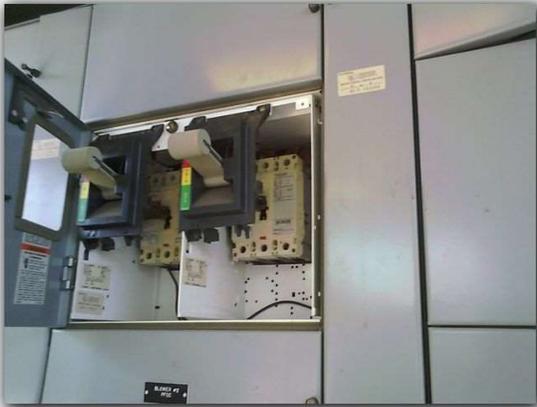
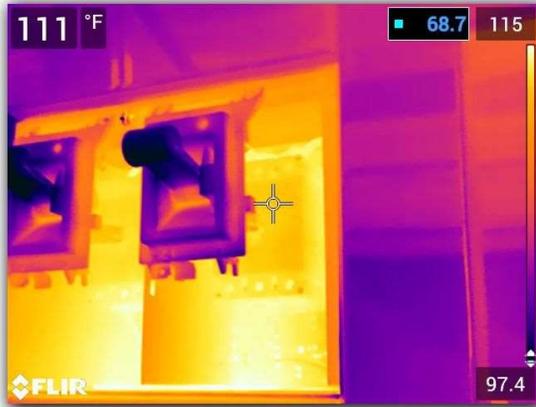
Equipment: Main Breaker

No deficiencies were noted during the inspection of this equipment.

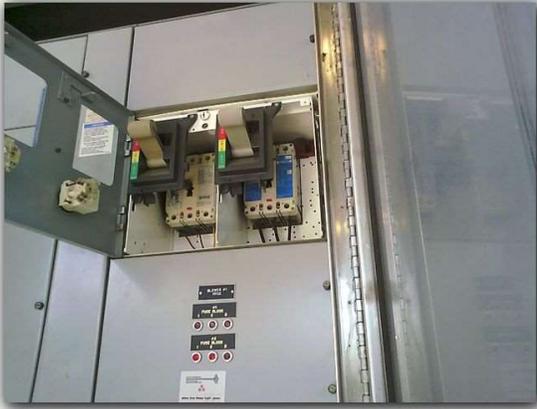
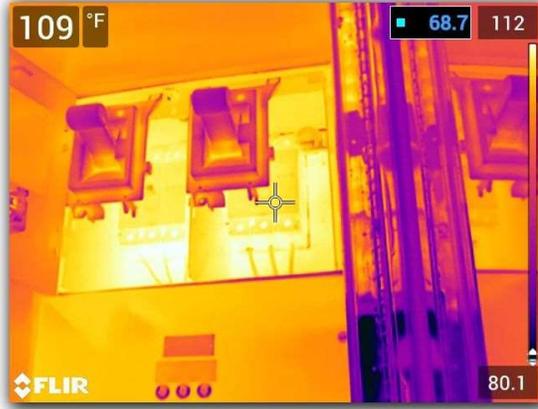
Equipment: Main Breaker

No deficiencies were noted during the inspection of this equipment.

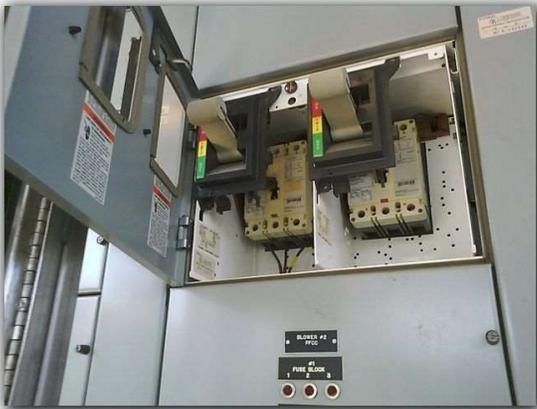
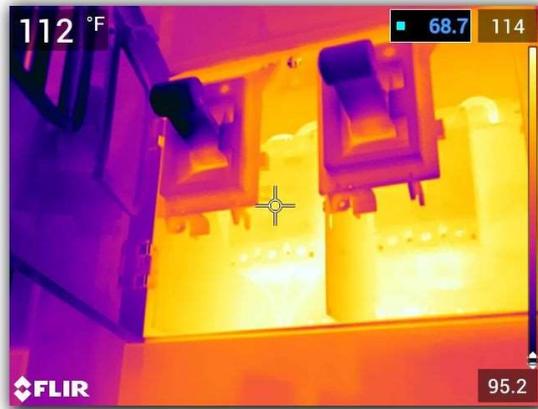
Equipment: Main Breaker

No deficiencies were noted during the inspection of this equipment.

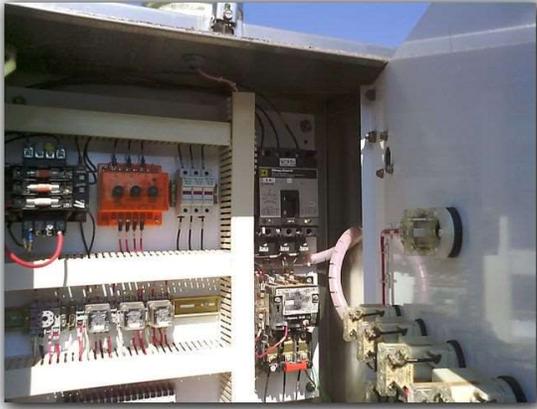
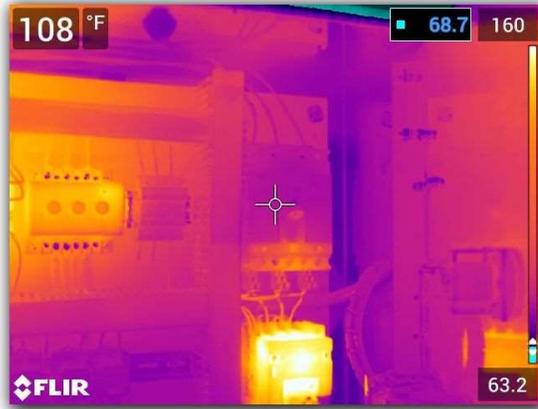
Equipment: Breaker

No deficiencies were noted during the inspection of this equipment.

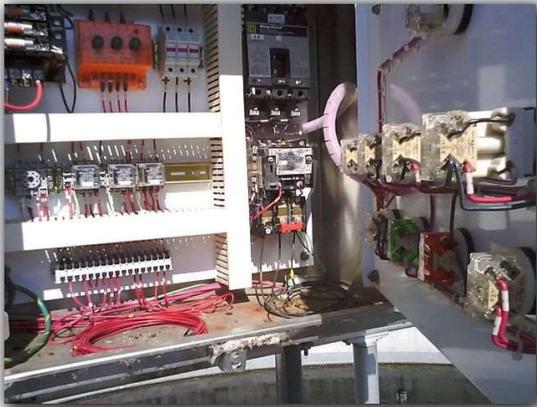
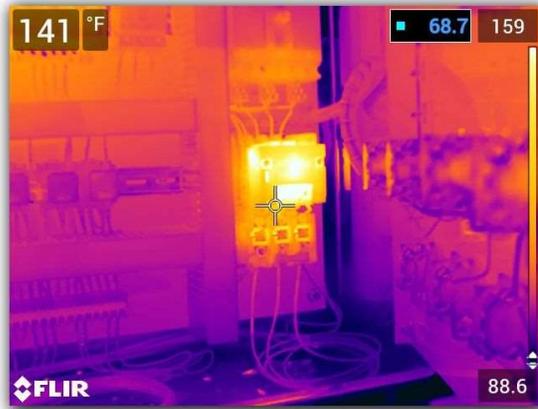
Equipment: Starter

No deficiencies were noted during the inspection of this equipment.

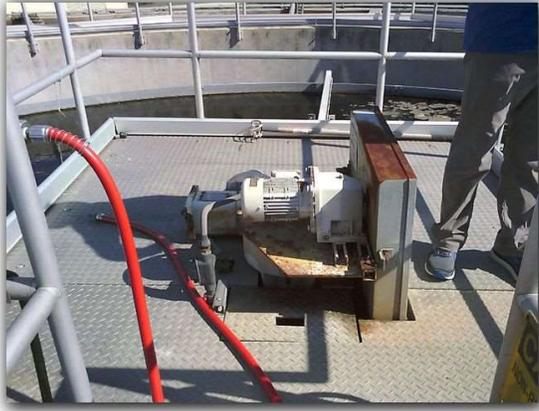
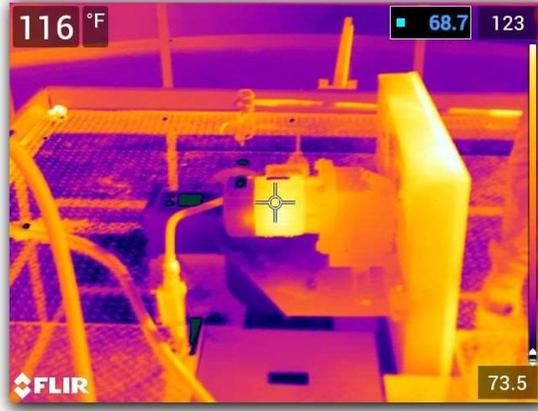
Equipment: Motor

No deficiencies were noted during the inspection of this equipment.
