# HOUSTON INSPECTIONS

January 31, 2017

## CONSTRUCTION / PHASE INSPECTION REPORT

**Concerning:** 1234 Concrete Lane, Houston, TX 77777  
(Address or Other Identification of Inspected Property)

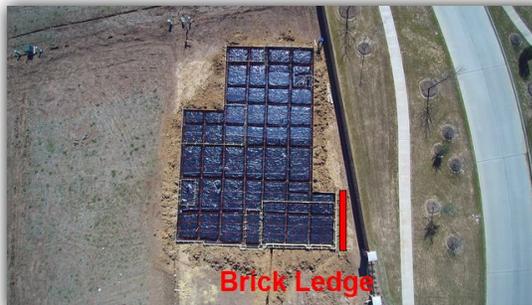
Brick ledge not installed at all sides - verify plans to insure brick ledge installed at proper locations

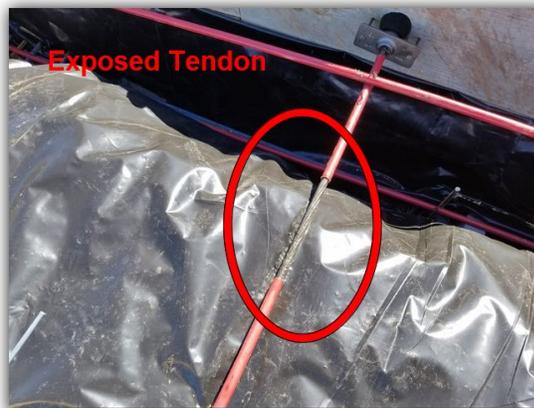
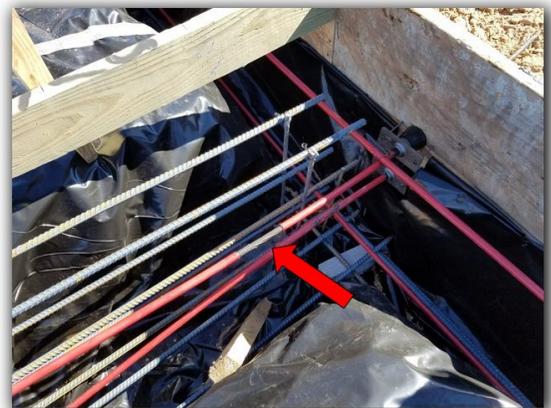
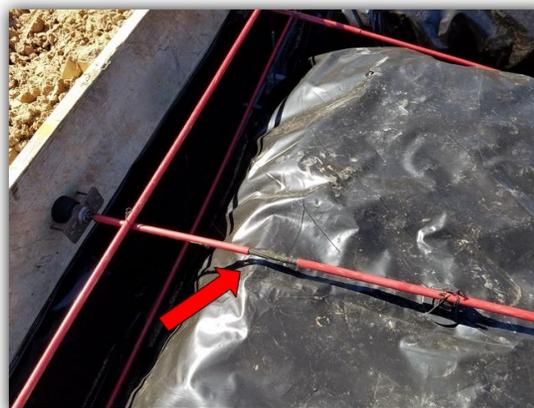
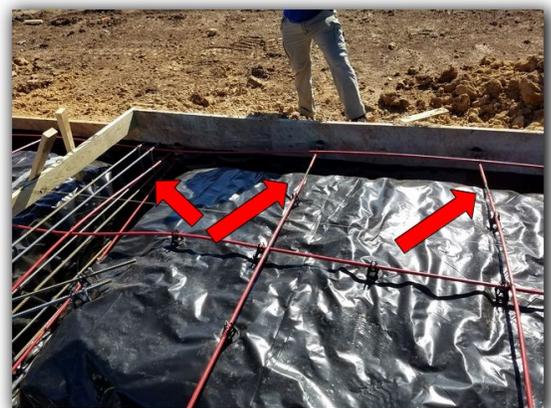
Live ends stripped of plastic not over 1" or taped:  Yes  Deficient

The amount of tendon exposed at the live ends should be decreased to 1"

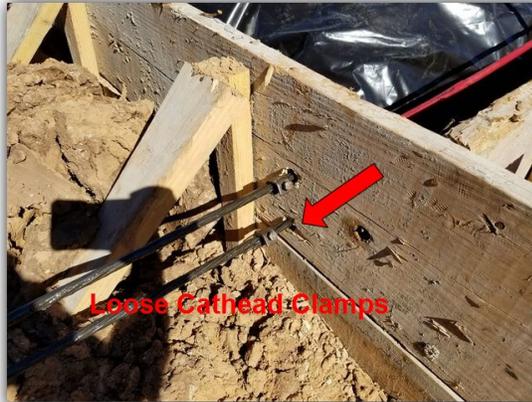
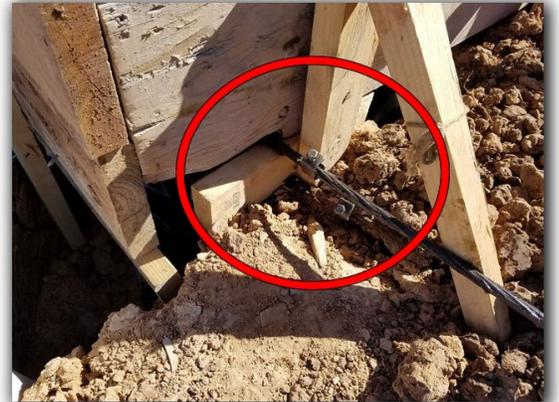
Many of the cathead's are loose / not secured firmly at form boards. Recommend improvements.

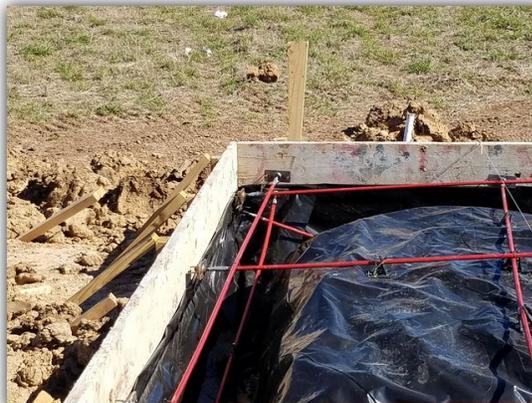
All tendon intersections should be properly tied with wire.

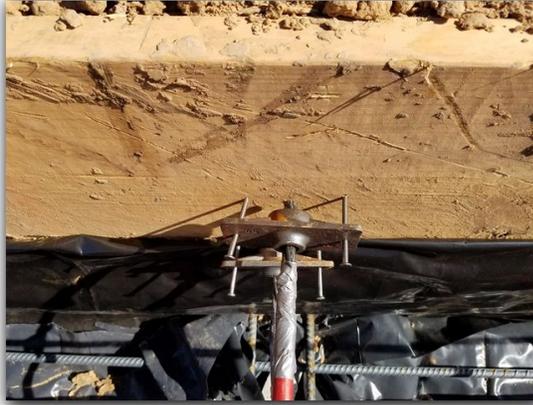
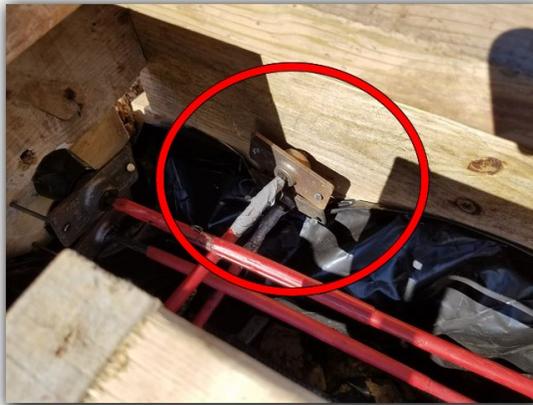
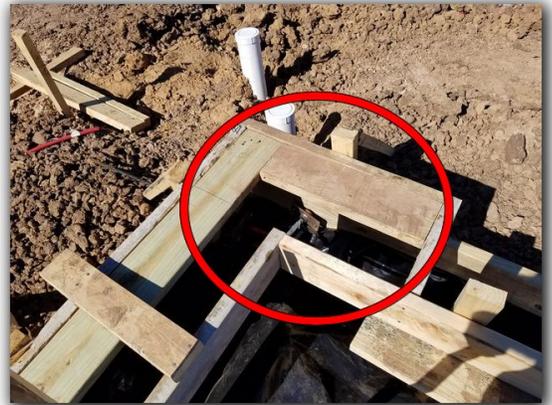
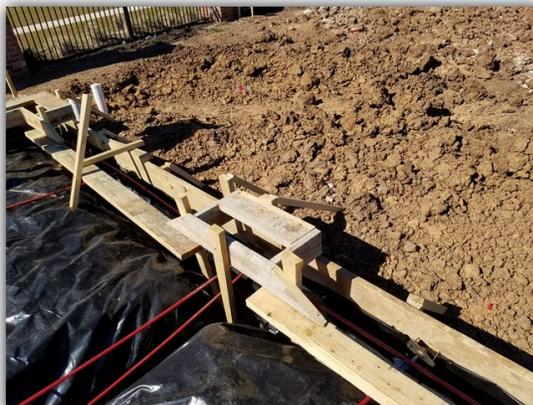
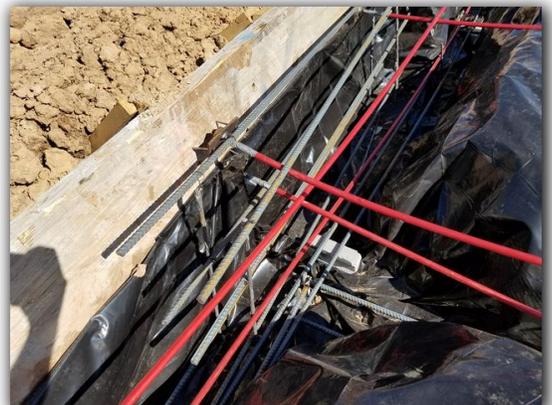
Dead ends have 3/4" clearance to forms:  Yes  No

The clearance between dead ends and form boards should be improved to provide 3/4" to 1" clearance or less.

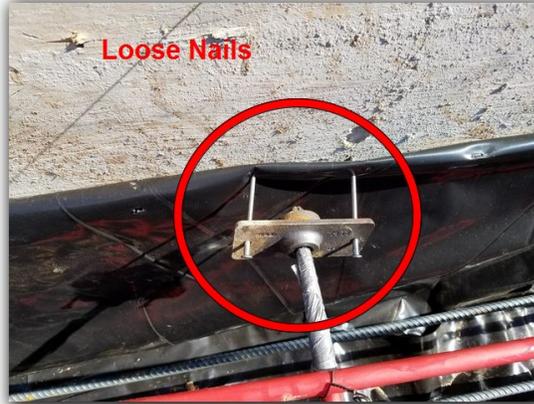
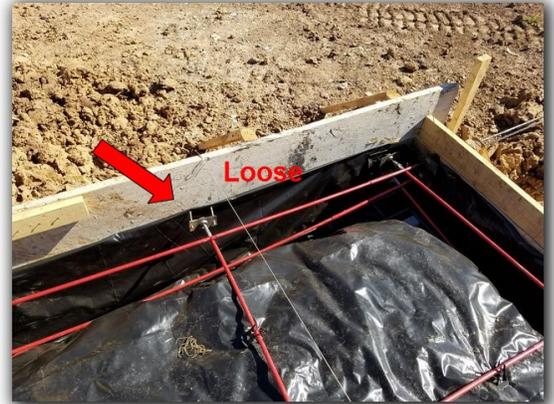
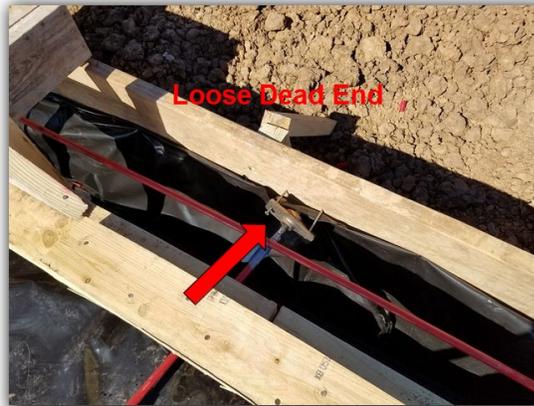
Loose dead ends were found at the back middle portion of the foundation and at the garage. Recommend nailing dead end properly.

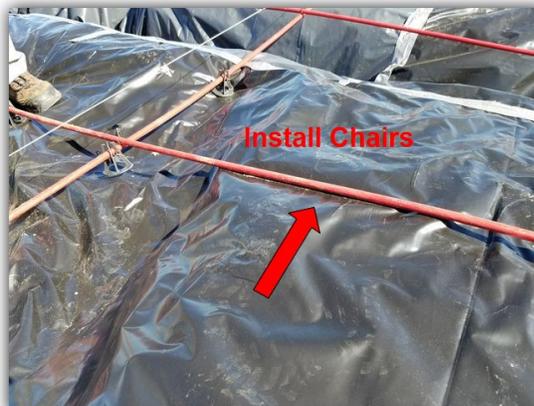
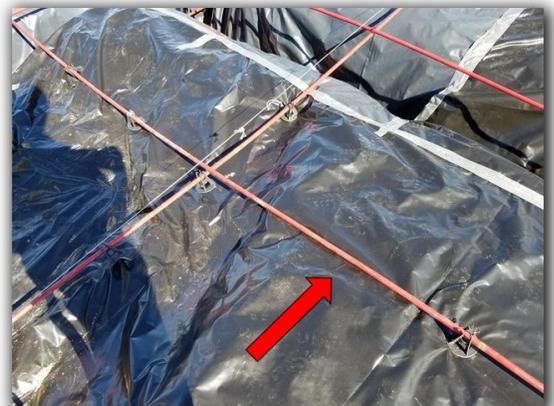
Missing wire ties were found at various cable chairs.

Provide provide proper clearance at pads and tendons.

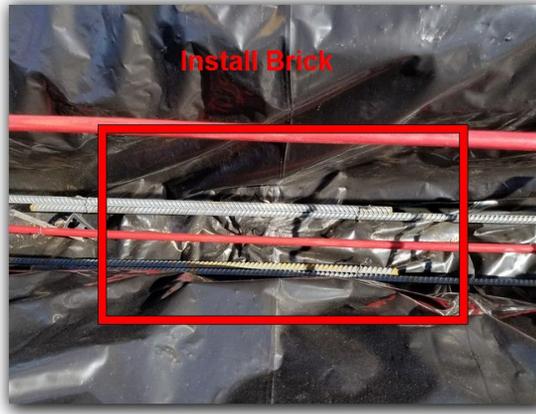
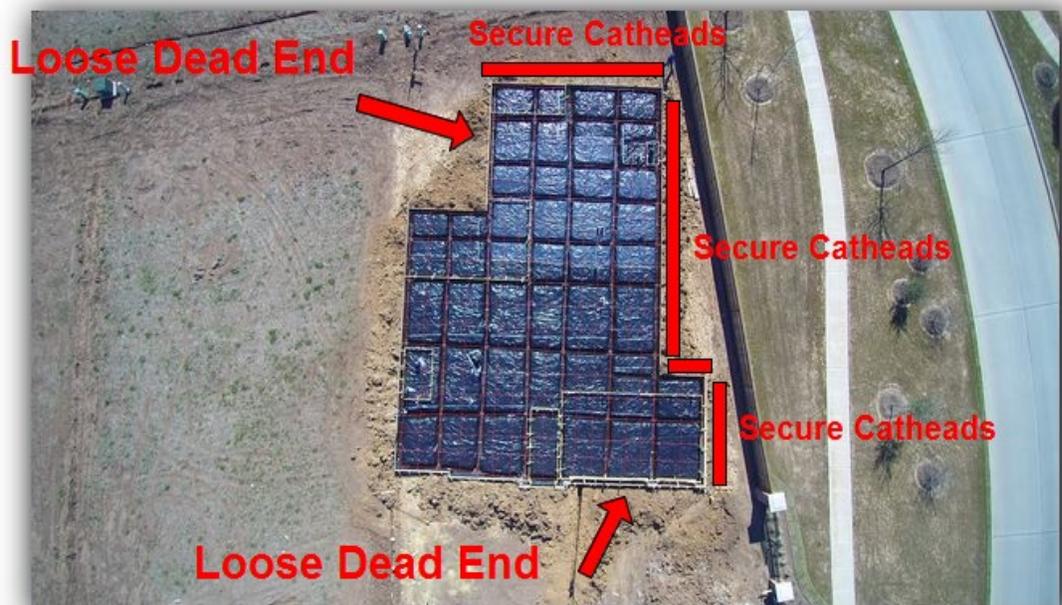
Rebar supported off bottom of beams:  Yes  No  
Rebar should be supported with bricks off bottom of beams.

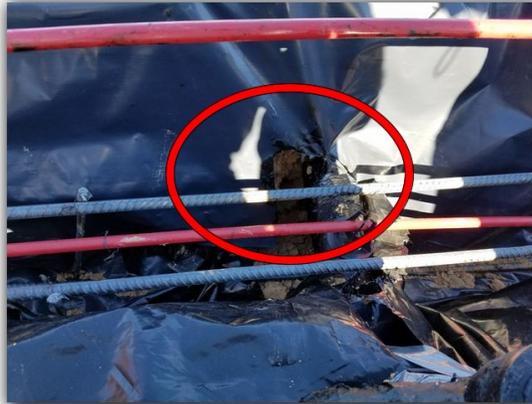
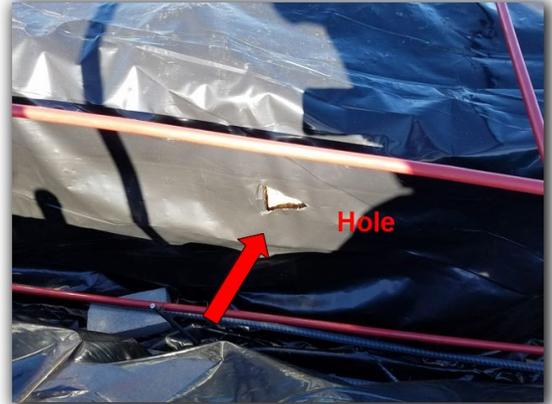
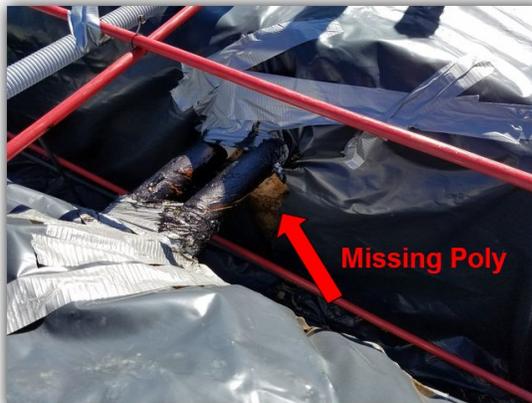
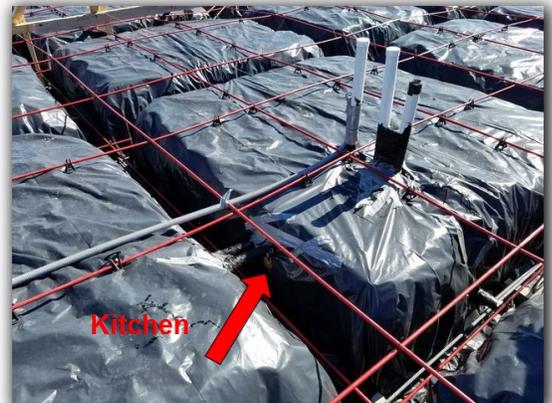
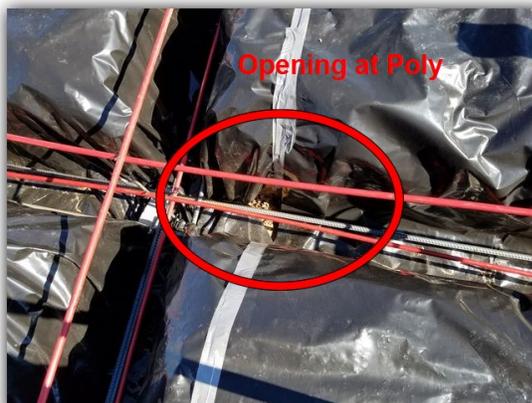
Damaged and missing polyethylene sheathing was found at beams and sections of the pad.  
Recommend repairs to provide proper coverage at all areas.

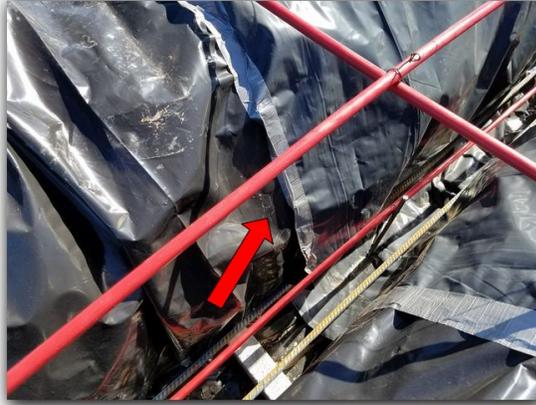
Loose intersection of poly.

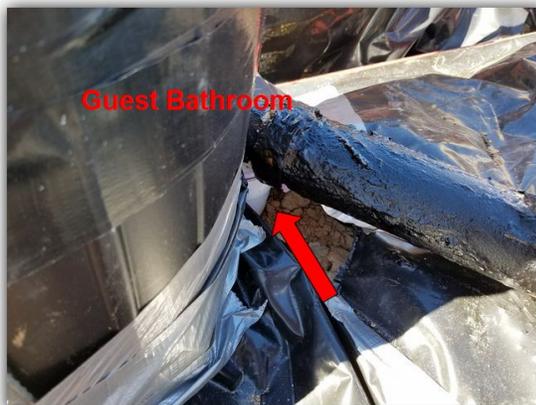
Exposed PVC piping was found. All exposed PVC should have mastic applied prior to pour.

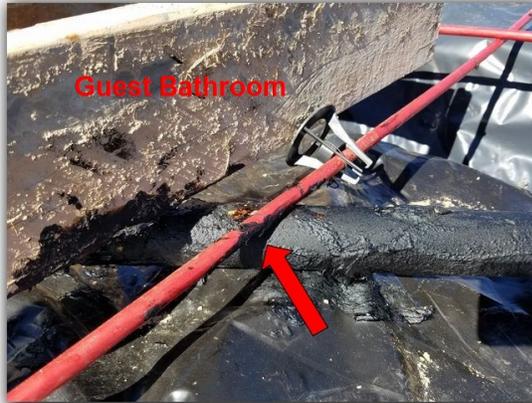
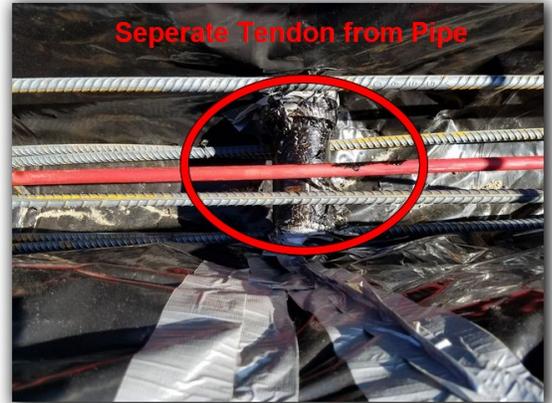
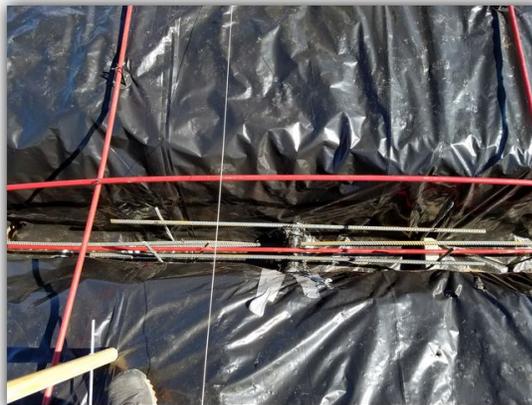
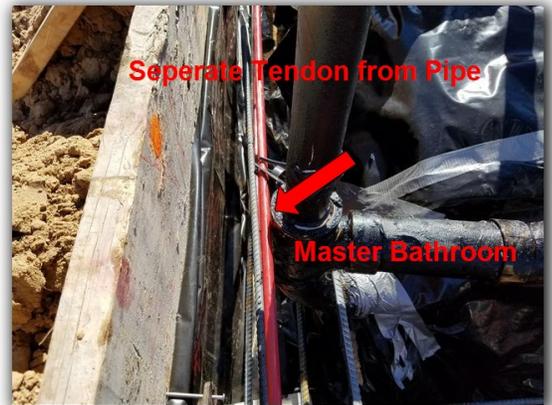
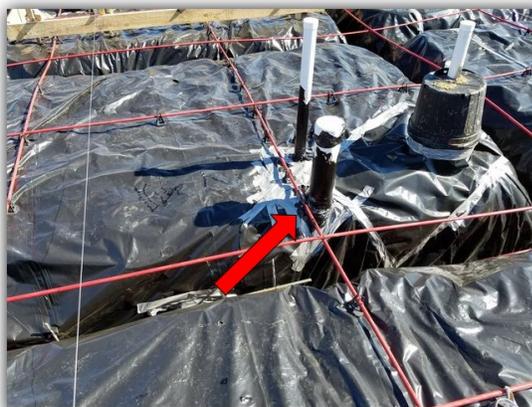
Separation / chairs installed between tendons and plumbing pipes:  
Recommend improvements between tendons and plumbing pipes.
