1234 Main Street

3. Tuesday, May 24, 2016
Inspection Date

5. House with detached garage.

Wood Destroying Report Addendum / Photos

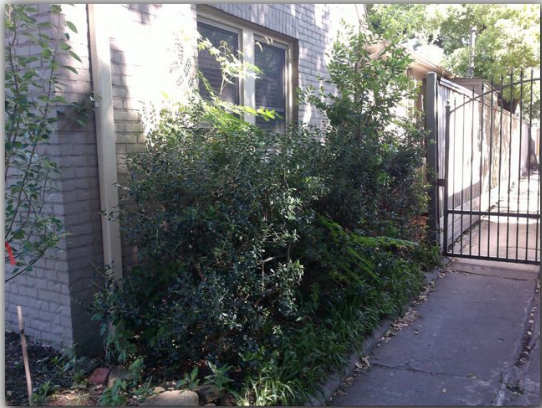
Conducive Areas

Conducive conditions were found during the inspection of the property, which could conceal insect activity or promote future insect activity or conceal damage. DUE TO THE CONDUCTIVE CONDITIONS FOUND WE CANNOT GUARANTEE THE ABSENCE OF WOOD DESTROYING INSECTS. The conducive conditions should be corrected. After the conducive conditions have been corrected it is recommended that the property be re-inspected for wood destroying insects. The client should take into consideration the cost of associated with correcting the conducive and / or performing a subterranean termite treatment and plan accordingly.

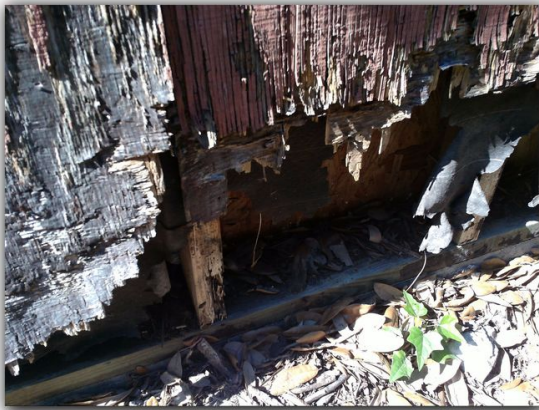
Previous Subterranean Termites - Home

Evidence of previous infestation of wood destroying insects were found during the inspection as reflected on this report / graph. If evidence / documentation cannot produced verifying a treatment we are required to recommend the property be treated.
