HOUSTON INSPECTIONS

TREC Inspection

PROPERTY INSPECTION REPORT FORM

John Doe <i>Name of Client</i>	09/06/2022 <i>Date of Inspection</i>
123 Main St, Houston, TX <i>Address of Inspected Property</i>	
Shawn Emerick <i>Name of Inspector</i>	#4623 <i>TREC License #</i>
R. Shawn Emerick <i>Name of Sponsor (if applicable)</i>	#4623 <i>TREC License #</i>

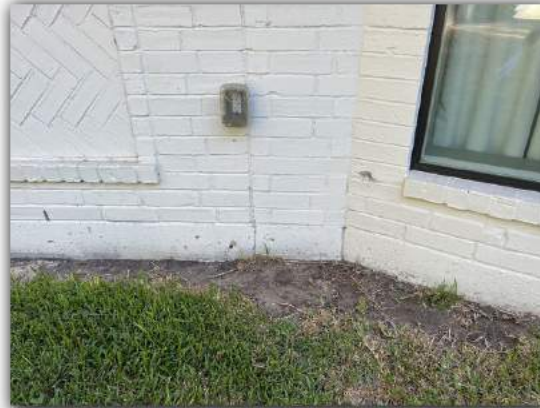
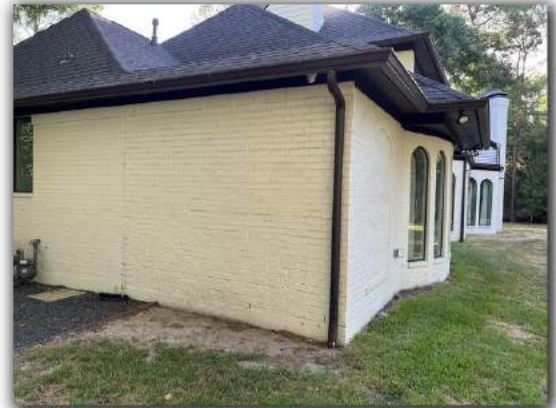
It appears that portions of the foundation(s) have been added onto since the original construction of the property. It is impossible for the inspector to determine the method in which the add-on was constructed. In addition, the slab joint between the two foundations are vulnerable for wood destroying insect activity and should be monitored closely.

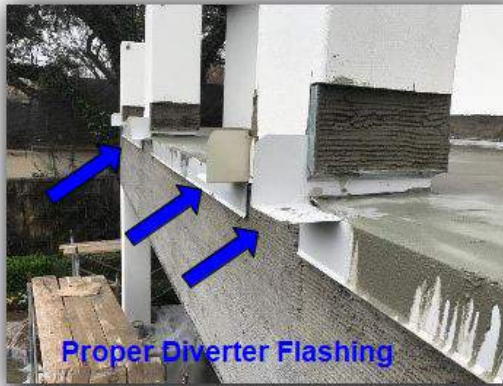
Diverter Flashing Not Visible / Improperly Installed - Further Investigation

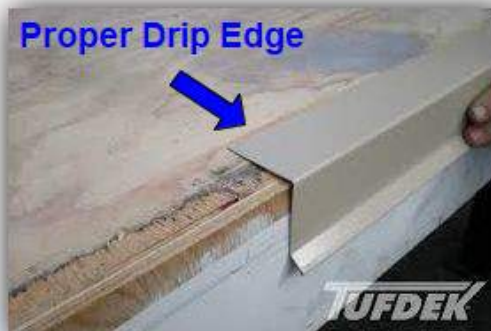
Drip edge flashing not installed or improperly installed - Further Investigation

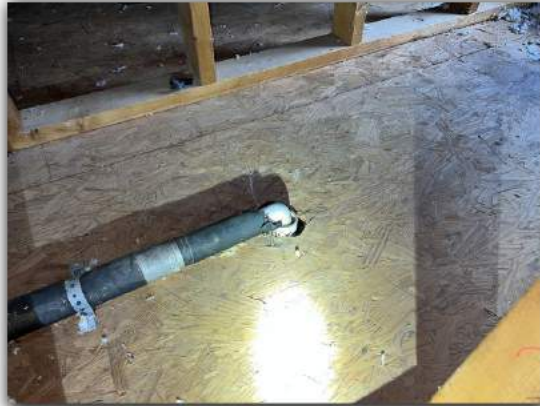
- Electrical receptacles missing at exterior and / or interior units
- Primary drain line not trapped

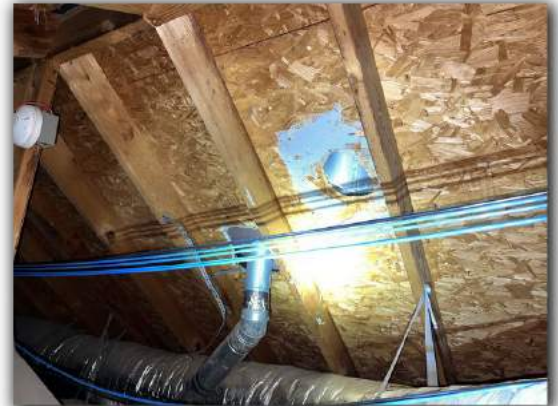
Loose plenum tape and connections were noted at the systems. A licensed HVAC contractor should be consulted to seal all voids at the systems and ducts.

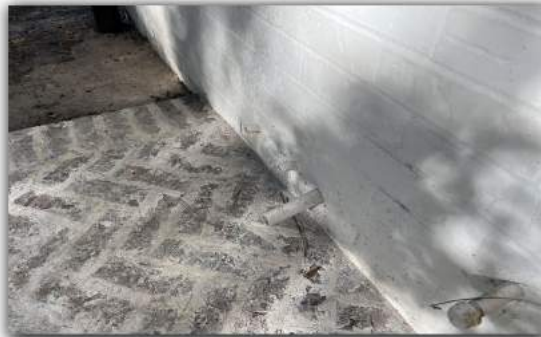
- T&P valve improperly plumbed

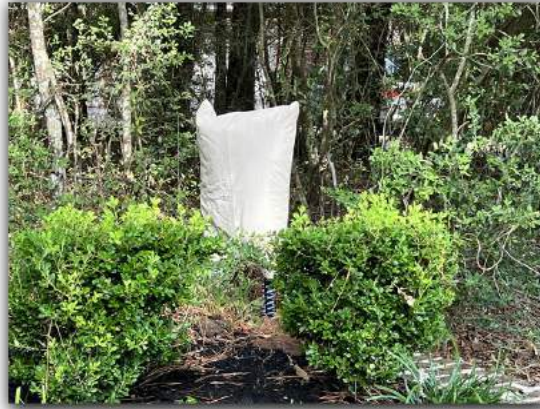
Backflow Prevention Valve:

Items Damaged, Non-Functional, or Operating Improperly
There is no sprinkler coverage in the backyard.

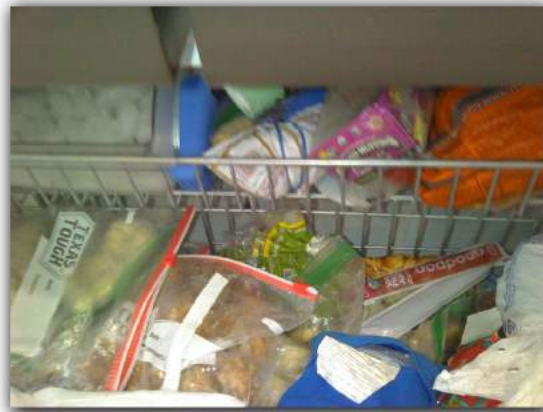
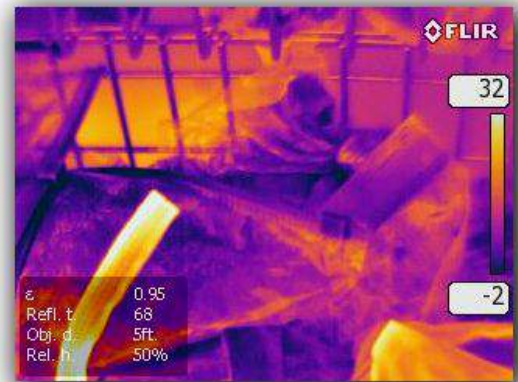
Infrared Image

- Freezer Temperature Measured: 0 - -4 Degrees F
The temperature measured in the refrigerator at the time of the inspection was or below 0 degrees F as recommended by the Food Drug Administration (FDA).
