PROPERTY INSPECTION REPORT

Prepared For: John Doe
(Name of Client)

Concerning: 1234 Anywhere Street, Anywhere, TX 77777
(Address or Other Identification of Inspected Property)

By: Shawn Emerick, Lic #4623 06/19/2017
(Name and License Number of Inspector) (Date)

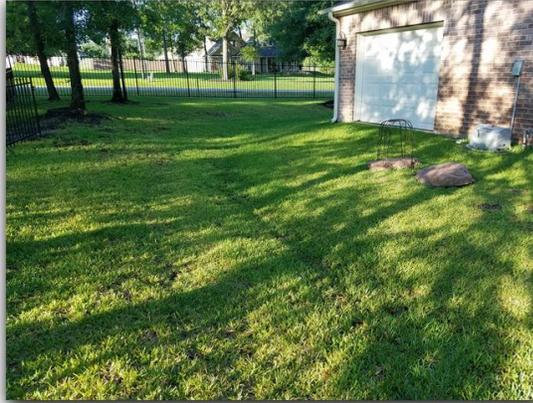
The drainage swale at the front and right of the guest house is holding water. The lot should be graded to allow storm water to drain to the street. If grading improvements cannot be made the installation of underground drainage systems should be considered.

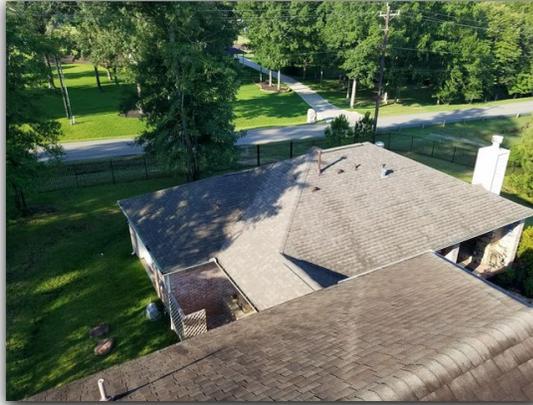
Staining was found at sections of the roof decking as evidence of active roof leaks (main house garage attic). A qualified tradesman should further evaluate the roof and make the necessary repairs to repair the leaks.

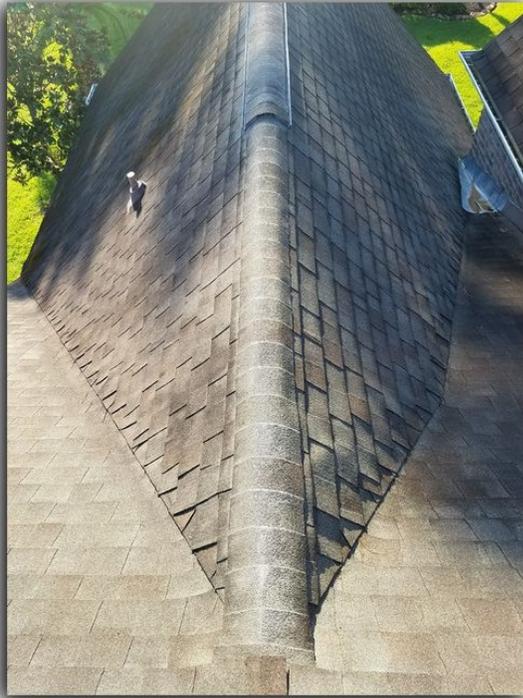
Damaged and / or missing shingles were found during the inspection of the roof covering. Recommend repairs by a qualified tradesman.

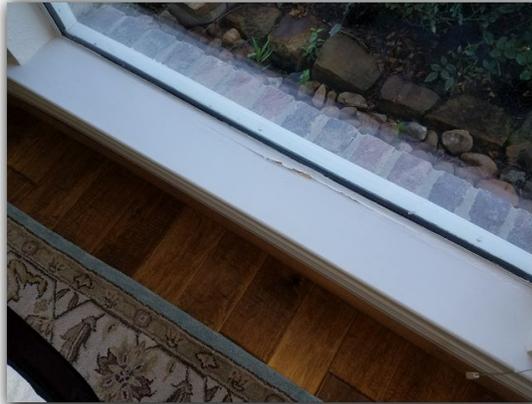
Staining and discoloration was found at the windowsills in the master bedroom. Sealing on the exterior of the windows can sometimes correct this problem. At a minimum these areas should be monitored and repaired as needed. No moisture was found present at the inspection.

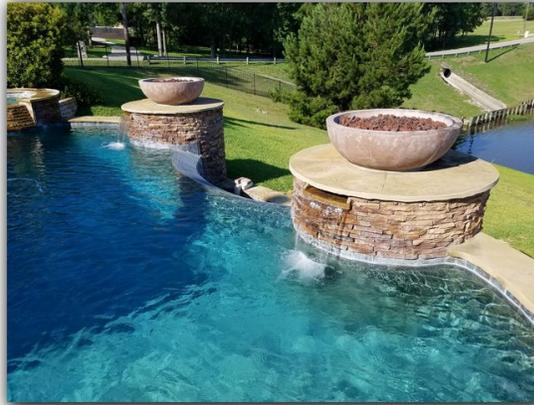
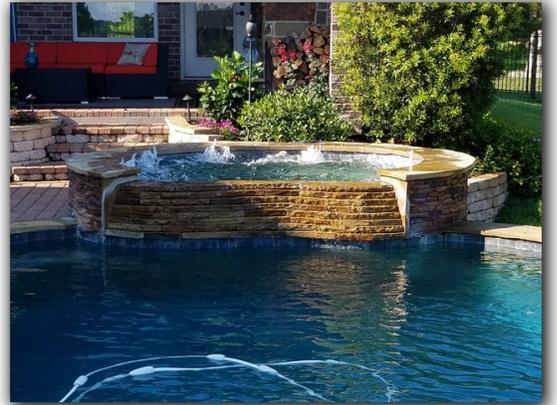
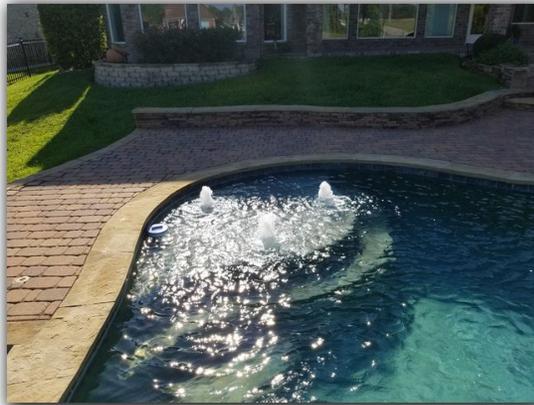
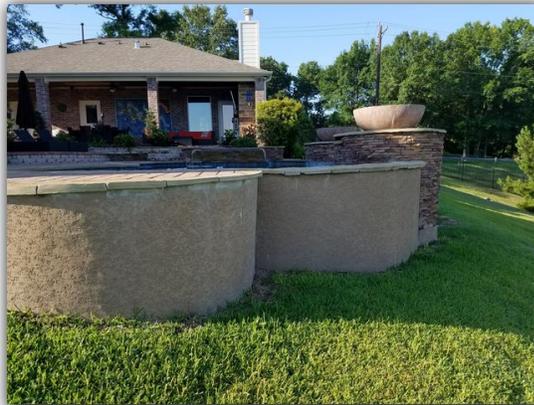
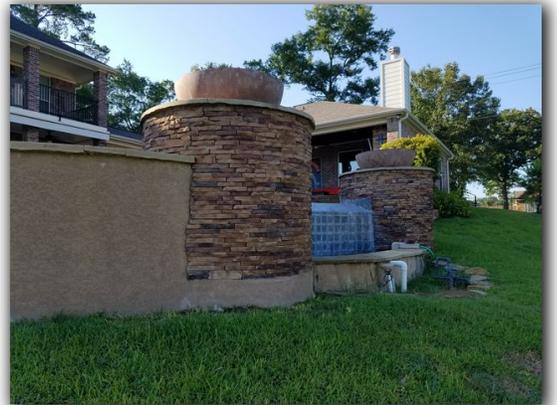
- Alarms not installed at doors leading to pool
- Locks not installed properly at doors leading to pool

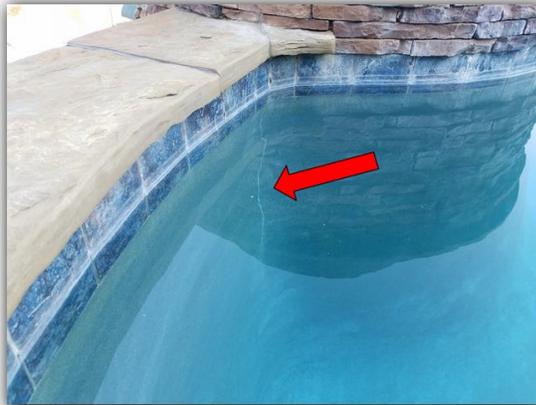
Missing grout / mortar was found at some locations of the coping. Recommend sealing.

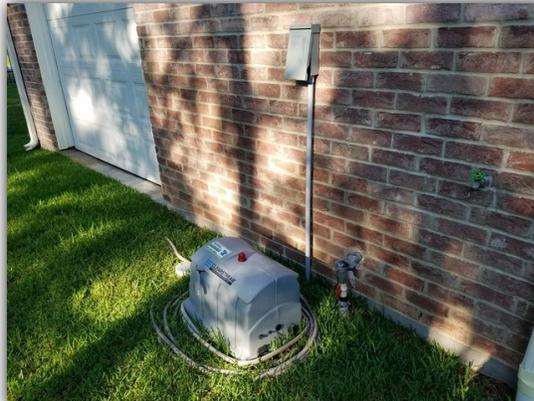
The private sewage disposal (septic) system and related components do not appear to be operating adequately at the time of this inspection. The system is not achieving an operation, function, or configuration consistent with accepted industry practices for its age. It is recommended further evaluation by a qualified tradesman.

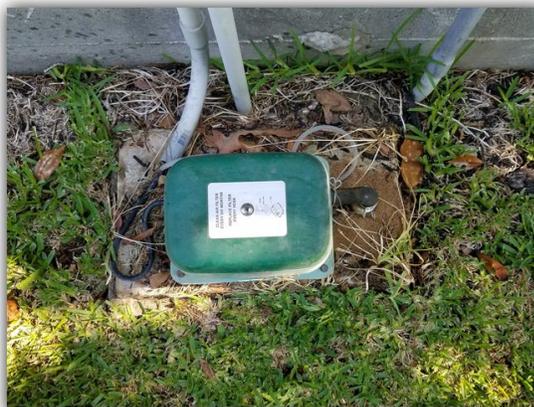
The insect activity needs to be corrected at the aerobic pump motor for the main house.

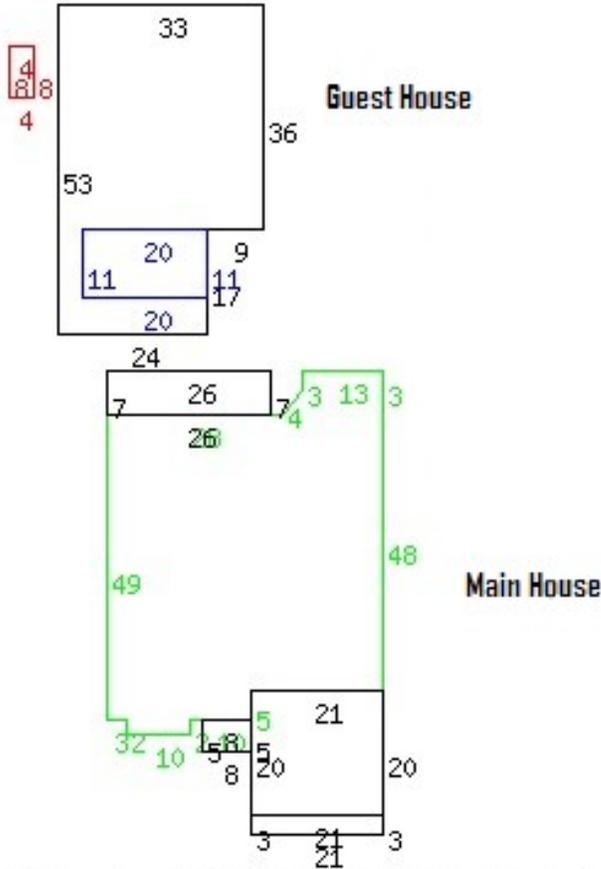
Diagram of Structure(s) Inspected

Additional Comments There is no visible evidence of active wood destroying insects found at the time of this inspection. _____
