HOUSTON INSPECTIONS

PROPERTY CONDITION REPORT

Concerning: 1234 Any Street, Houston, TX
(Address of Inspected Property)

By: Dennis Inman, Lic #20664 10/31/2018
(Name and License Number of Inspector) (Date)

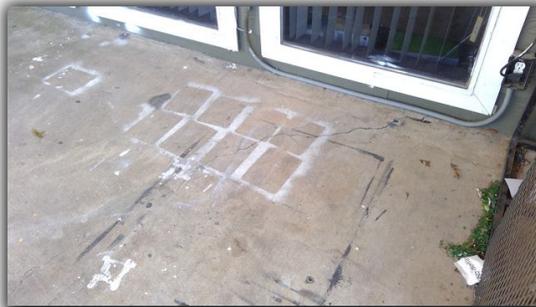
Clubhouse B1

Evidence of significant sloping at floors

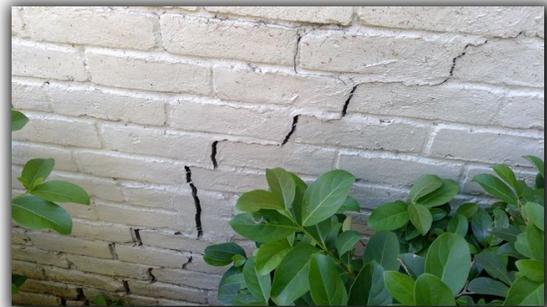
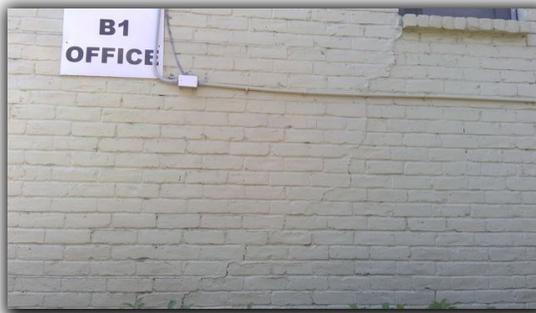
Brick mortar cracking with separations

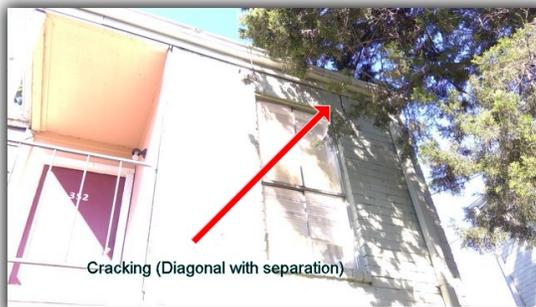
B4

Brick/mortar cracking with separation

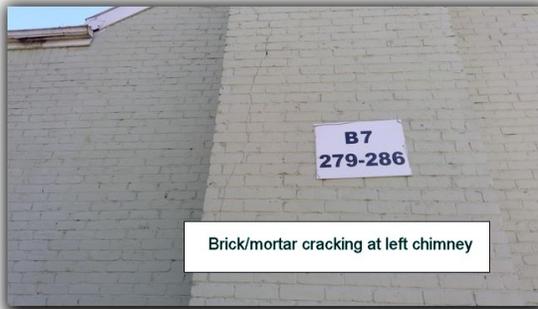
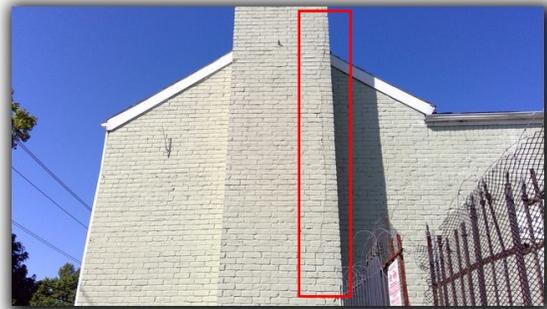
B7
Brick/mortar cracking with separations

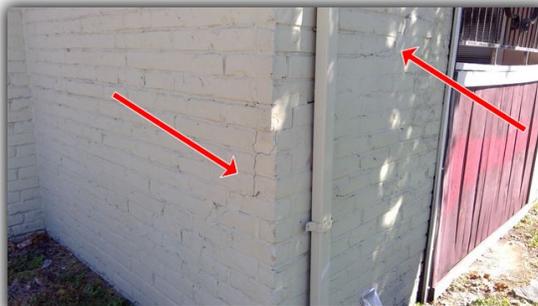
Diagonal cracking as evidence of potential differential movement

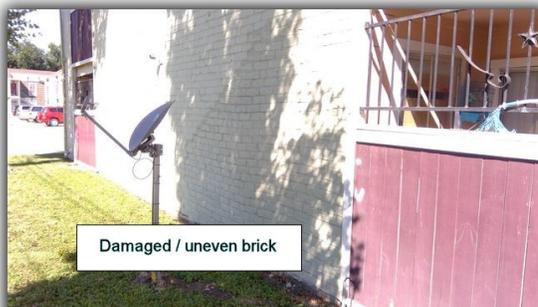
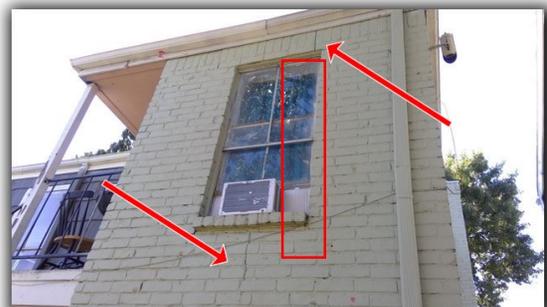
Brick/mortar cracking with separation

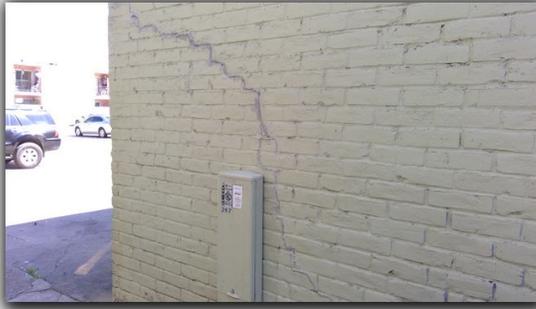
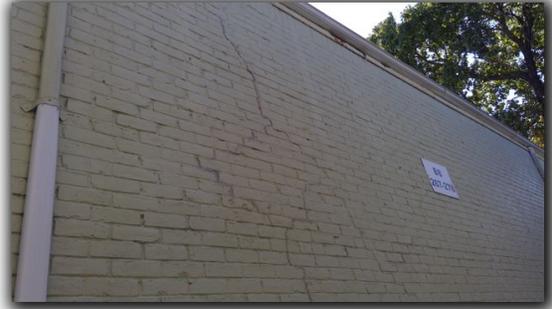
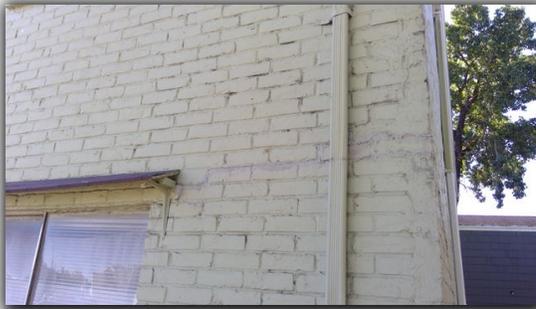
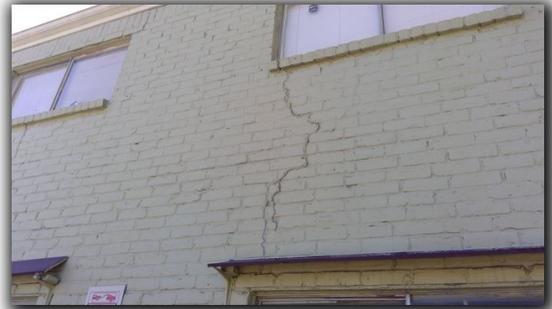
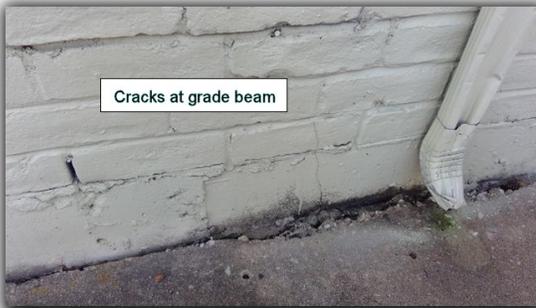
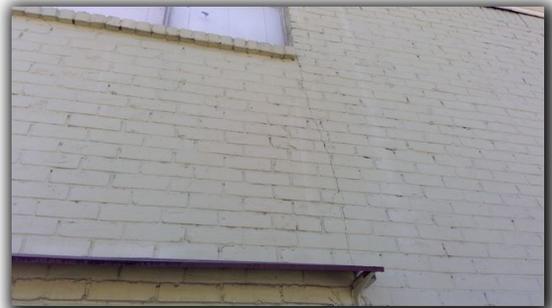
B8:
Extensive masonry cracking with separations and grade beam cracks

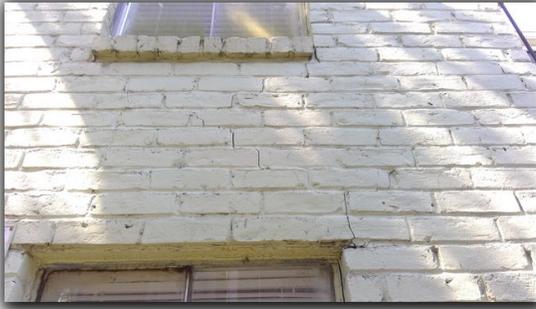
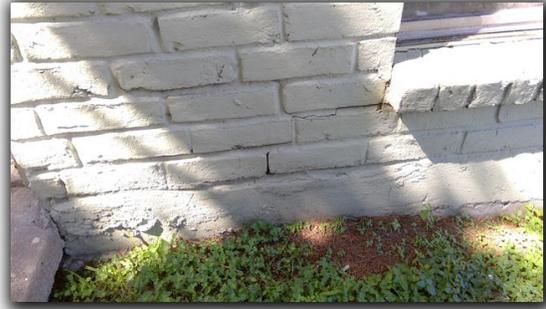
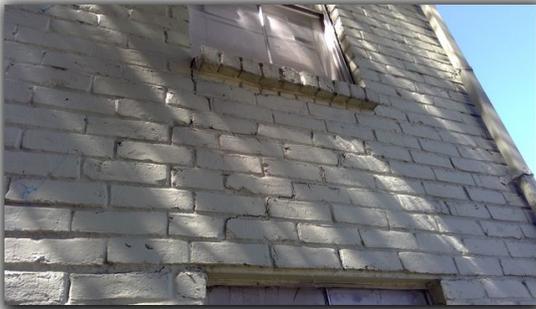
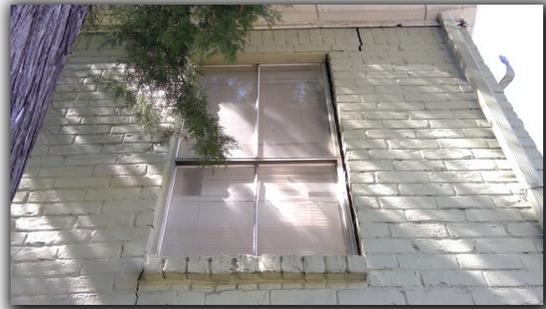
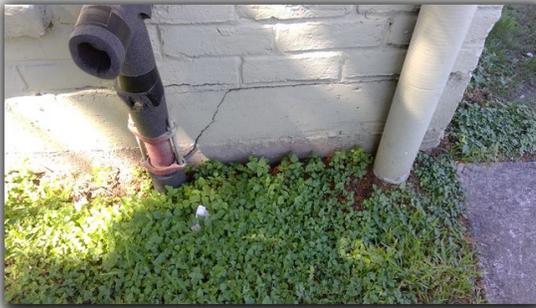
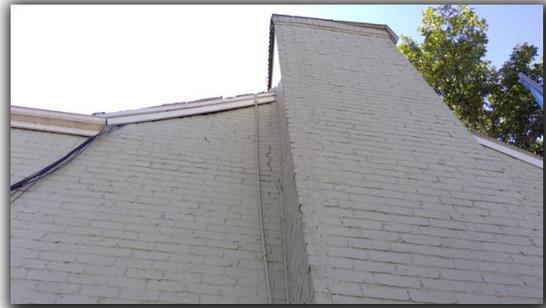
B15

Masonry cracking some with significant separations Grade beam cracks

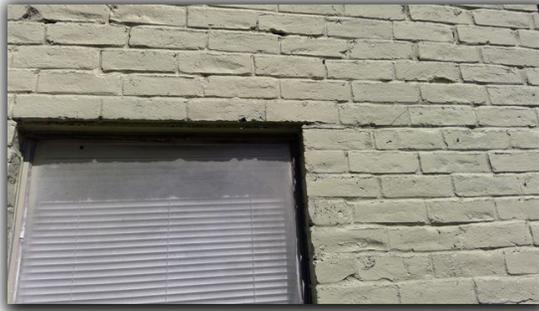
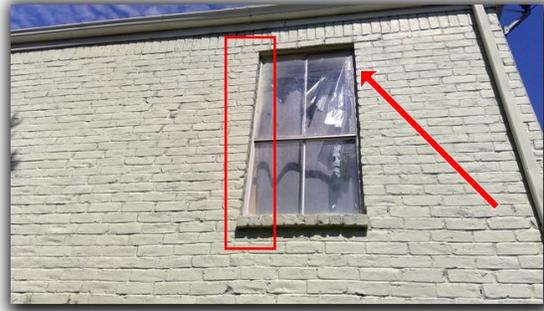
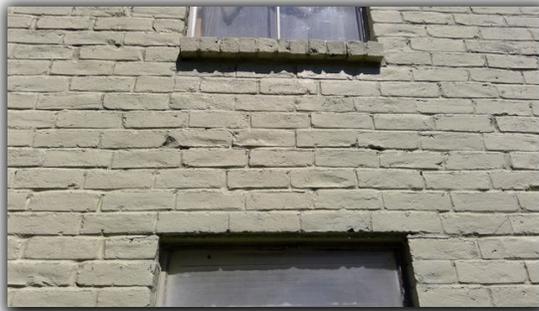
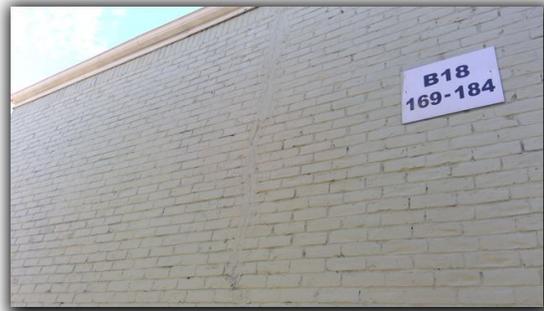
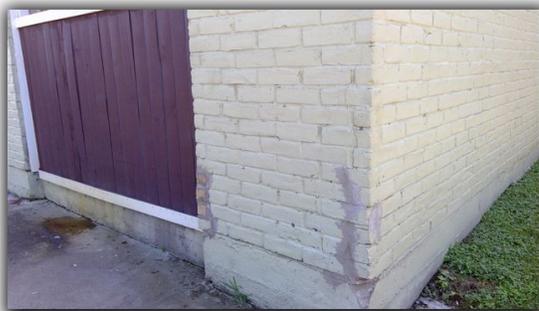
B18

Masonry cracking with significant separations at some locations

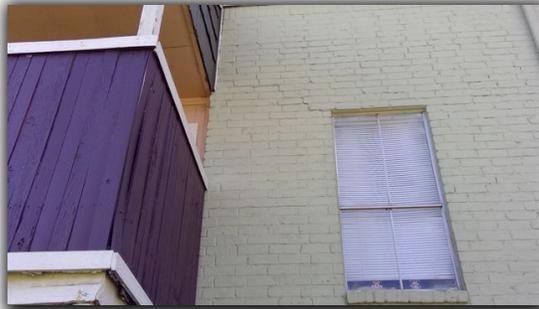
B2

Brick/mortar cracking with potential differential settlement

At the time of the inspection evidence was found at these buildings that indicated that the foundation of the following may not be performing their intended function (Generally limited cracking ,separations at veneers. etc.) It is recommended that further inspection be made by a Registered Professional Engineer to determine if there has been a of loss of structural integrity and if repairs are needed.

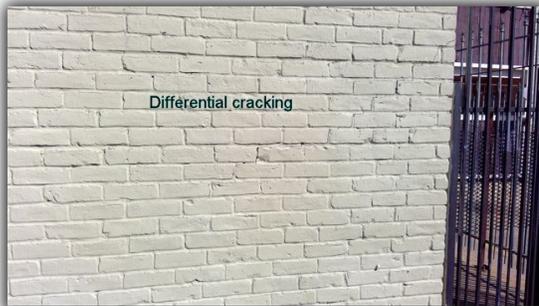
B5

Evidence of potential differential cracking

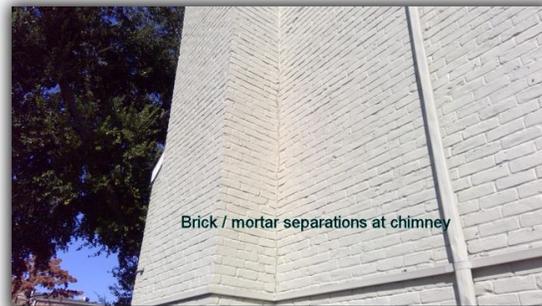
Brick/mortar separations

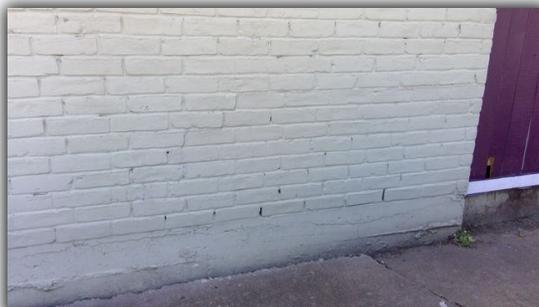
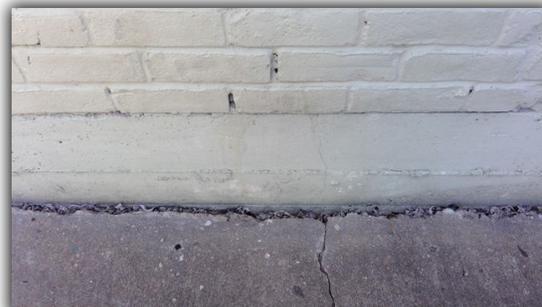
B12

Limited cracking at brick/mortar

Cracking without significant separation at grade beam

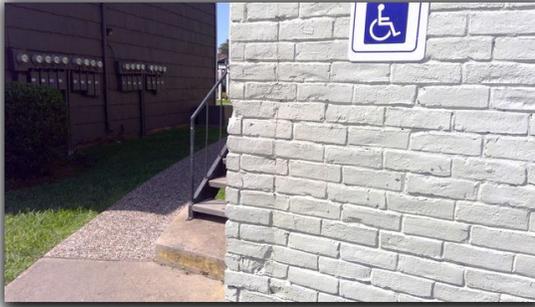
B14
Wall deflection

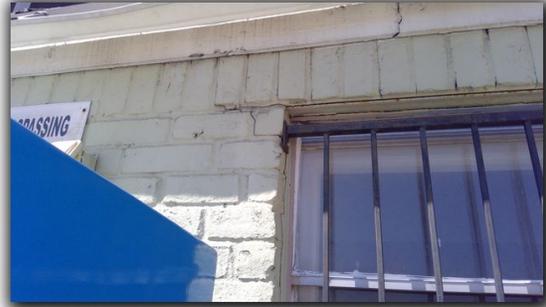
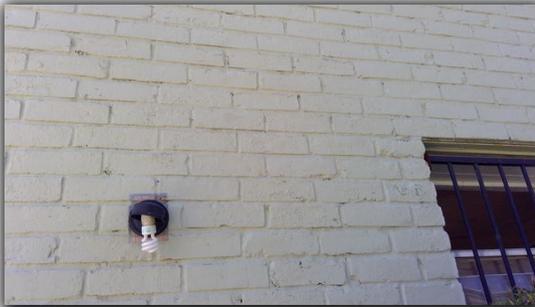
Brick/mortar cracking

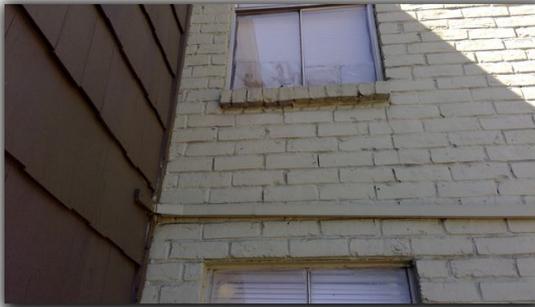
B16
Brick/mortar cracking

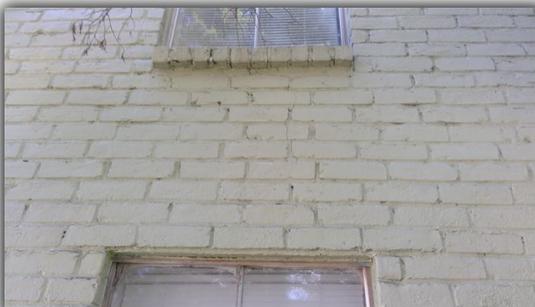
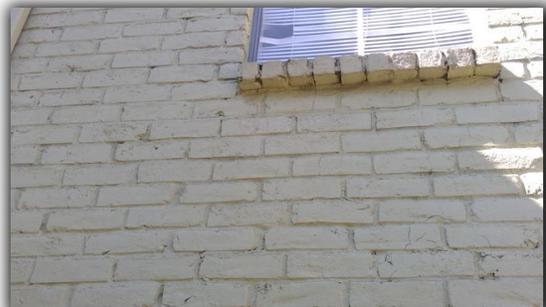
B17
Brick/mortar cracking

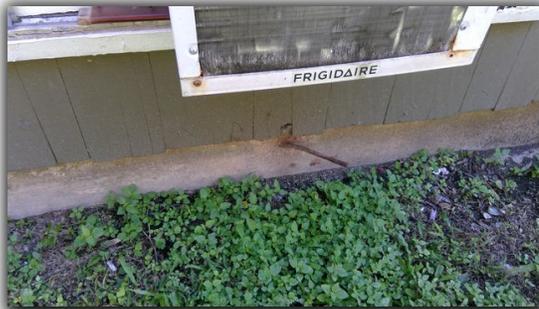
Exposed steel reinforcing bars (rebar) were noted at the visible portions of the foundation grade beams (B11). Recommend repairs to prevent ongoing corrosion and deterioration of the steel.

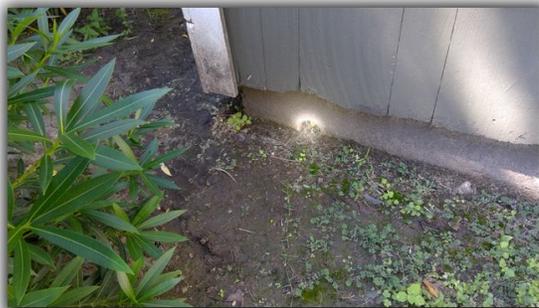
Exposed post tension tendon ends were noted at the visible portions of the foundation grade beams (B13). The steel tendon ends should be cleaned and covered with an approved material.

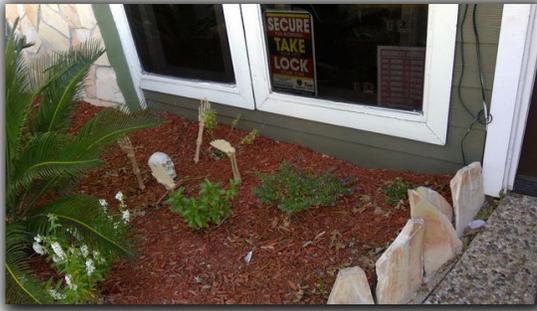
The top soil and / or mulch around the structure is too high at the clubhouse. The soil should be lowered to provide 4-6" exposure of the foundation. Lowering the top soil will reduce the likelihood of damage at the exterior veneers, allow proper ventilation of the wall cavities, and assist in monitoring the foundation for movement.

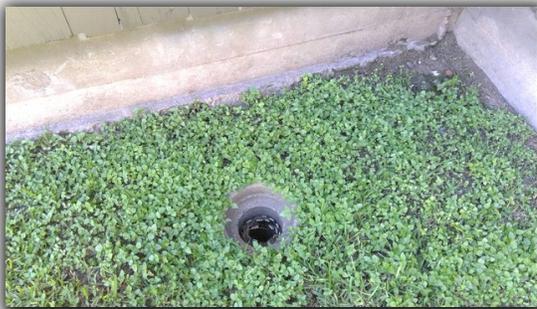
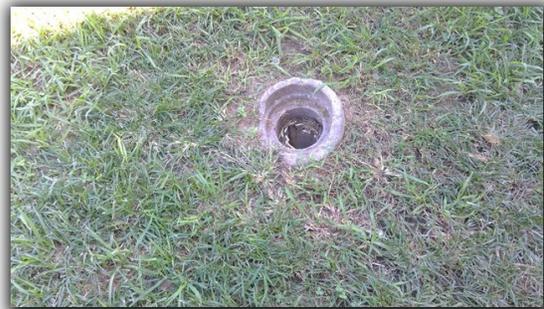
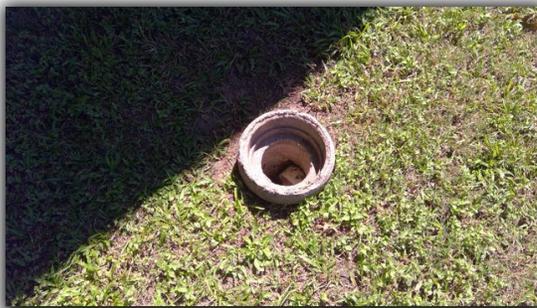
Missing drain covers should be replaced to prevent possible injury and obstruction from debris.

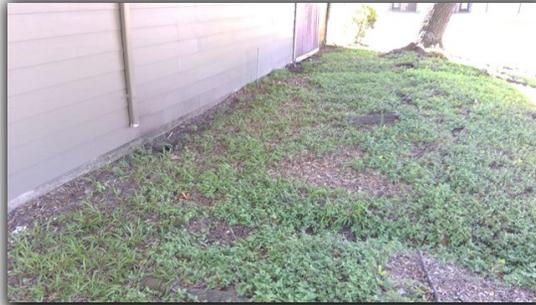
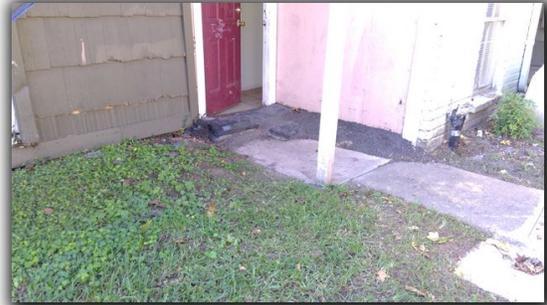
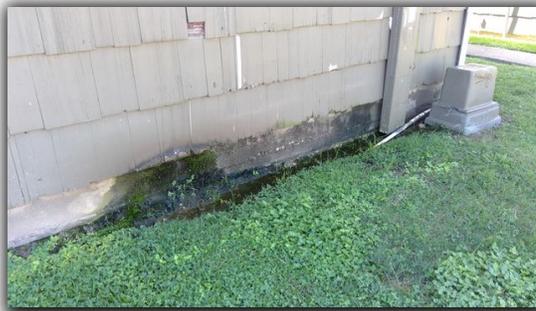
The existing grade at the slab perimeters is not adequate for shedding water away from the structures on all sides. The ground should slope away from the structures at a rate 6" in the first ten feet. Where lot lines, walls, slopes or other physical barriers prohibit 6" of fall within the first 10', drains or swales should be provided to ensure drainage away from the structures. Ideally, at least eight (8) inches of clearance should be maintained between soil level and the top of the foundation walls.

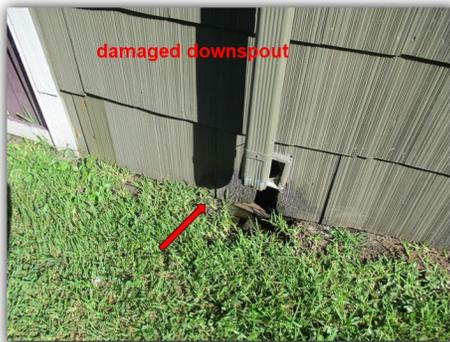
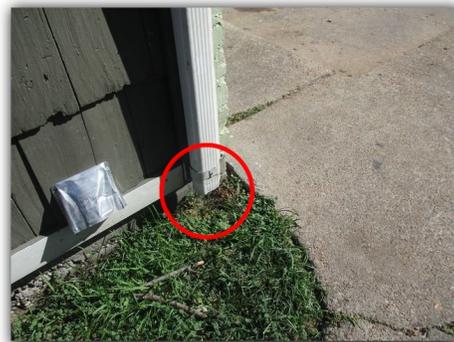
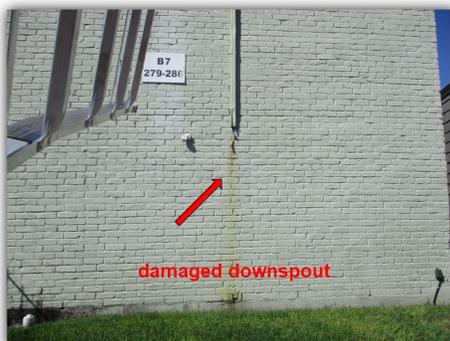
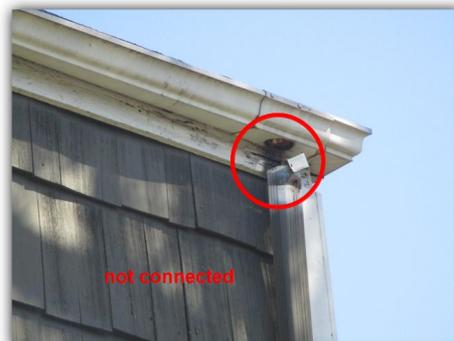
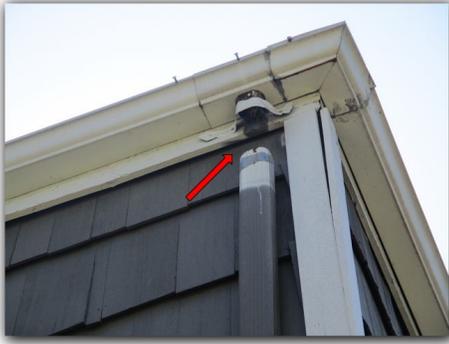
Missing gutter splashblocks should be installed at the base of the gutter downspouts to reduce soil erosion.

Damaged downspouts were found at gutters.

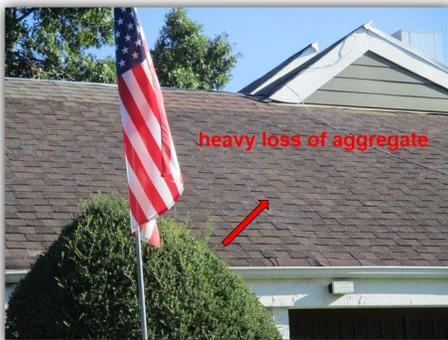
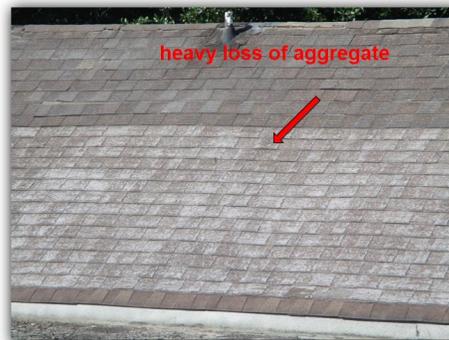
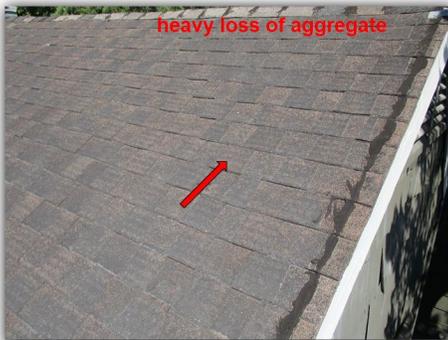
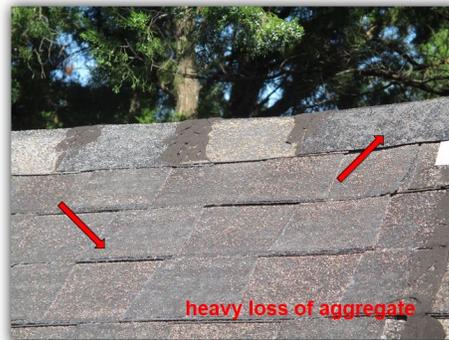
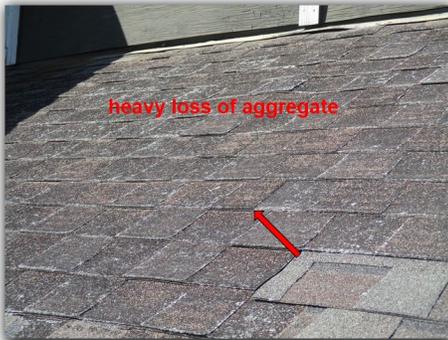
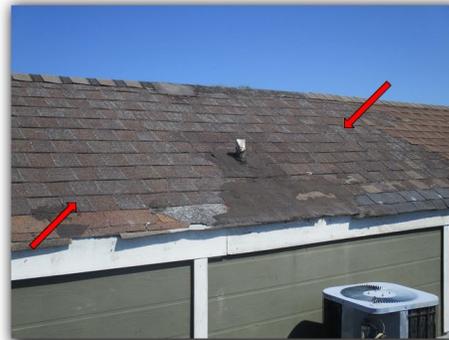
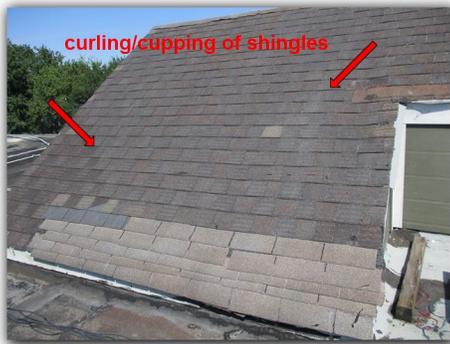
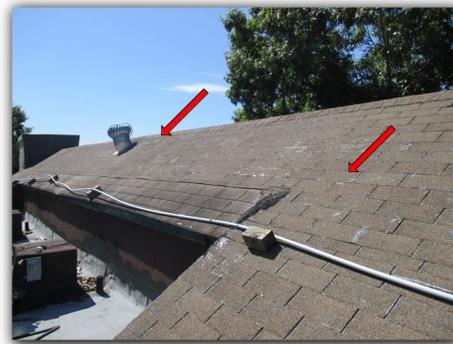
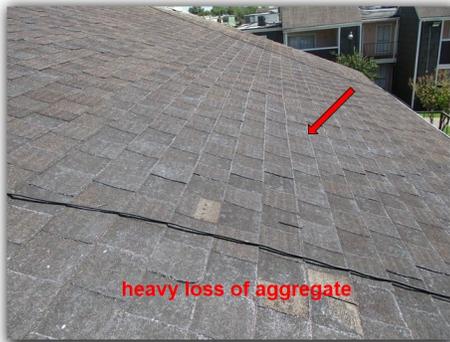
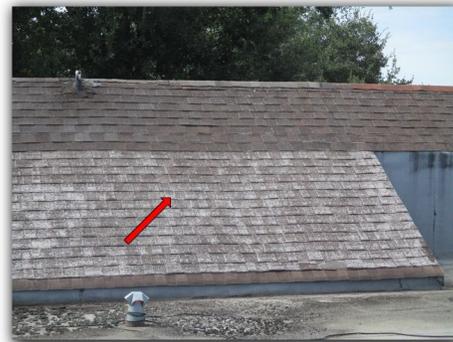
The roof coverings are in need of repairs. The overall condition of most of the roof coverings are in poor condition. Problems found during the inspection of the roof coverings are listed in the section below. It is recommended that a qualified tradesman be consulted to completely evaluate the roof coverings and perform all necessary repairs to insure the roofs are watertight, all shingles and other components are secured properly. The tradesman should also to determine if hidden or not visible damage is present that is in need of repairs. Most of the composition roof coverings (shingles) appear to be nearing the end of their serviceable life. The roofing shingles have experienced severe loss of aggregate, curling, and cupping. Replacement of the roof coverings should be considered.

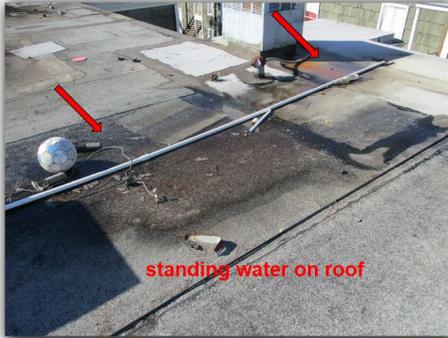
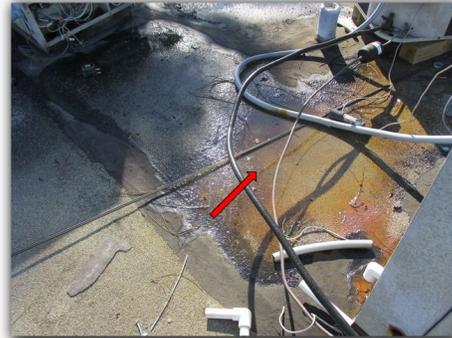
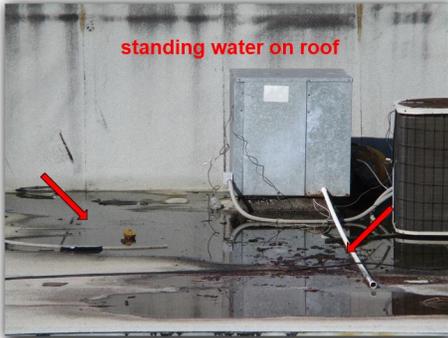
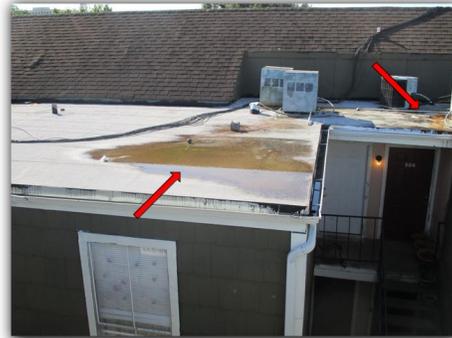
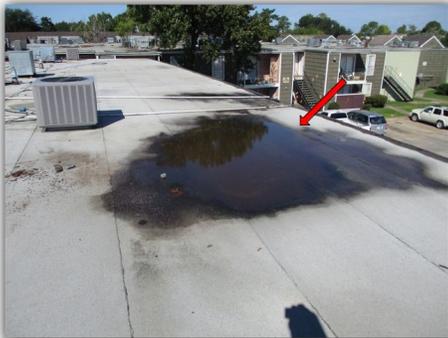
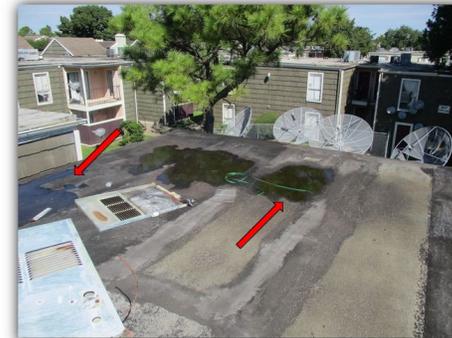
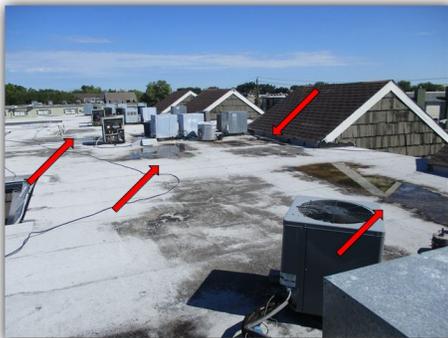
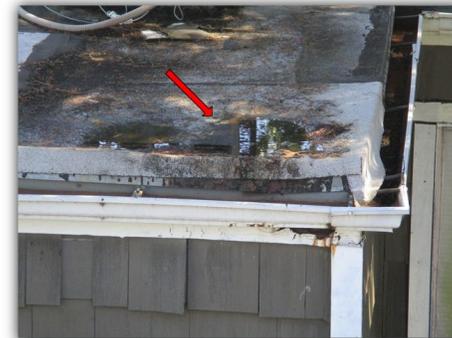
During the inspection of the flat roof, water was found standing **at all buildings**. Ideally, the roofs should be sloped to allow rain water to run from the roofs (within 48 hours). However, this is difficult to perform after the roof coverings have been installed. Additional drains and other methods should be considered to correct this problem. A qualified tradesman/roofing company should be consulted to evaluate these problems and make the necessary repairs.

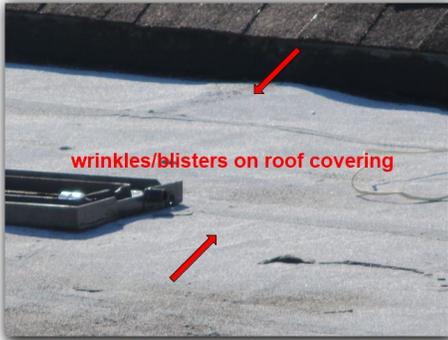
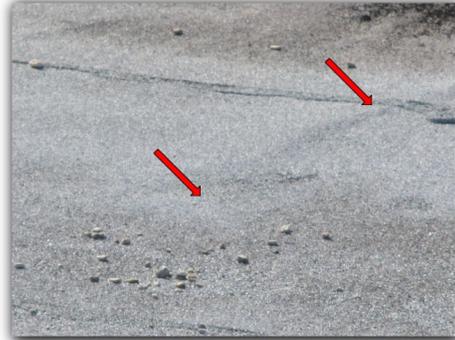
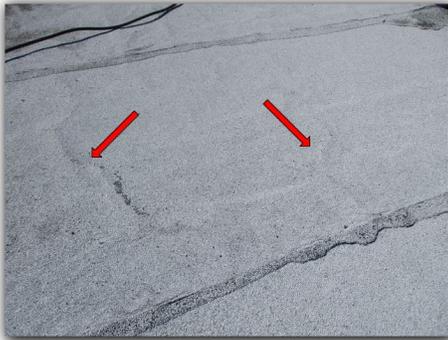
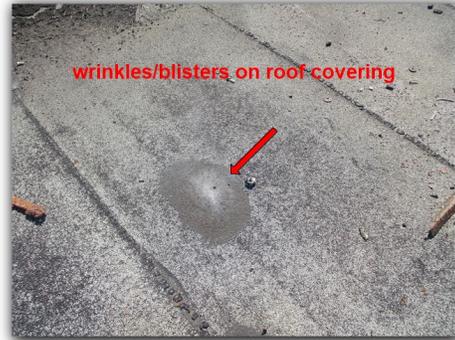
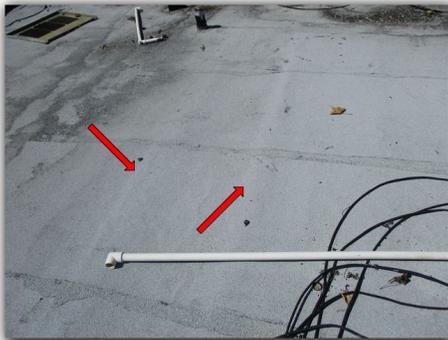
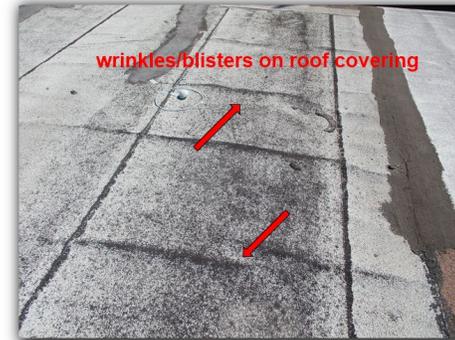
Wrinkling/blistering was noted in areas of the flat roof coverings. This can be caused by built up moisture and/or air under the roofing materials. Recommend further inspection/repairs by a qualified tradesman.

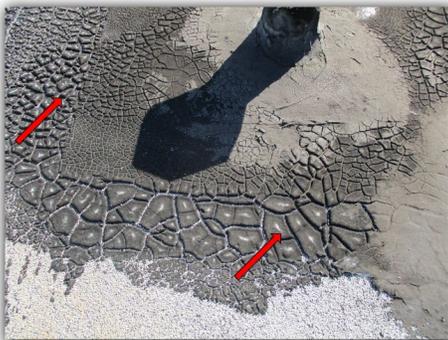
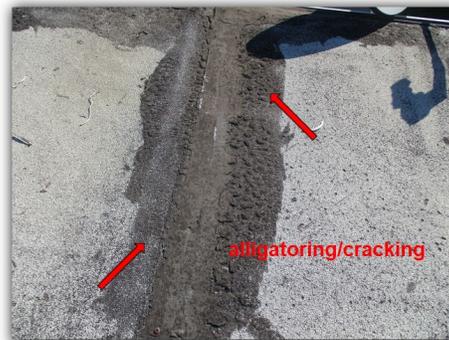
Alligatoring was noted on areas of the flat roof coverings. This can be caused by the sun's UV rays that dry out any type of exposed asphaltic roofs. These areas should be monitored and repaired as needed to prevent future problems with the roof coverings.

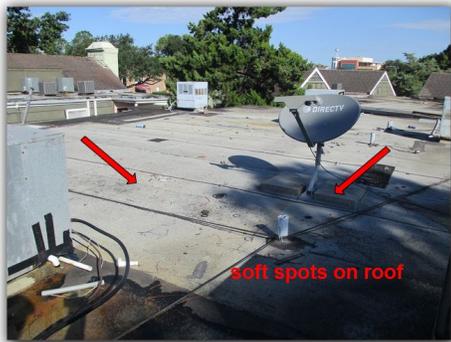
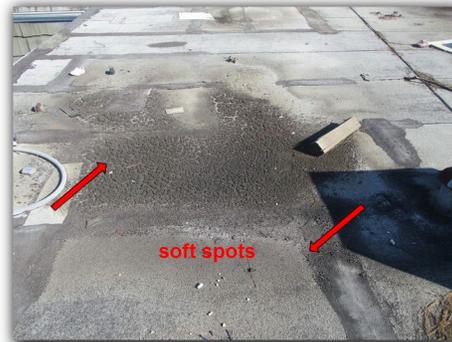
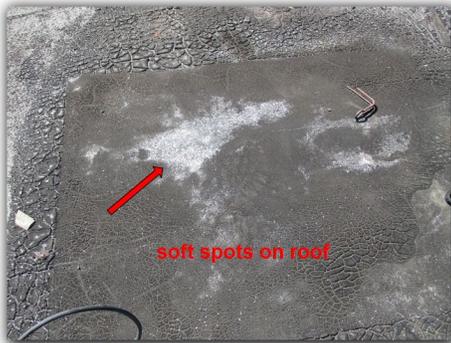
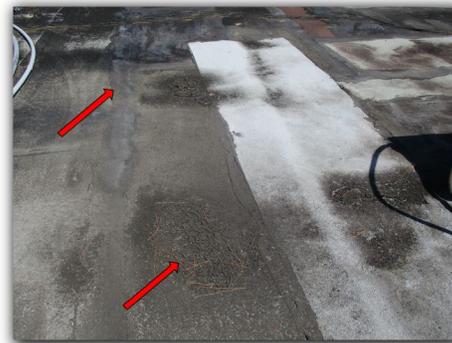
Soft spots were noted in a various locations on the rolled flat roofs. Soft spots on flat roofs could indicate rotted or improperly installed sheathing below the rolled roofing. A qualified tradesman should be contacted to inspect/repair the soft spots as needed.

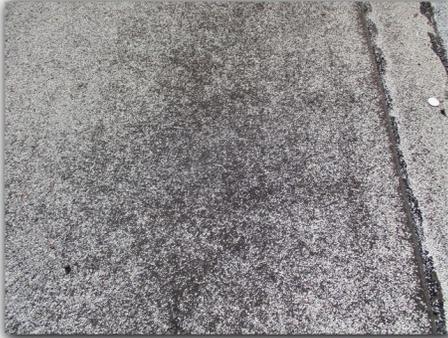
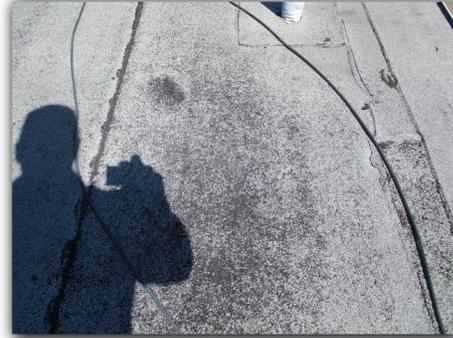
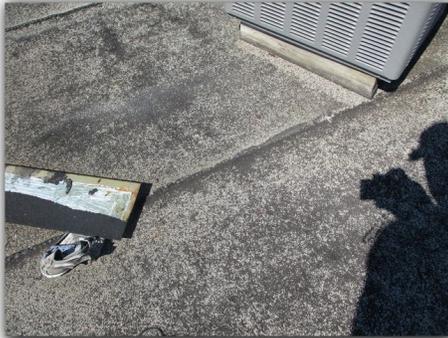
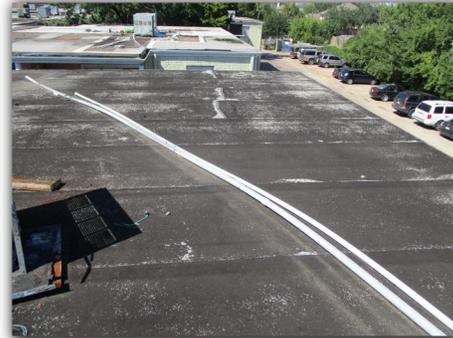
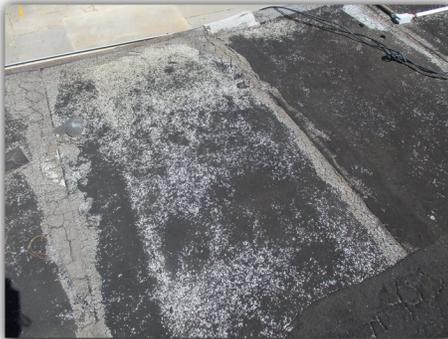
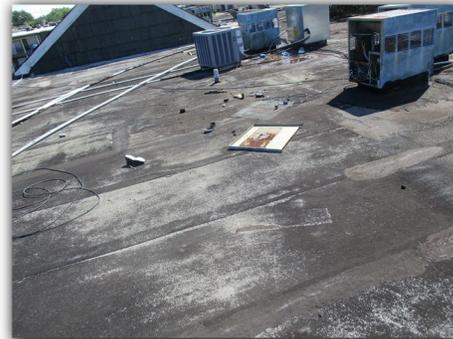
Worn asphalt was noted in areas of the flat roof coverings as evident by bare spots exposing underlying materials. Recommend further inspection/repairs by a qualified tradesman to prevent possible leaks.

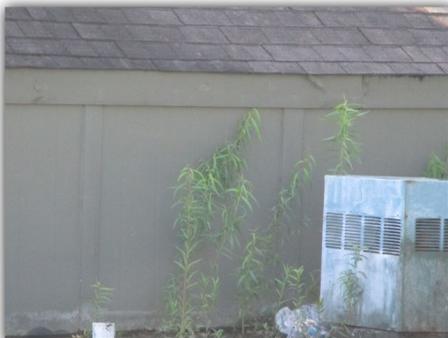
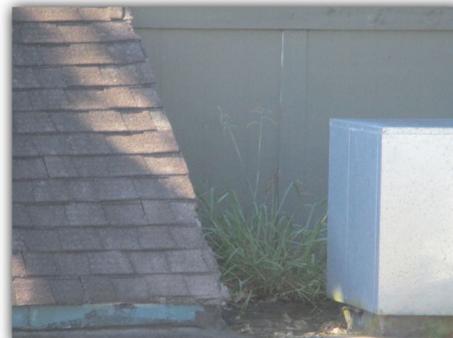
Vegetation was noted growing on the roof covering of Building 7. The removal of the vegetation should be considered.

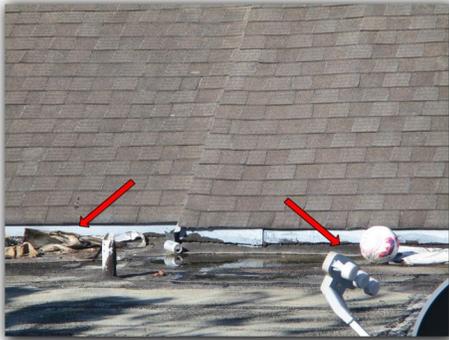
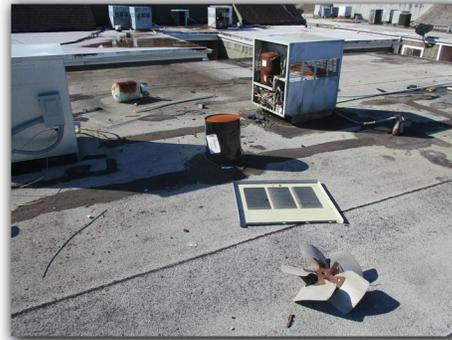
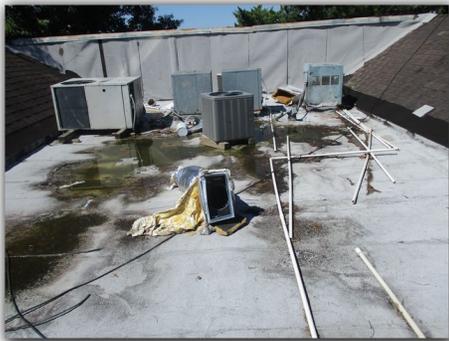
Recommend removal of all trash and debris from roof coverings to help with drainage of the roofs. Trash/debris was found on roofs of most of the buildings.

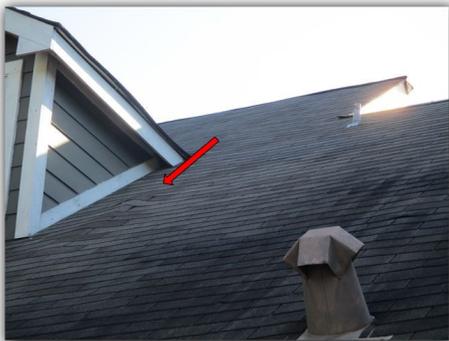
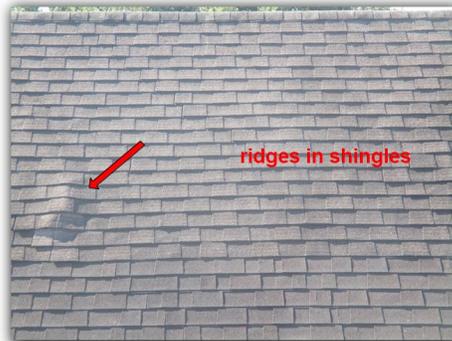
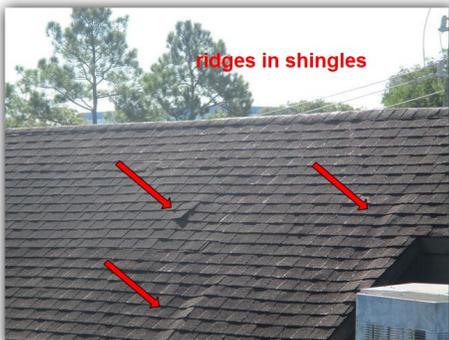
Ridge(s) in shingles were observed on plane of the roof surface in rear of the clubhouse . This is a possible indication that the roof sheathing or underlayment is not installed properly . Recommend inspection/repairs by a qualified tradesman as needed.

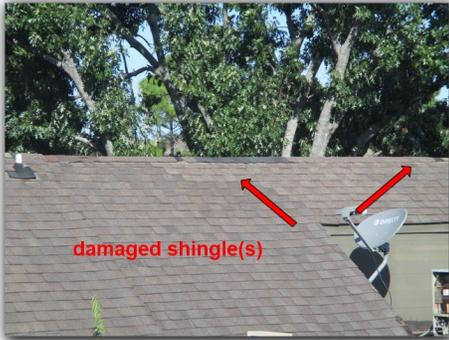
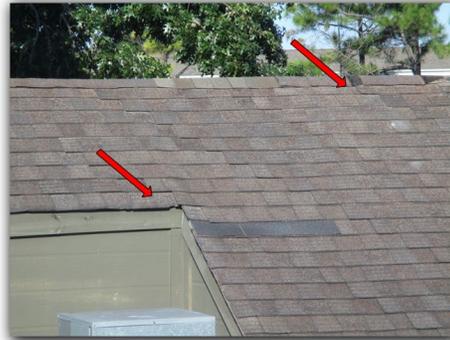
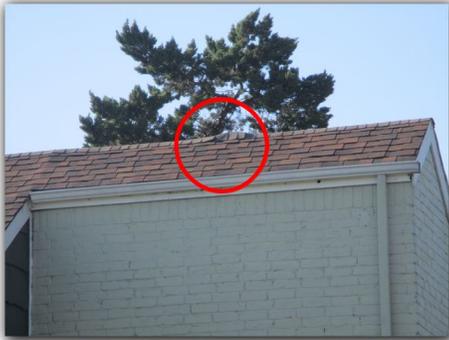
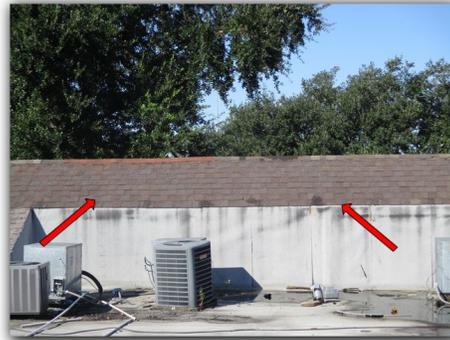
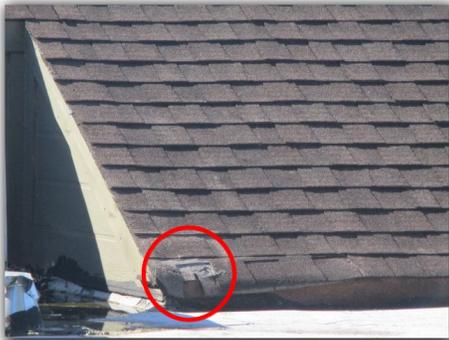
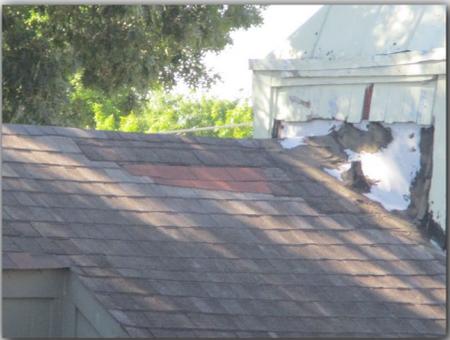
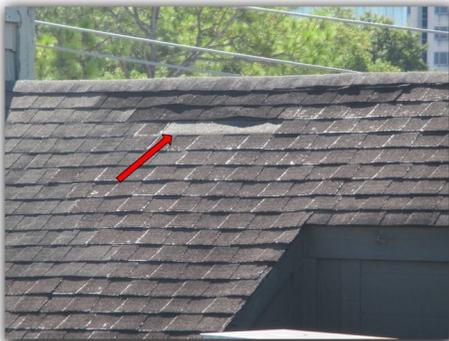
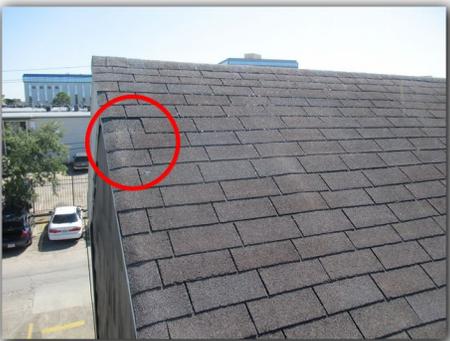
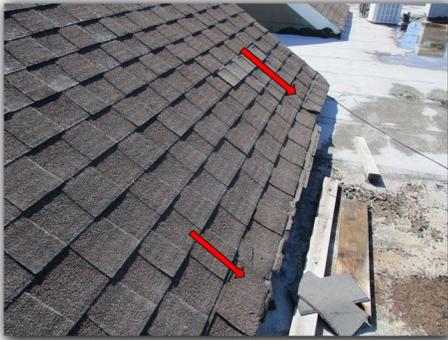
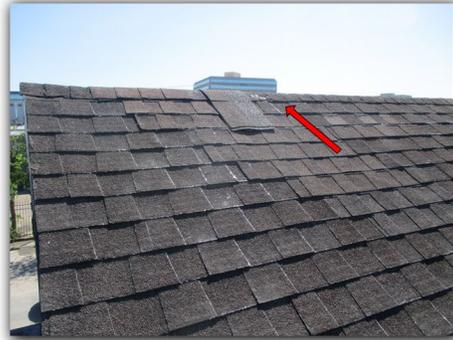
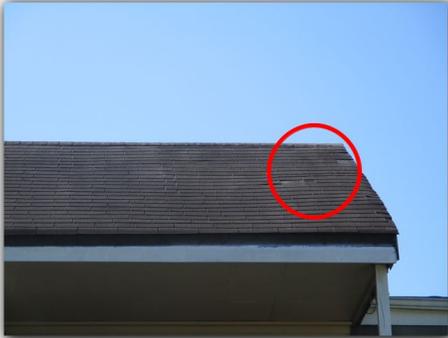
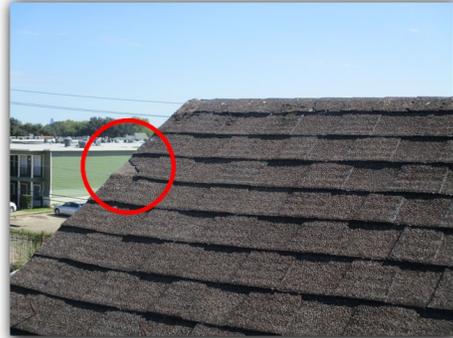
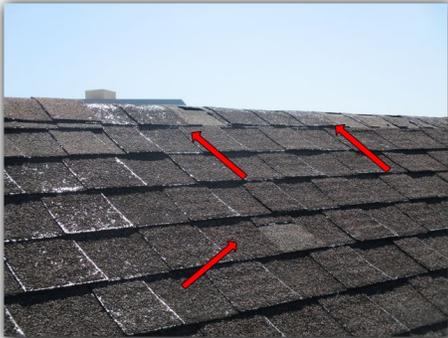
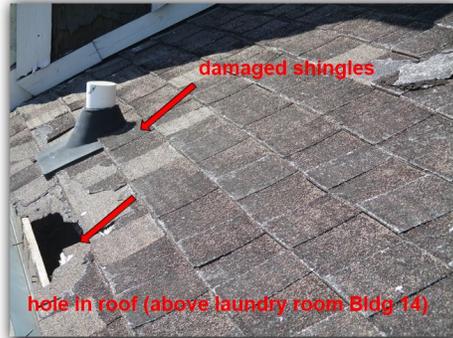
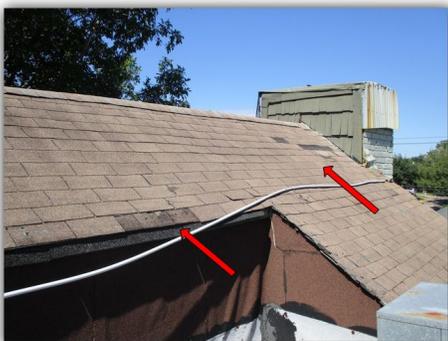
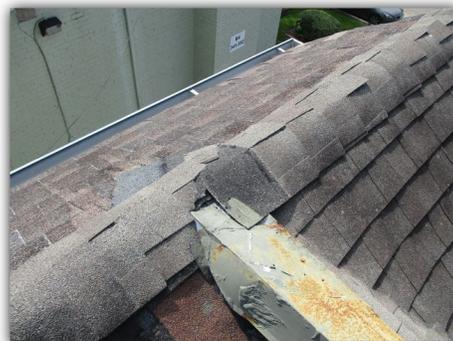
Damaged and / or missing shingles were found during the inspection of the roof coverings. Recommend repairs by a qualified tradesman.

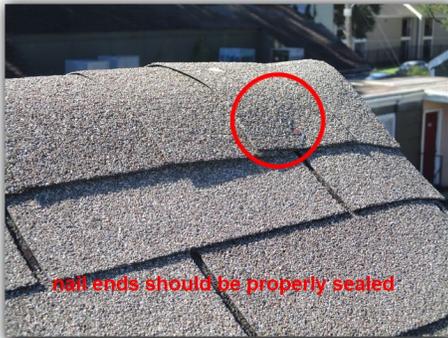
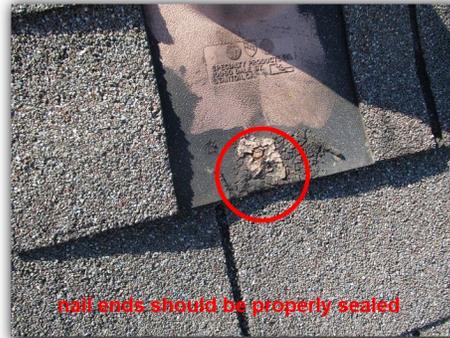
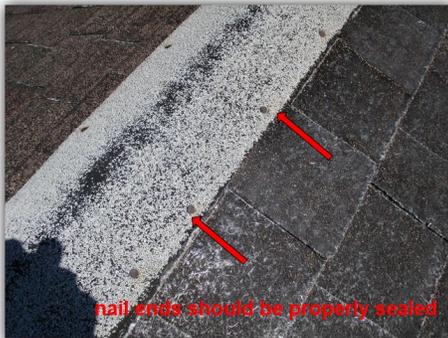
Exposed nail heads were found at roof jacks and / or sections of the flashings. All exposed nail heads should be sealed to prevent water penetrations.

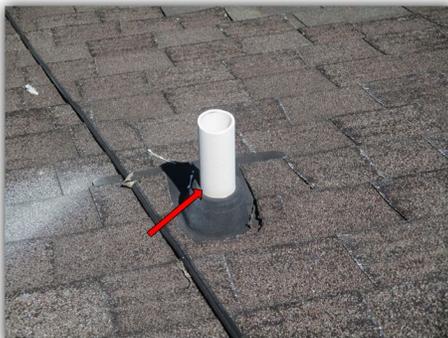
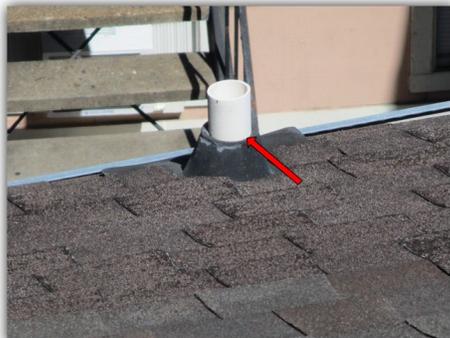
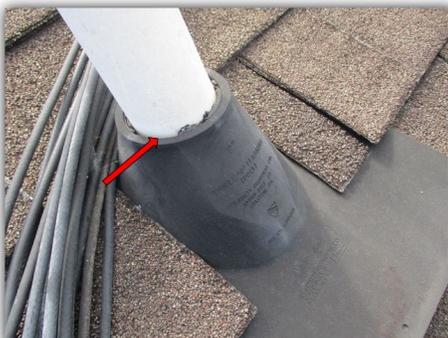
Deteriorated sealant / caulking was found at the rubber roof jacks. This material acts as a moisture barrier to prevent water from entering between boot and vent pipe. The re-sealing of these areas should be considered.

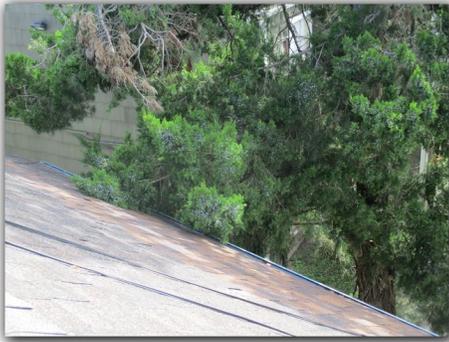
Tree limbs were noted in contact or within 3' of the roof coverings. The tree limbs should be trimmed back away from the roof coverings to prevent damage to the roofs.

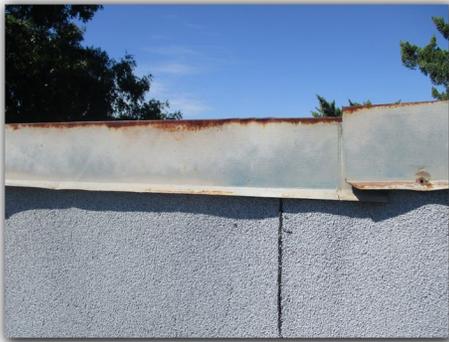
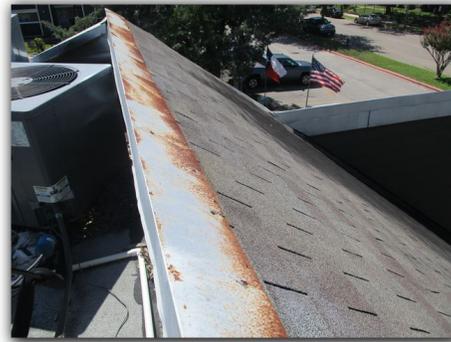
Rusted metal flashing was found at some of the roof penetrations. Recommend replacement of the flashing to prevent future leaks.

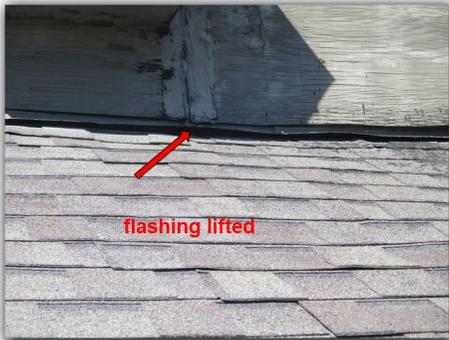
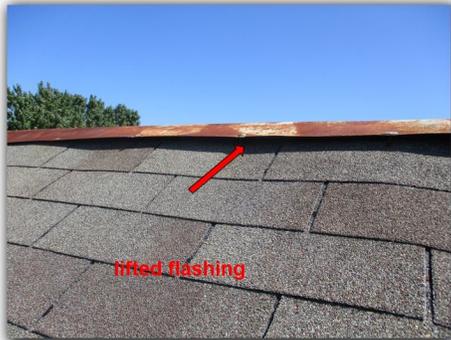
Sections of the roof flashings are raised which could lead to water penetrations. Recommend repairs.

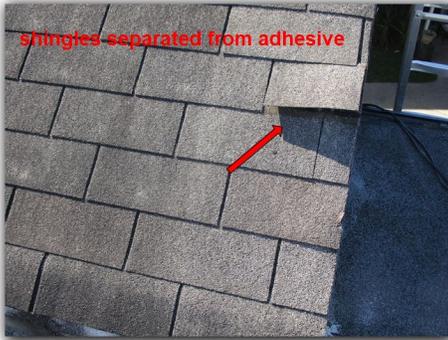
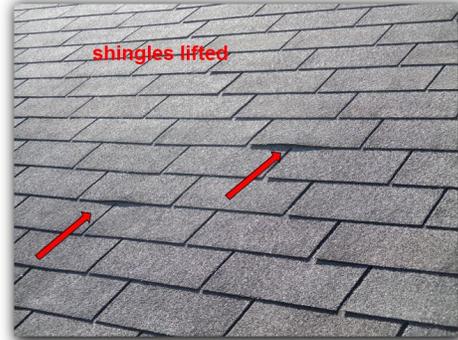
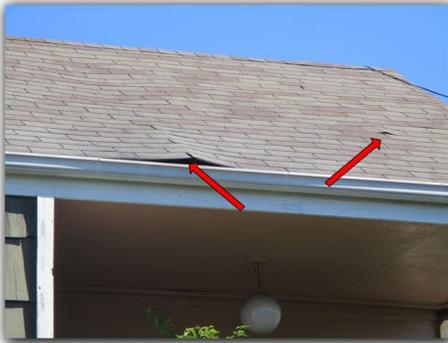
Raised shingles were found at the sections of the roof coverings. Recommend repairs by a qualified tradesman.

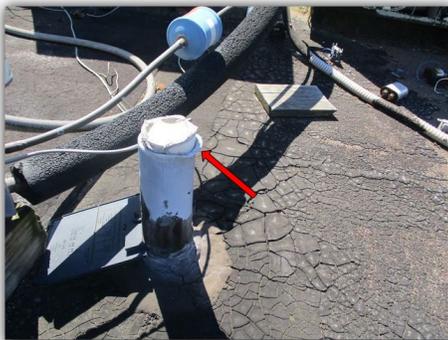
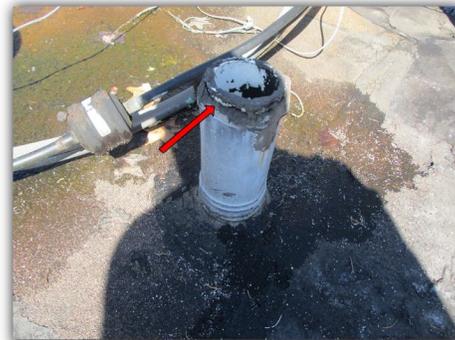
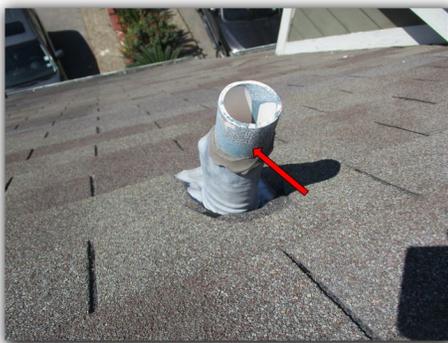
The lead / metal roof jacks have not been installed properly at some locations. The jacks do not completely cover the plumbing vents. These areas will be prone to water penetrations.

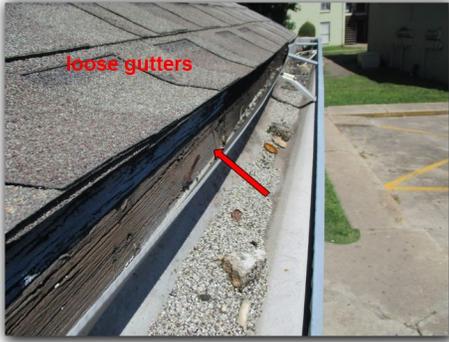
Loose gutters / gutter nails were found around the perimeter of the roof coverings. Recommend repairs.
