HOUSTON INSPECTIONS

PROPERTY CONDITION REPORT

Concerning: 1234 Any Street, Houston, TX
(Address of Inspected Property)

By: Dennis Inman, Lic #20664 10/31/2018
(Name and License Number of Inspector) (Date)

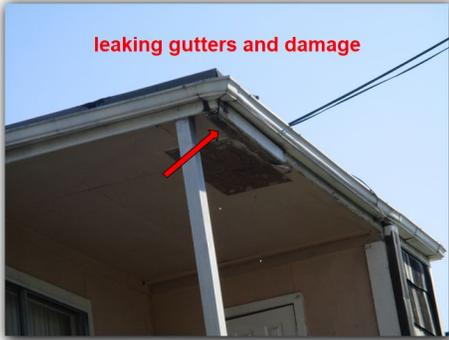
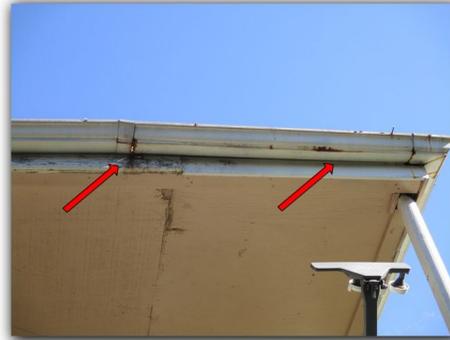
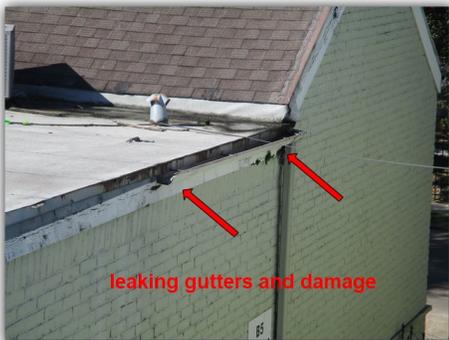
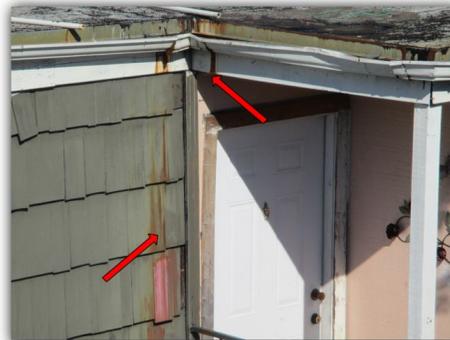
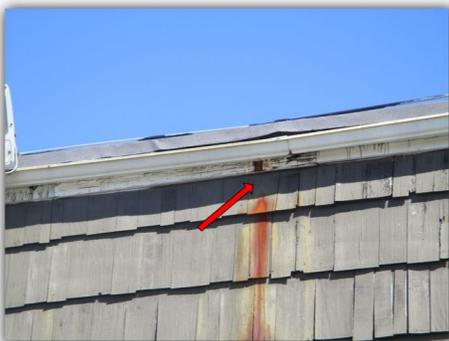
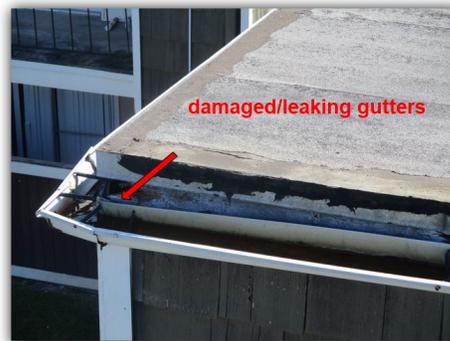
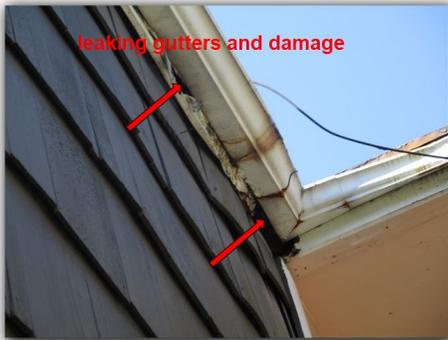
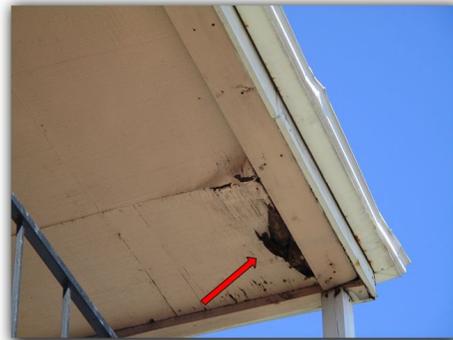
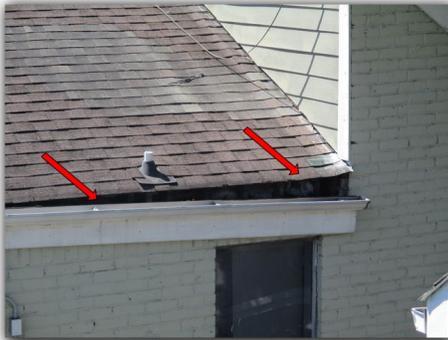
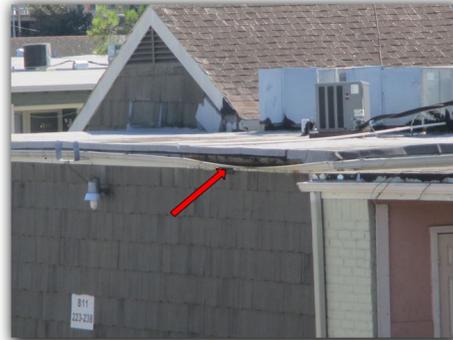
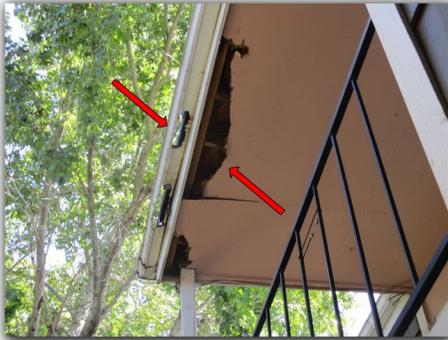
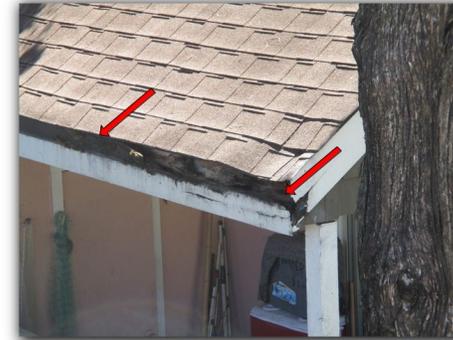
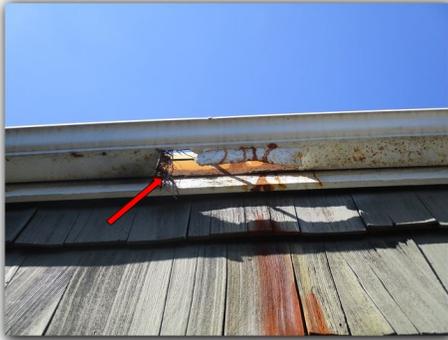
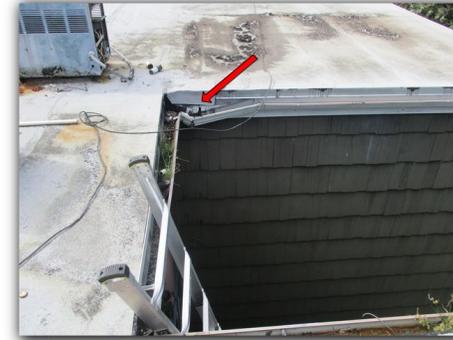
Leaky & damaged gutters were found around the perimeter of the roof coverings. The leaks should be repaired along with any damage caused by the leaks. It appears that multiple areas of damage have been caused by the leaking gutters. Repairs of the gutter / downspout systems as well as associated damages by qualified tradesmen is recommended.

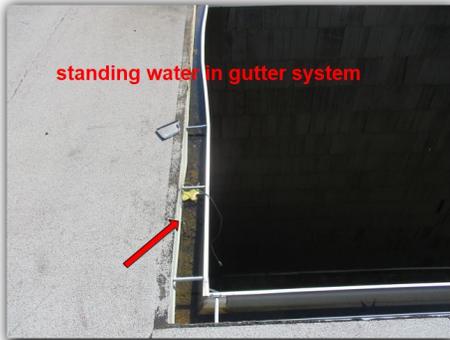
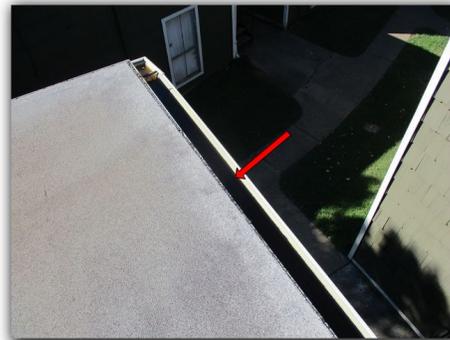
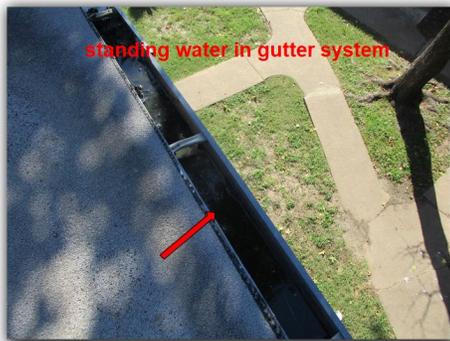
Evidence of improper sloping of the gutters were found as evident by standing water in sections of the gutters. This problem can lead to future leaks.

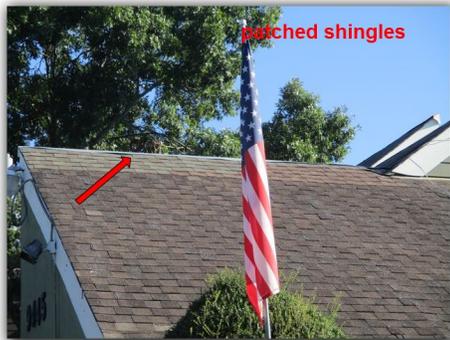
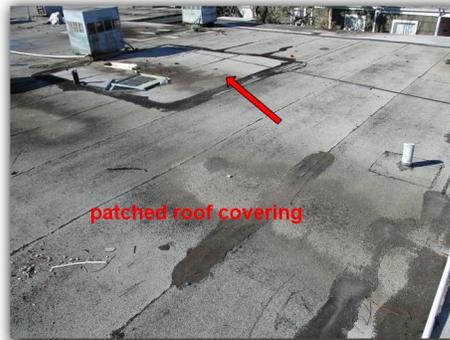
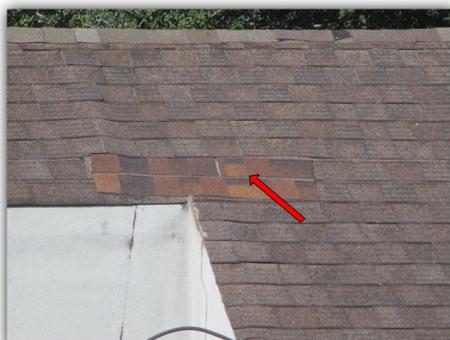
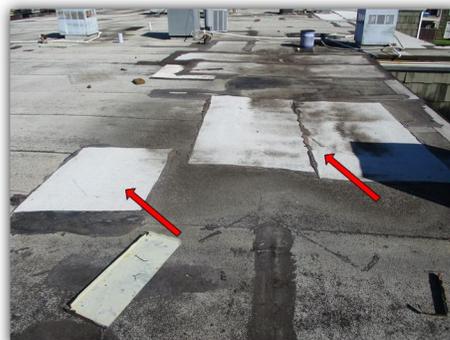
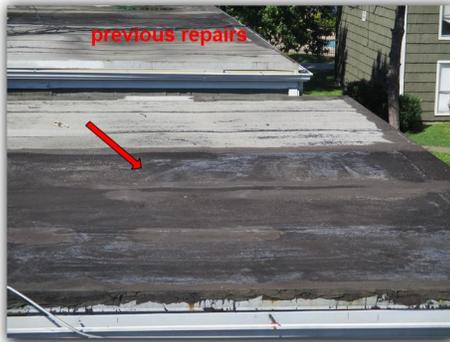
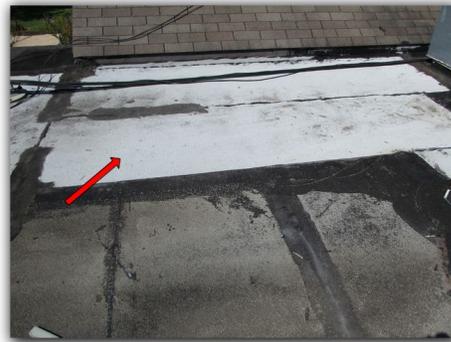
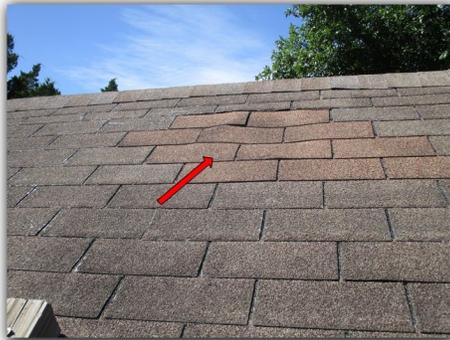
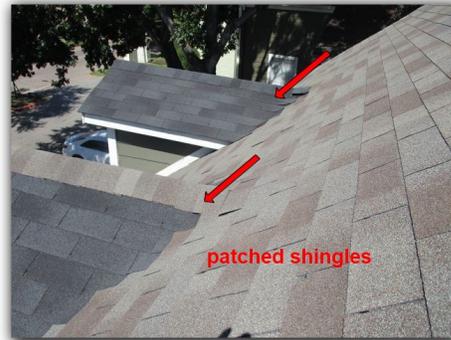
Evidence of previous repairs were found during inspection of the flat and composition roof coverings, i.e. roofing tar at sections of the flashing, new roof jacks, patched shingles, etc.

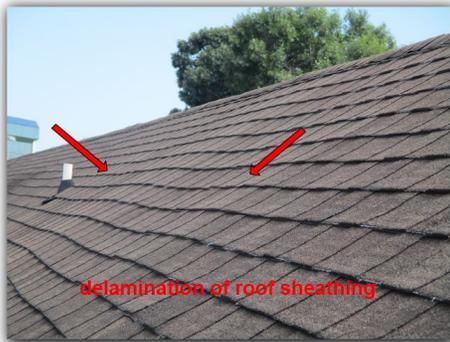
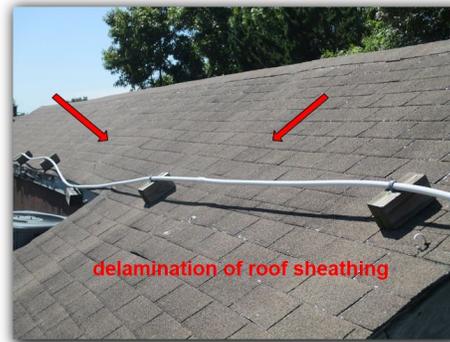
During the inspection of the roof structures from the exterior of the structures, uneven sections were observed in portions of the roof decking/sheathing. It appears that the roof sheathing has started to show signs of delamination (possibly due to age, defective wood, moisture, etc.). Delamination is the process of the glue particles separating or breaking down in the wood decking/sheathing. It is recommended that a qualified tradesman be consulted to evaluate this problem and repair/replace if needed.

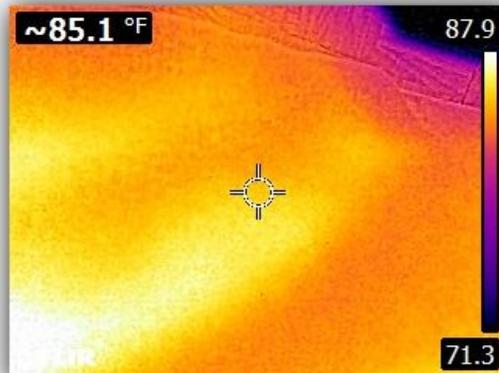
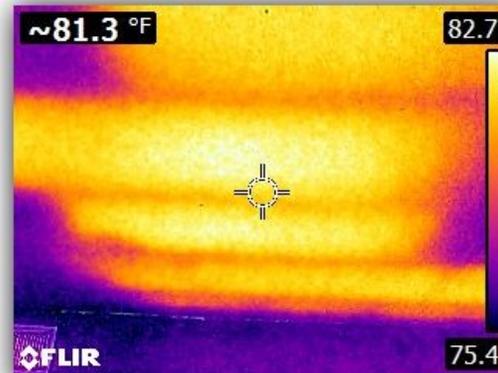
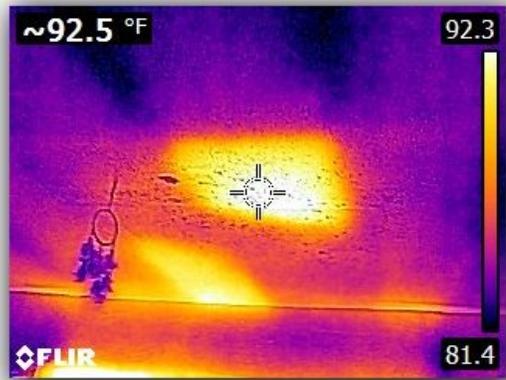
Thermal abnormalities were found at the interior of multiple units as evidence of missing insulation at sections of the ceilings while using an infrared camera. Improvements in the insulation is recommended to increase the energy efficiency of the building.

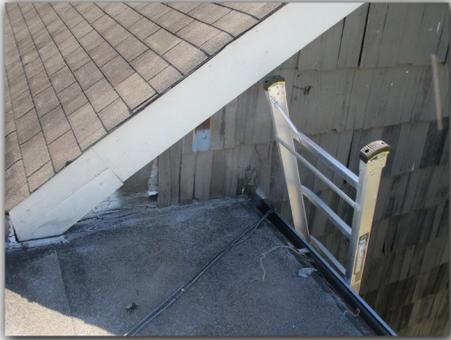
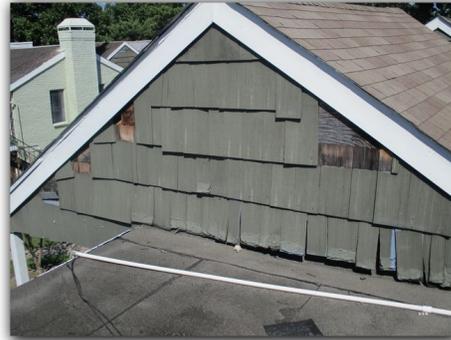
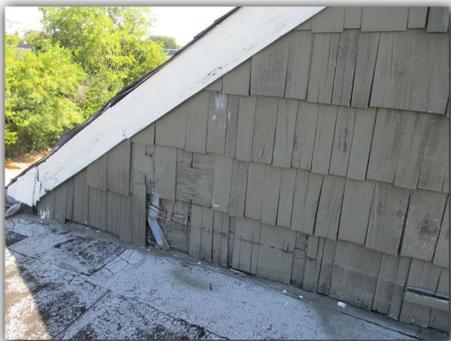
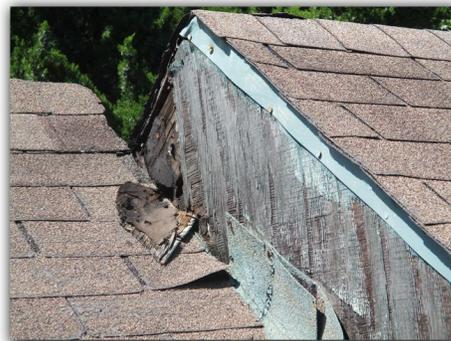
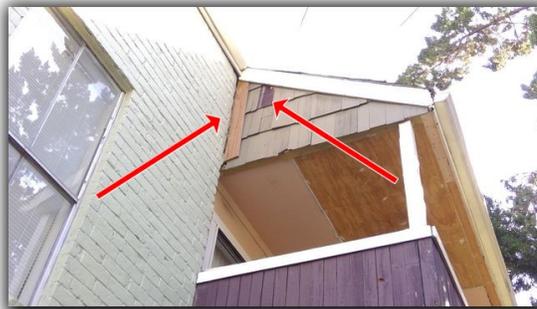
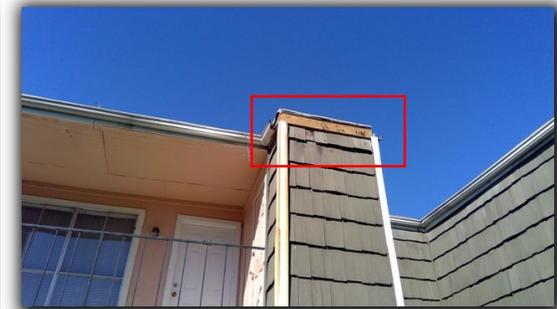
Damaged and / or missing items were found on the exterior of the property. Recommend repairs / replacement of the affected areas. In addition, areas where decay is present should be removed, exposing underlying materials for inspection prior to repair by a qualified tradesman.

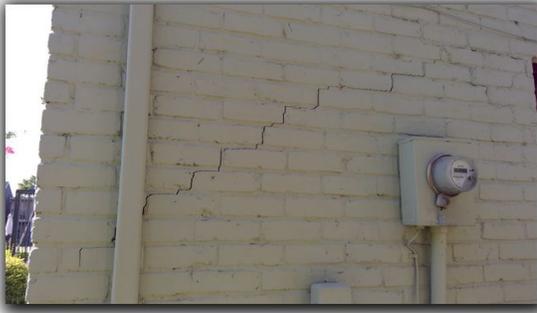
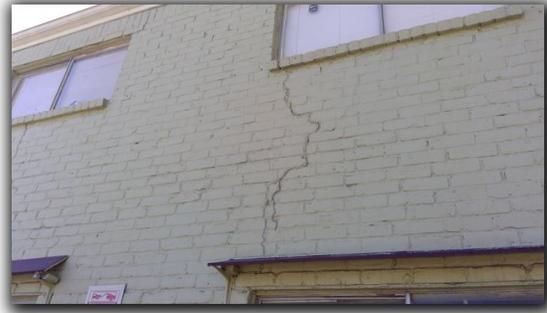
Brick / mortar cracks were found on the exterior of the structure as evidence of settlement of the structures.

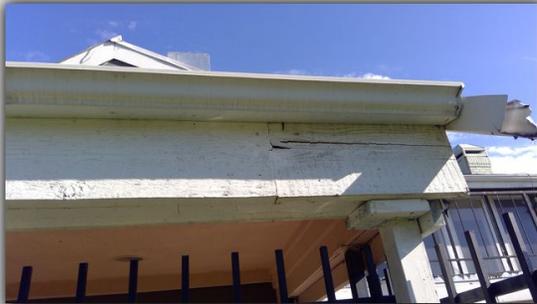
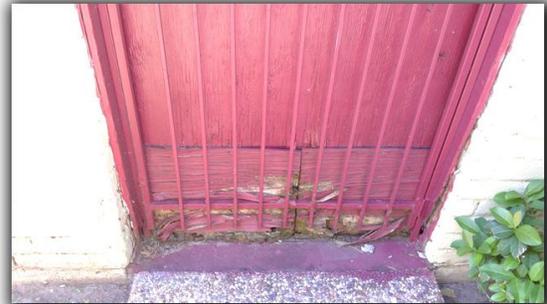
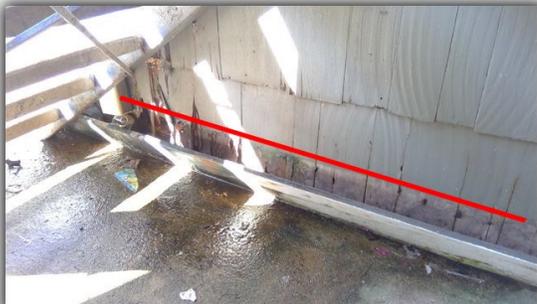
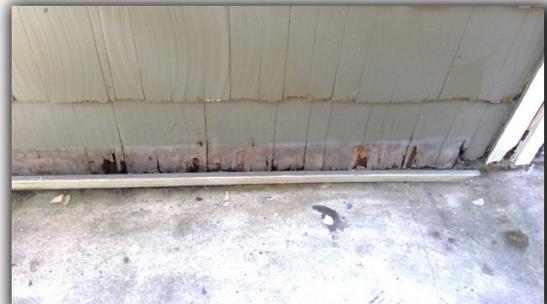
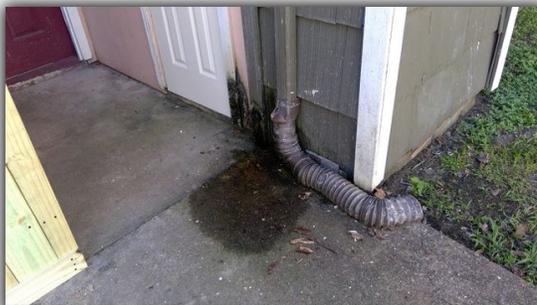
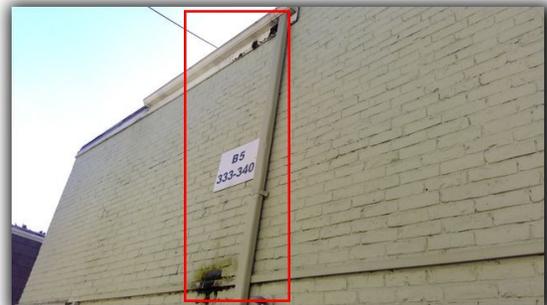
Moisture damaged wooden components were found at many locations. The vast majority of these extensive damages appear to have originated from improper clearances to soil/flatwork as well as moisture accumulation predominantly caused by improper, damaged, and incomplete gutter system. Underlying damages affecting the interior of these areas should be anticipated.

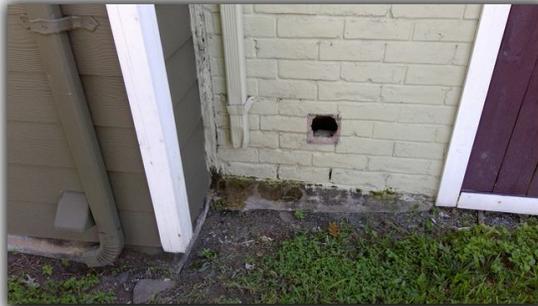
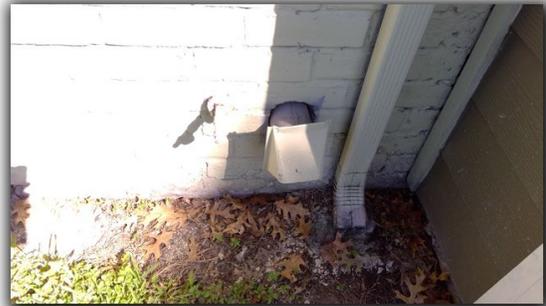
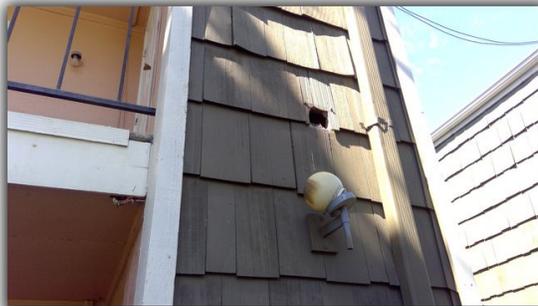
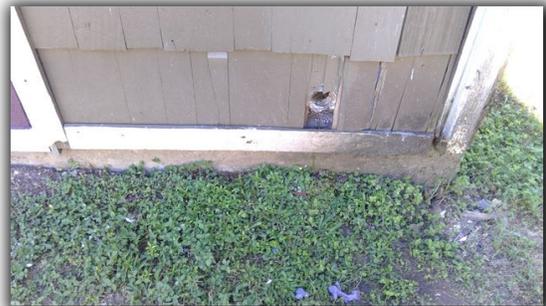
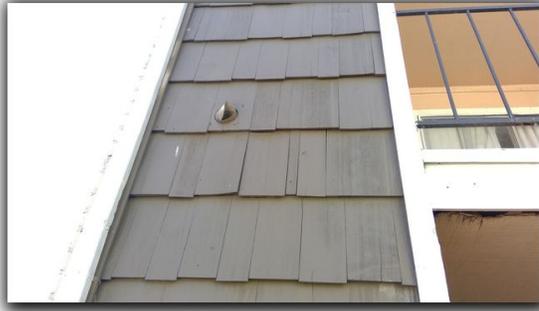
All exterior wall penetrations (electrical panels, electrical disconnects, light fixtures, etc.) and openings (expansion joints, windows, door thresholds, etc.) should be sealed with an approved material to prevent water penetrations into the wall cavities. Properly sealed exterior veneers help provide a barrier against the weather, insects, and enable environmental control of the interior spaces.

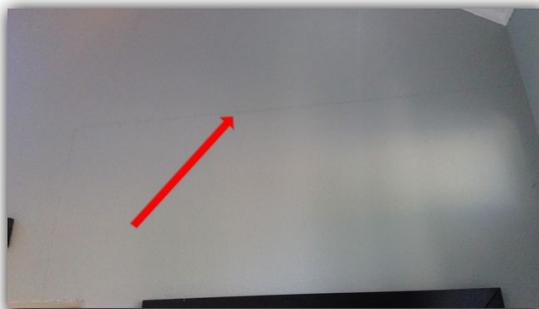
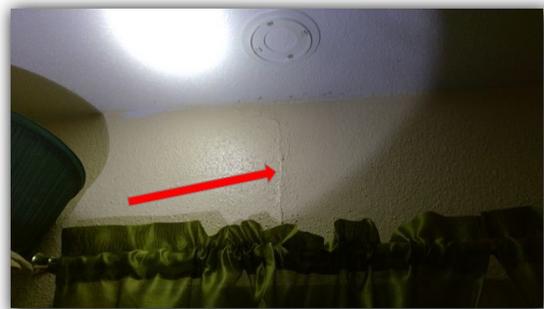
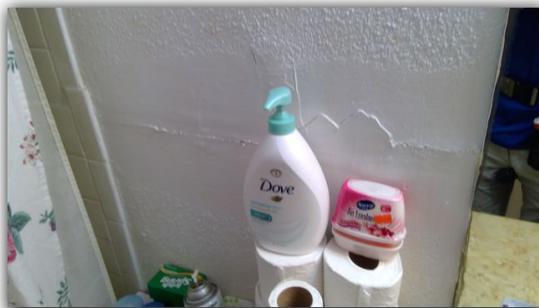
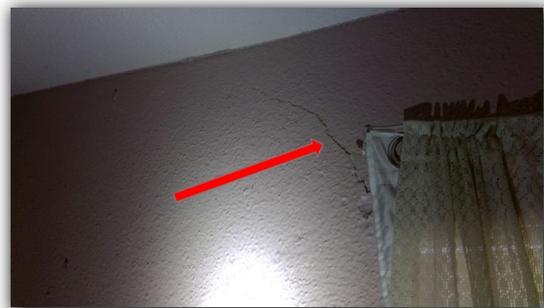
Drywall cracks were found on the interior of the property as evidence of settlement. The cracks can be repaired if desired for cosmetic purposes.

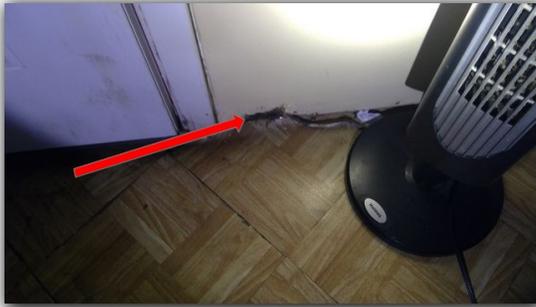
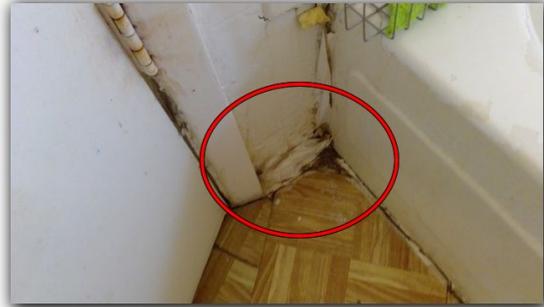
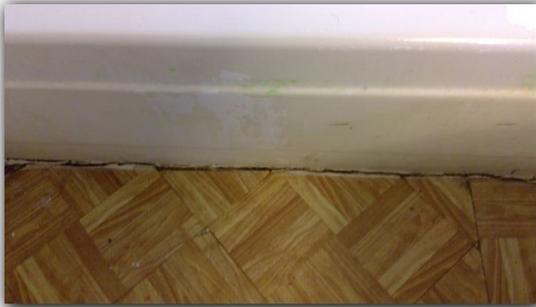
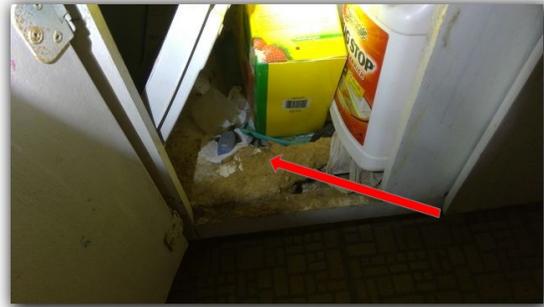
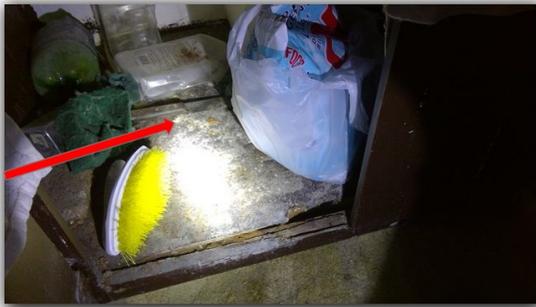
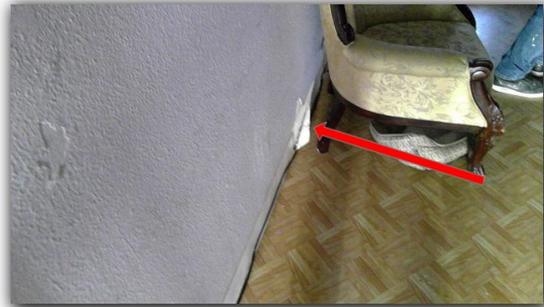
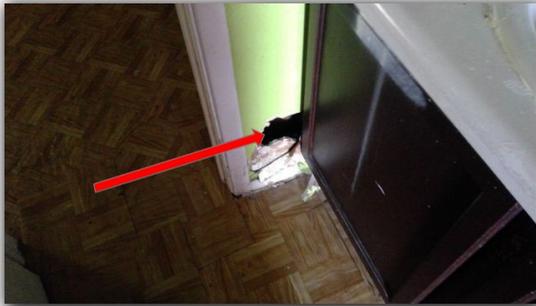
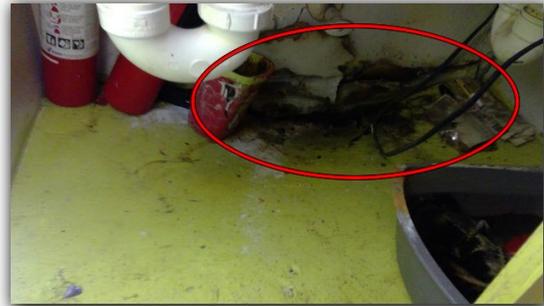
Damaged / missing areas were found at the interior of the units inspected
The problems have been possibly caused by one or more of the following: water penetrations, insects, impact, foundation / structural movement, etc. Repairs should include replacement of damaged underlying materials where needed.

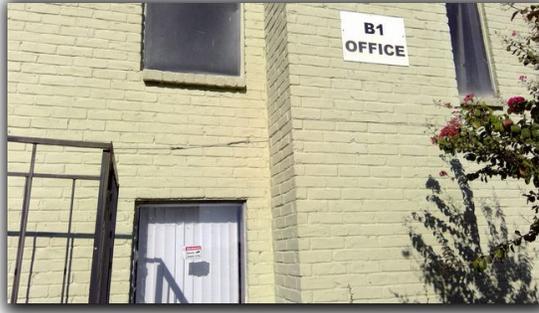
The brick on the exterior of the property has been painted. Painted brick can conceal brick cracks and other defects.

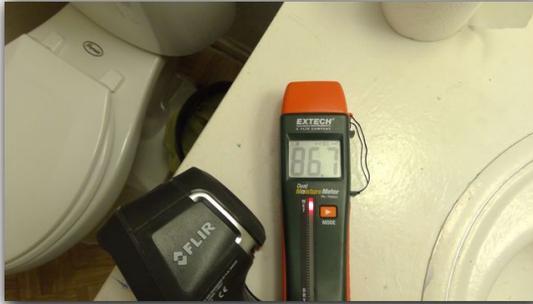
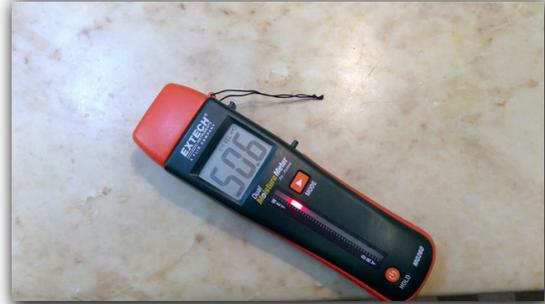
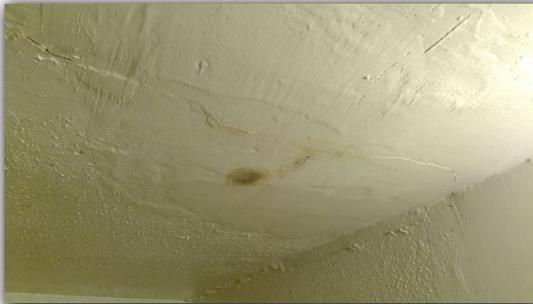
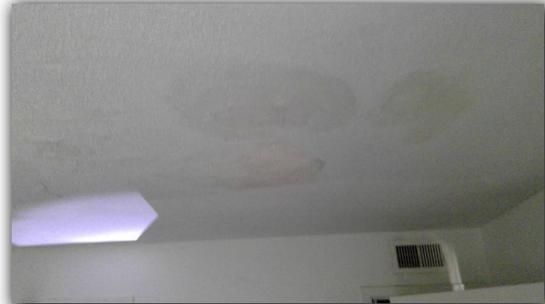
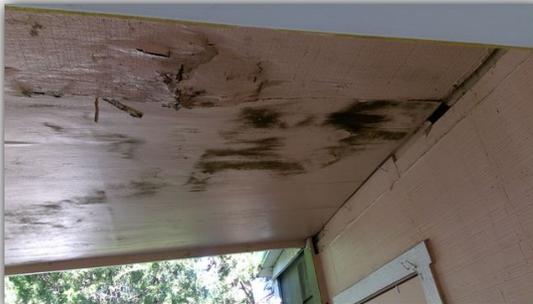
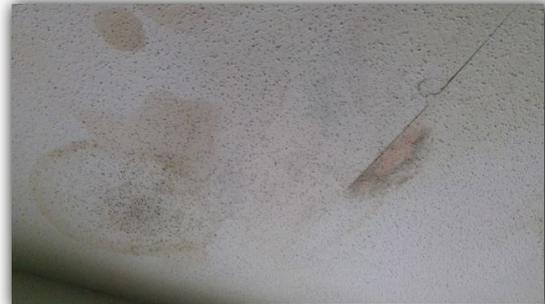
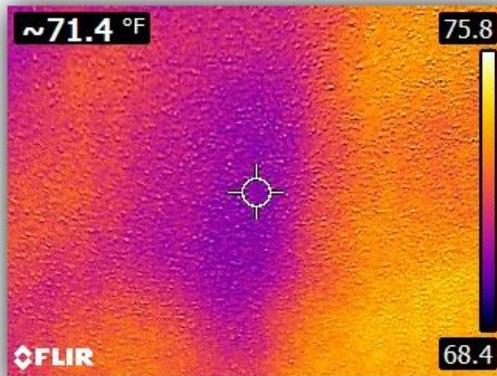
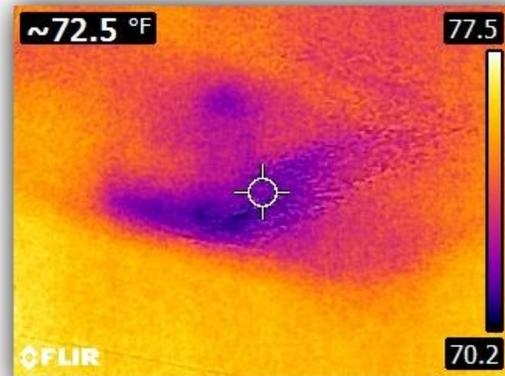
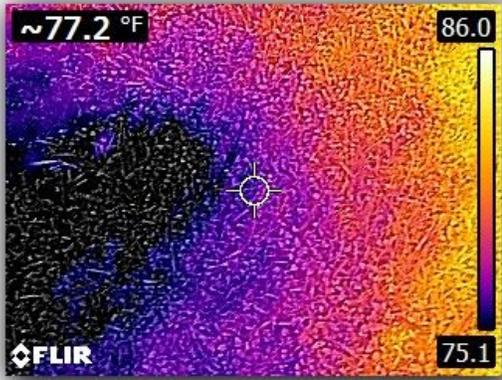
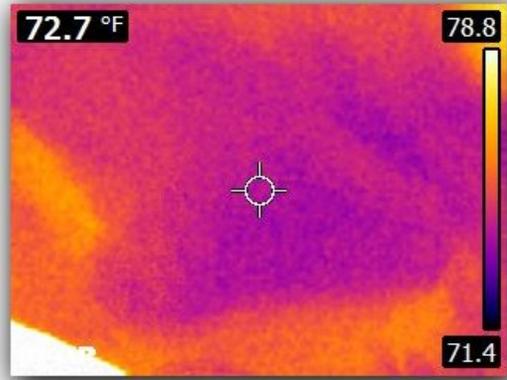
Thermal abnormalities were found in multiple unit ceilings during the inspection using an infrared camera. Elevated moisture measurements ranging above 8% and up to 87% (8% is an average "dry" moisture content for the material tested) were found at this location using a pinless moisture meter as evidence of active moisture intrusions. Repair of the moisture source and any associated damage by qualified tradesmen is recommended.

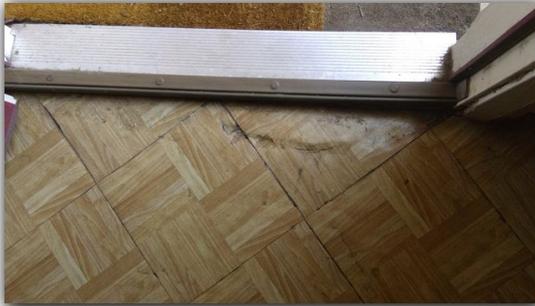
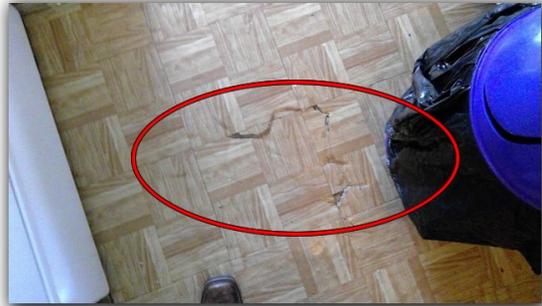
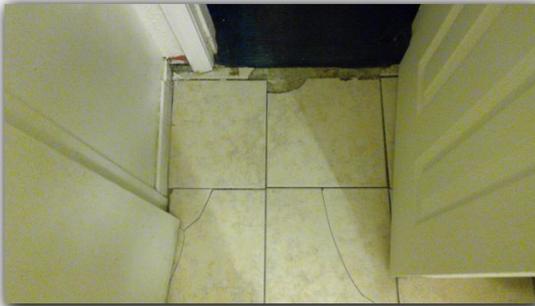
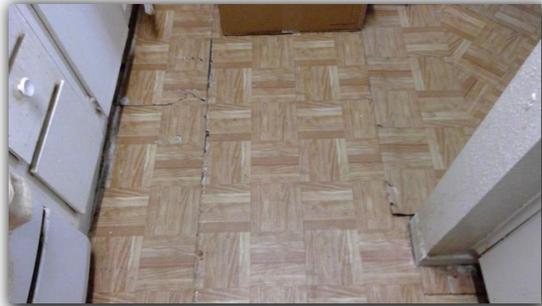
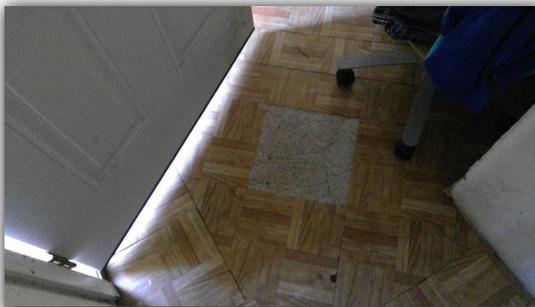
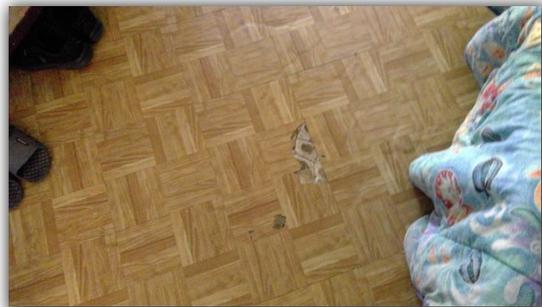
Damaged flooring was noted in multiple units

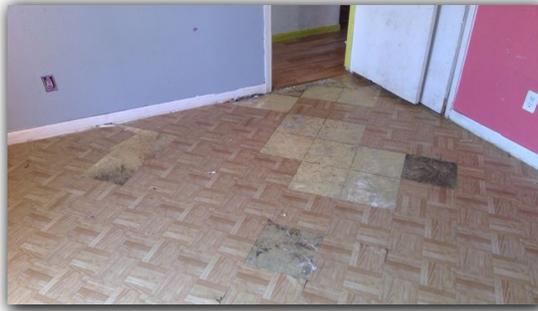
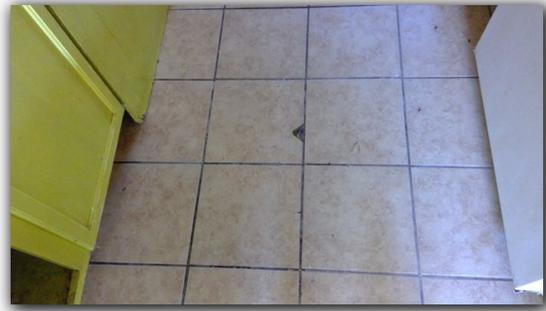
Sloping/unlevel floors were noted on majority of the units inspected. Recommend evaluation for repair by a qualified tradesman

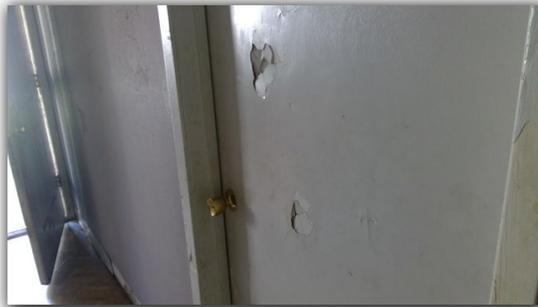
Multiple damaged doors were noted at the interior and exterior during the inspection. Recommend evaluation for repair by a qualified tradesman

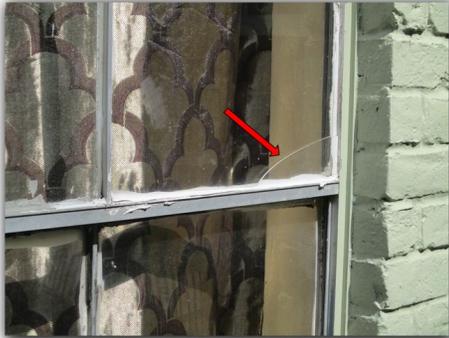
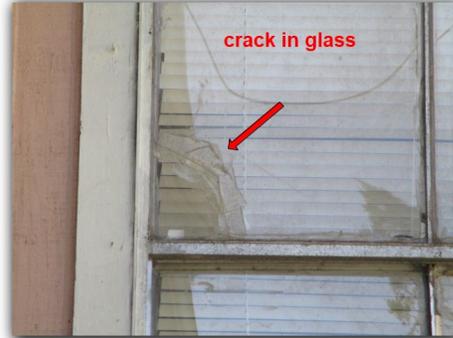
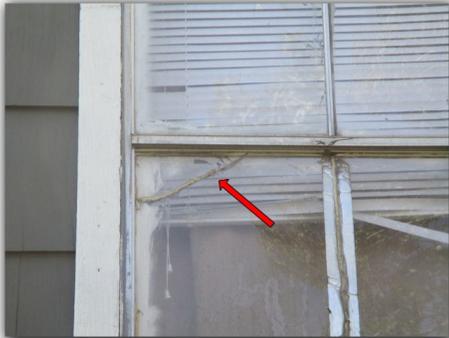
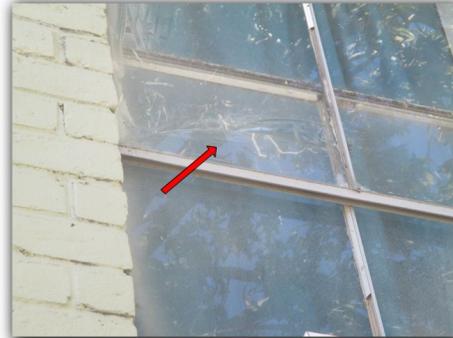
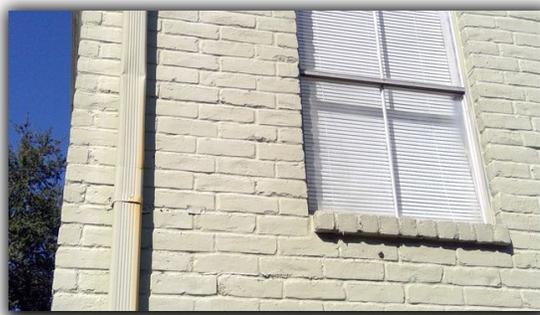
Cracked glass (visible from exterior) was found at multiple windows in the complex. The damaged glass should be replaced.

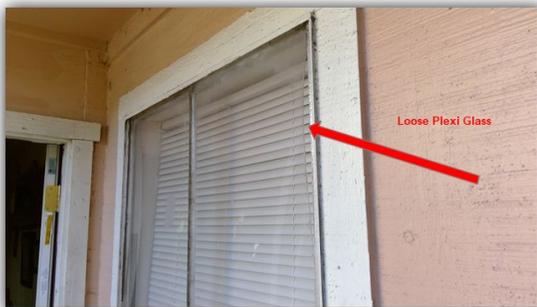
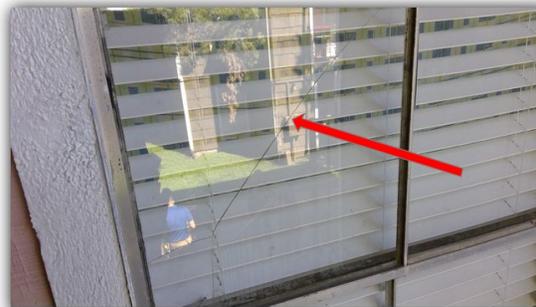
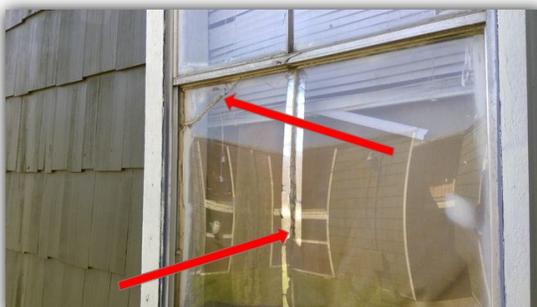
Cracked glass/loose and bowed plexiglass was found during the inspection. The damaged glass should be replaced.

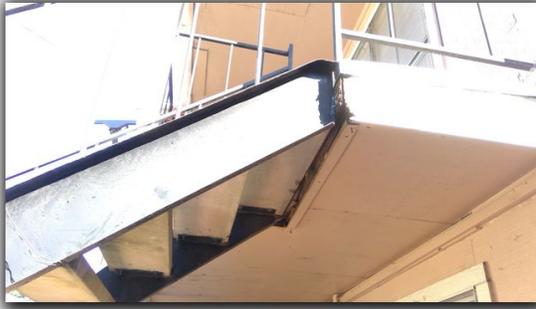
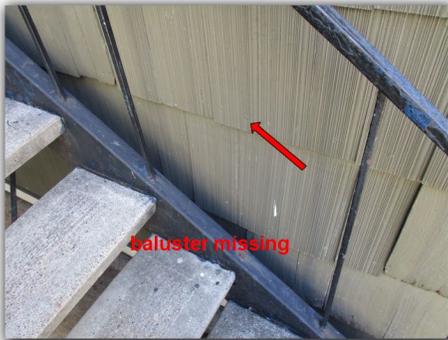
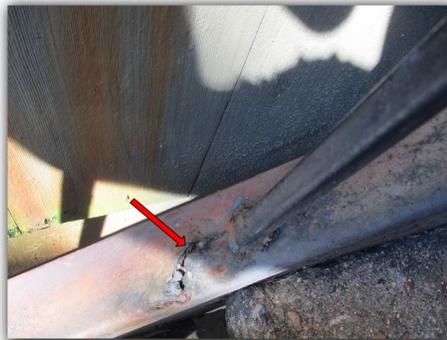
Damaged, rusted, and loose handrail/guardrails were found at many locations throughout the complex. Loose / missing fasteners, damaged landings, and damaged stairway assemblies were found at stairway/landing connections. Evaluation of all stair/balconies by a Licensed Engineer and/or qualified tradesman for repair is recommended to prevent potential collapse and/or personal serious injury.

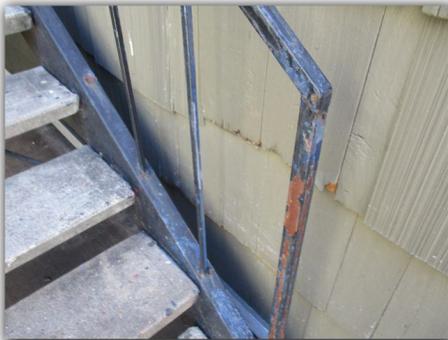
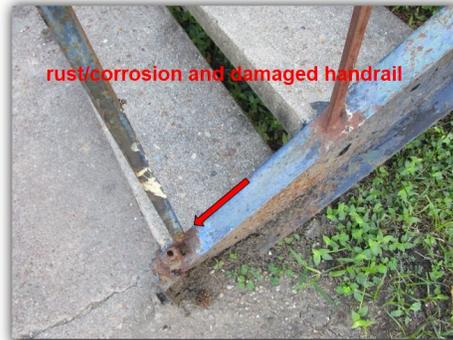
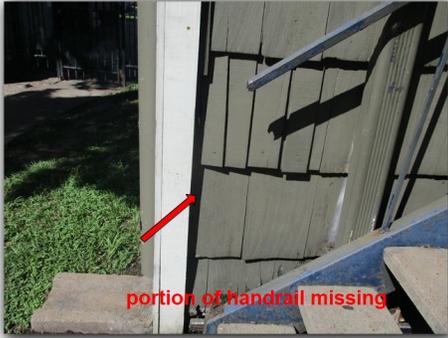
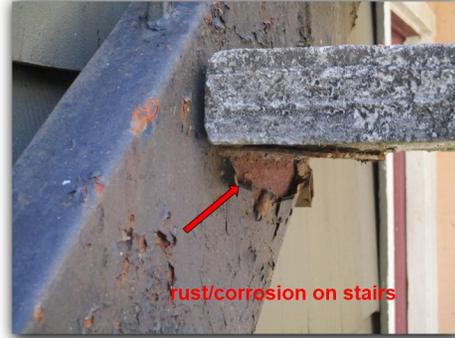
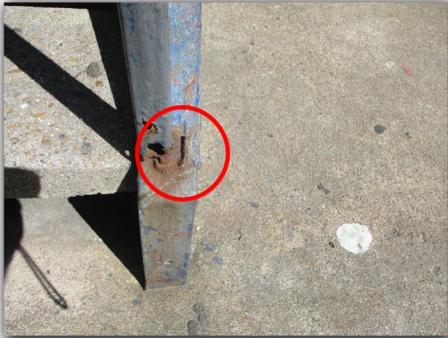
Rust, corrosion, damage and missing items were found at many of the handrails/balusters of exterior stairs. All rust should be removed to help prevent any future problems that may occur.

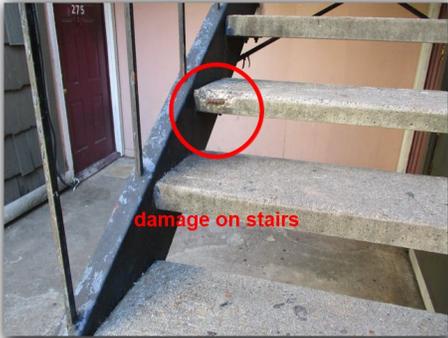
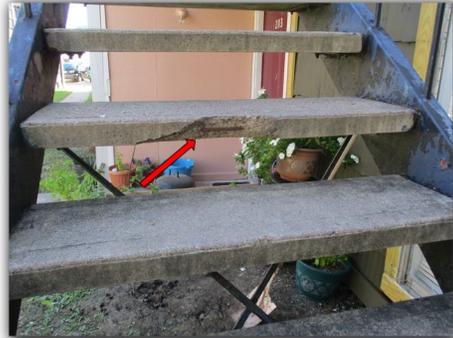
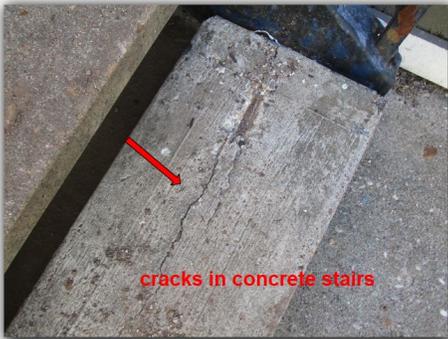
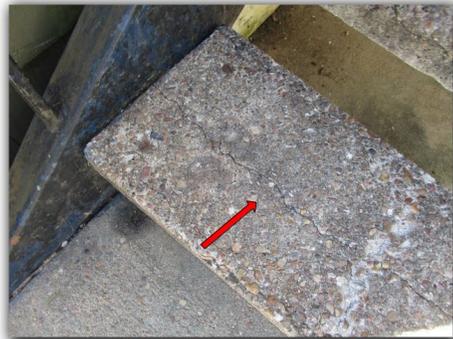
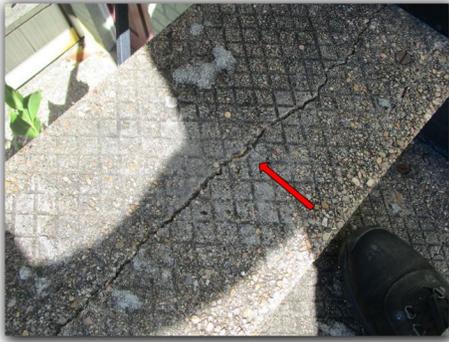
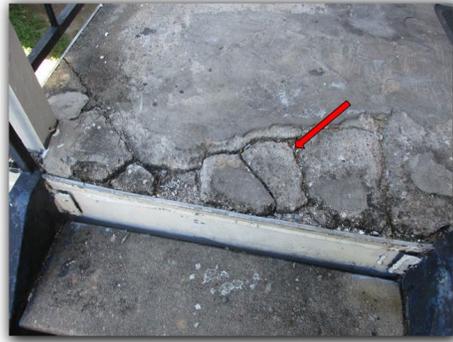
Cracked and damaged concrete stairs/treads were noted at several of the exterior stairs and landings. Recommend repairs to correct the structural problems and safety hazards.

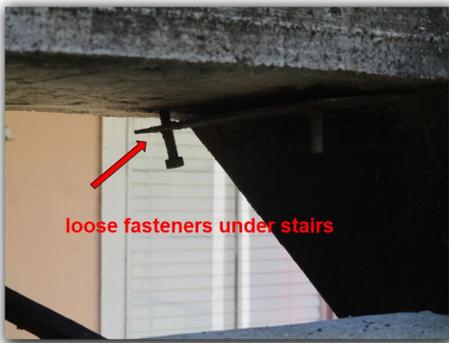
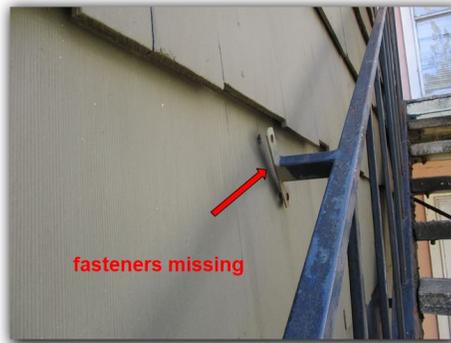
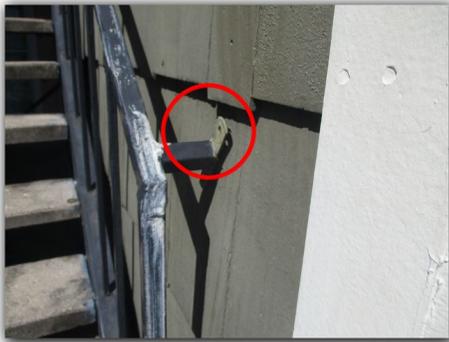
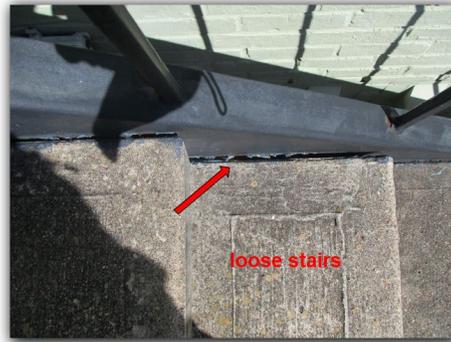
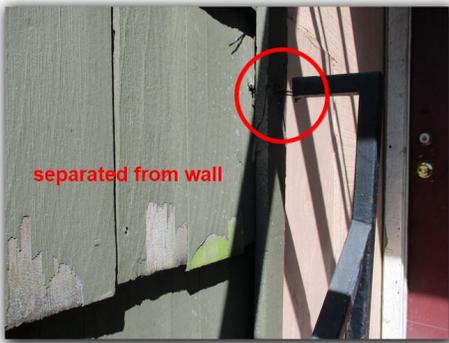
Several of the handrail(s)/treads are loose at the exterior stairways as evident by missing and loose fasteners at the brackets. Recommend repairs to insure proper support/function.

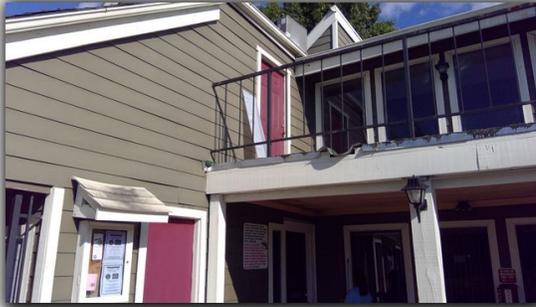
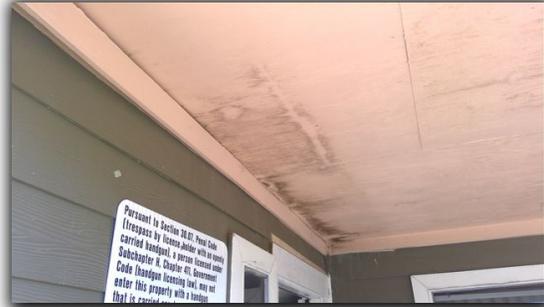
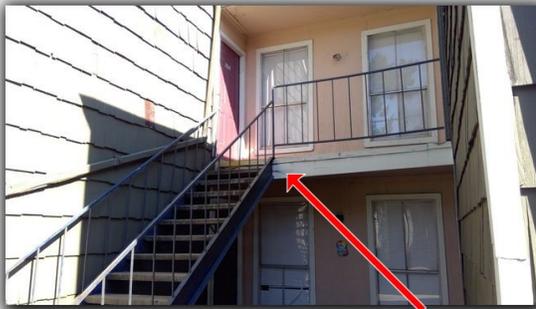
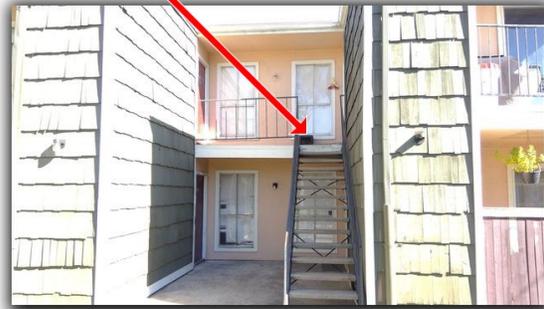
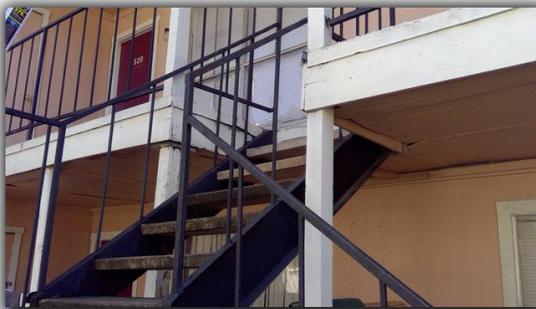
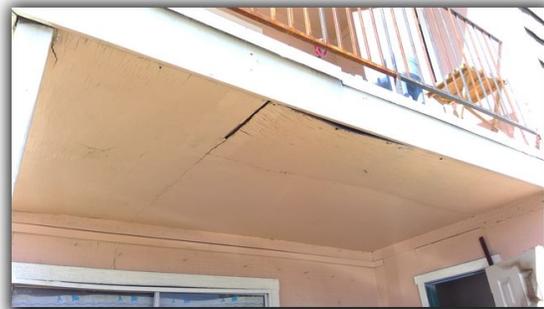
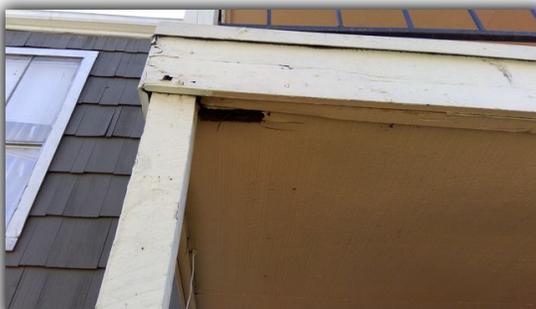
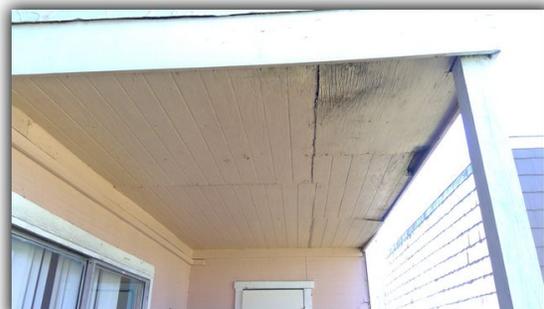
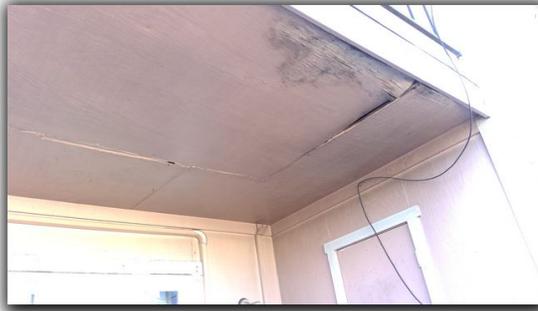
Damaged components were found at balconies as evidence of moisture intrusion/accumulation. Repair by a

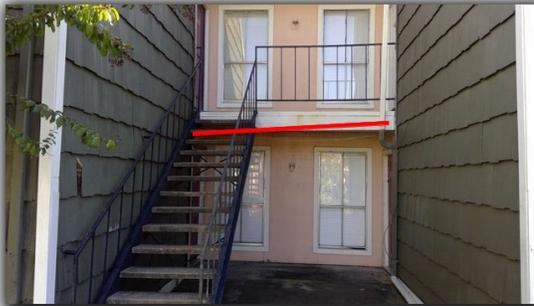
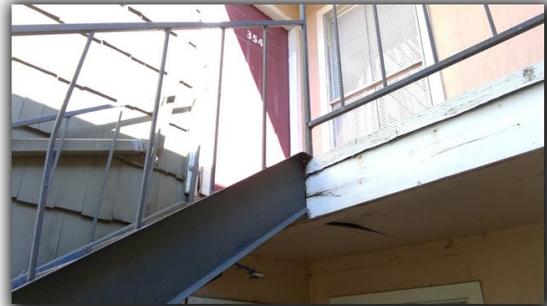
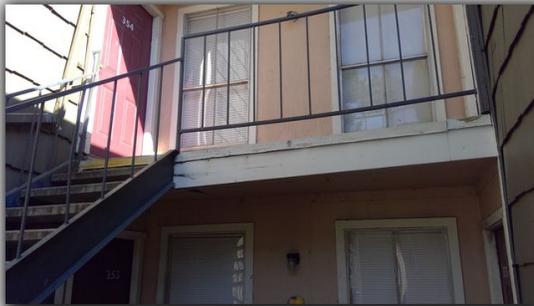
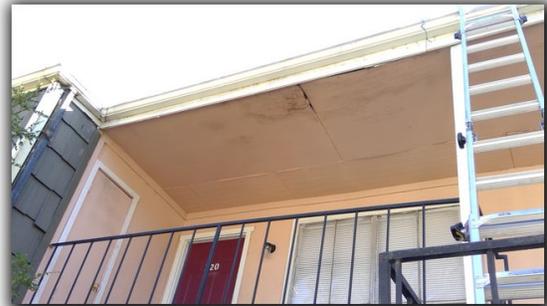
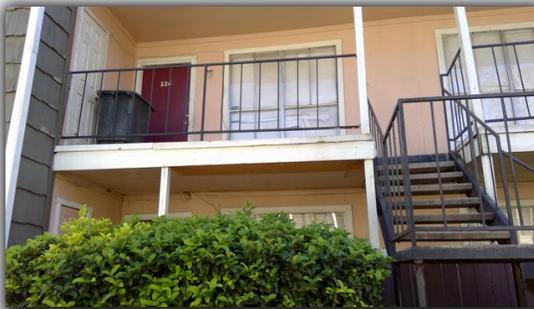
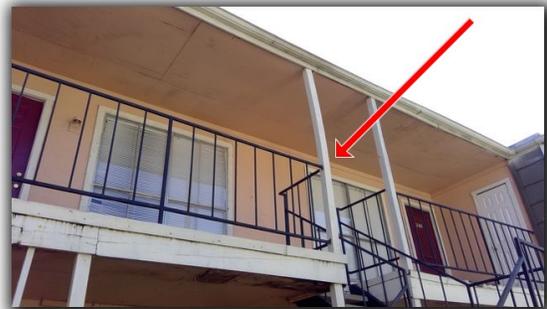
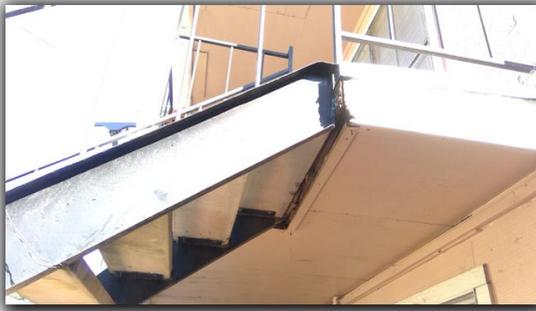
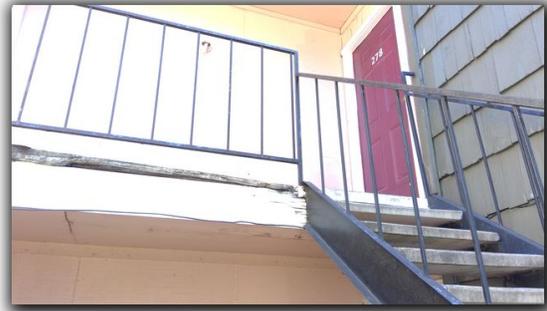
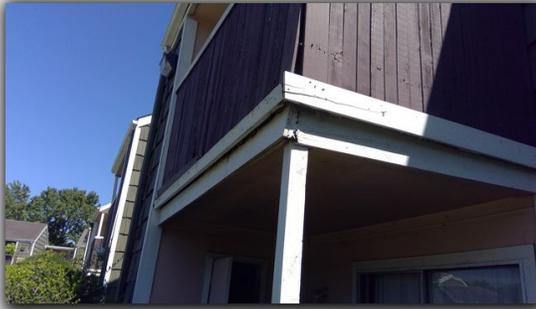
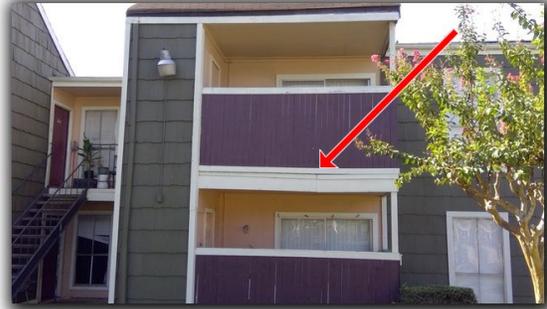
Evidence of improper support and/or damaged structural members were found at multiple balconies. Many of these areas appear to be structurally unsound. Evaluation of all stair/balconies by a Licensed Engineer and/or qualified tradesman for repair is recommended to prevent potential collapse and/or personal serious injury.

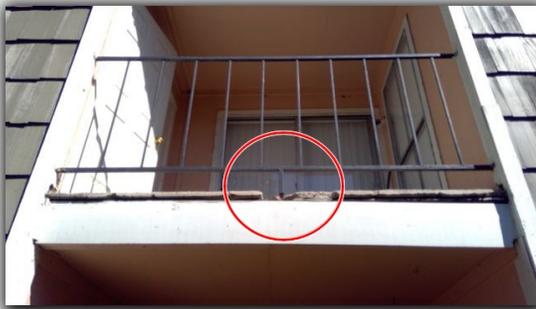
Damaged, rusted, and loose handrail/guardrails were found at many units. Damaged/cracked treads were also present. Repair is recommended.

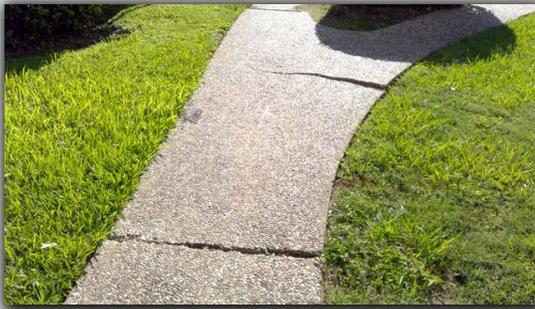
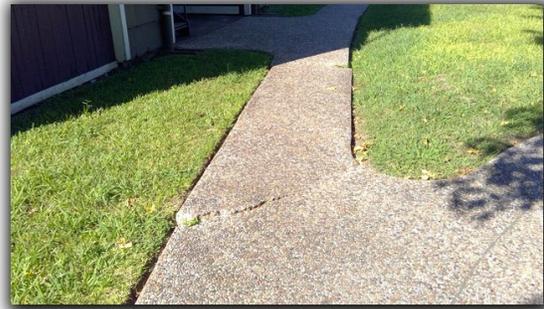
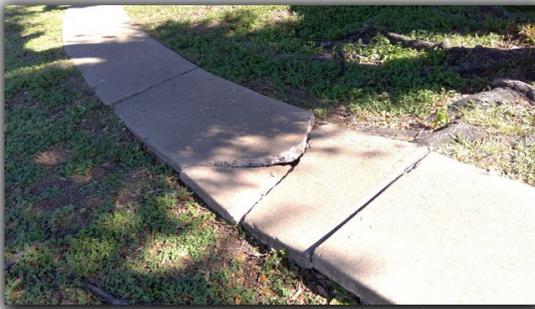
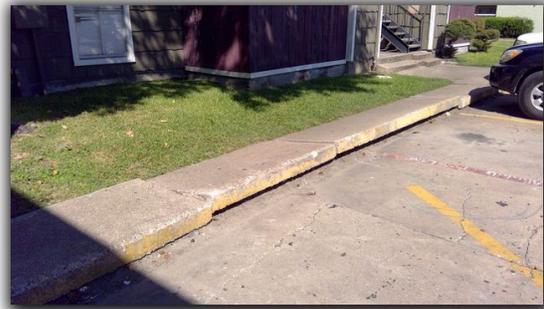
Uneven materials were observed at the flatwork. Flatwork should have a uniform surface (to prevent tripping) (i.e. patios, driveways, sidewalks, etc.).
