HOUSTON INSPECTIONS

PROPERTY CONDITION REPORT

Concerning: 1234 Any Street, Houston, TX
(Address of Inspected Property)

By: Dennis Inman, Lic #20664 10/31/2018
(Name and License Number of Inspector) (Date)

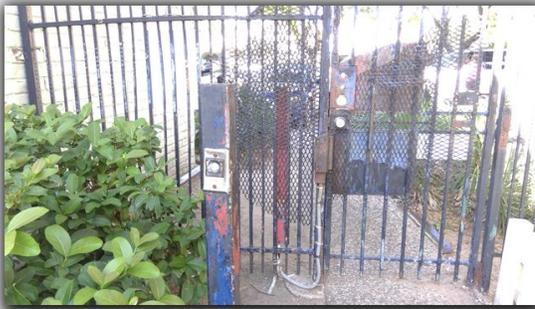
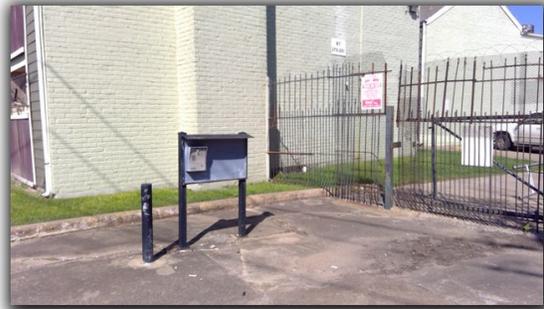
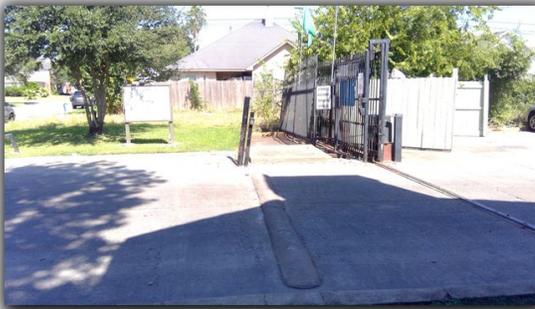
Electronic pedestrian and parking gates were not functioning at the time of the inspection, which can restrict exit in case of emergency.

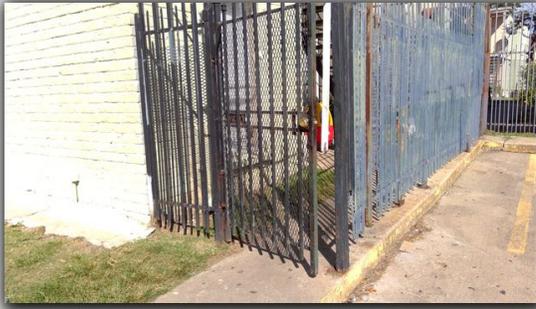
Pedestrian gates are damaged / did not secure at B5.

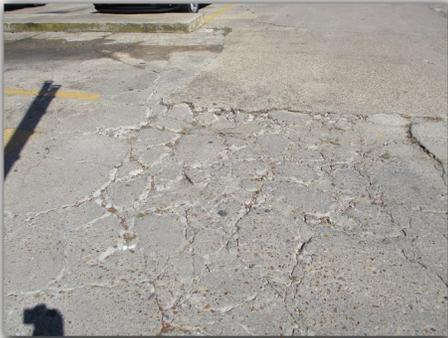
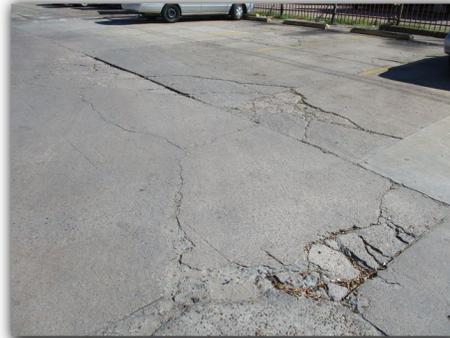
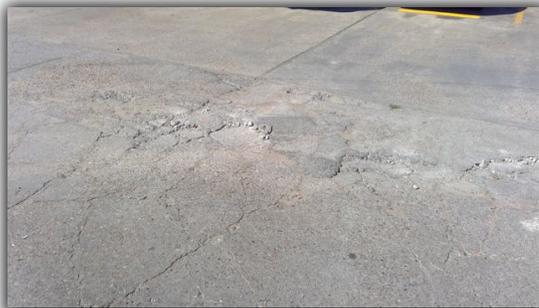
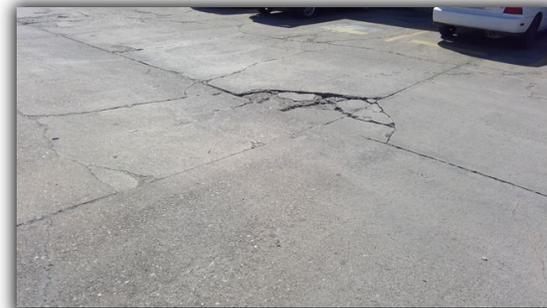
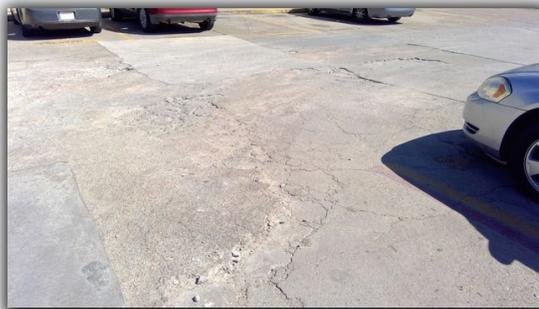
Cracking/damaged concrete was found at several areas of both rear parking lot areas. These areas should be monitored and repaired as needed.

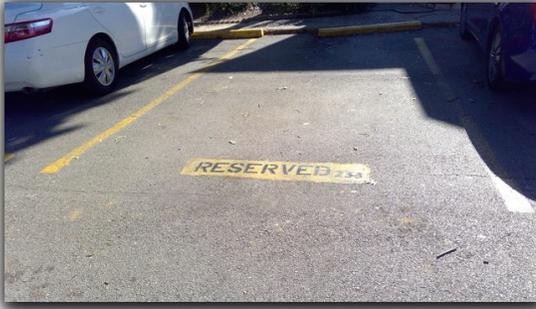
Paint/markings of the parking areas appeared to be legible and in fair condition at accessible locations.

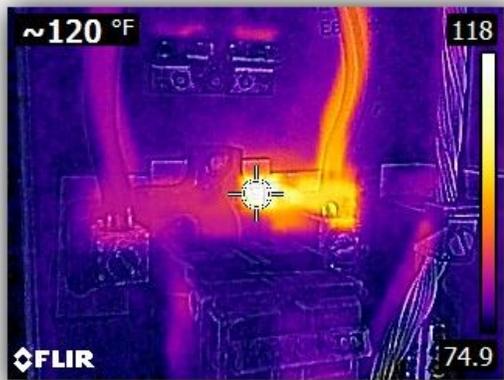
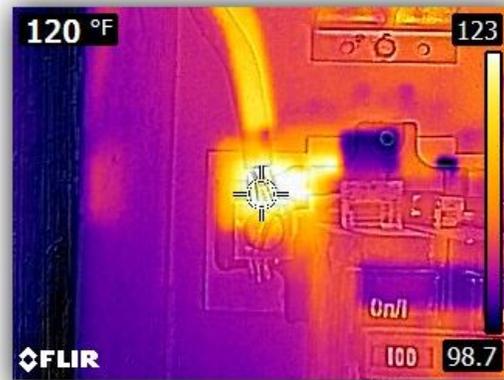
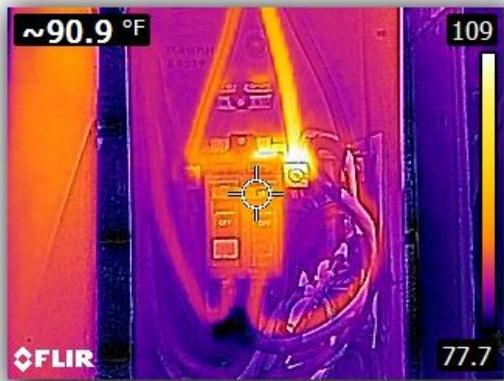
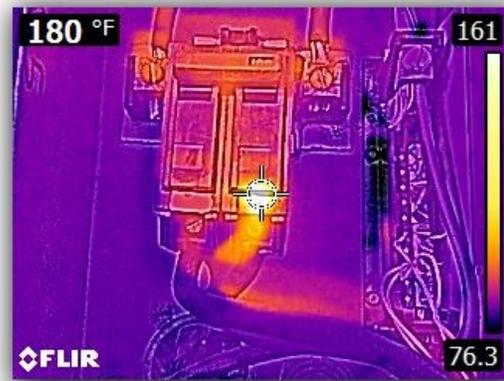
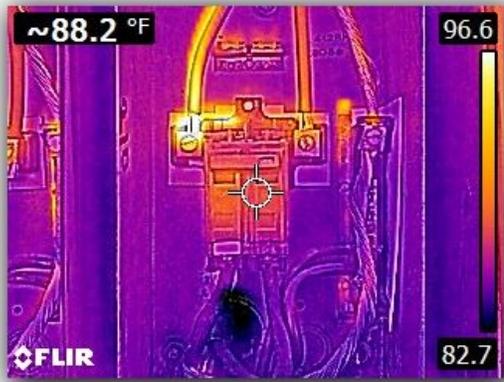
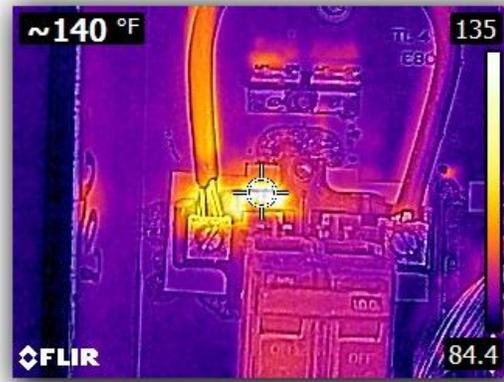
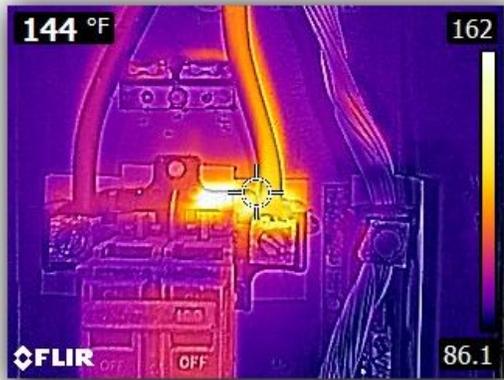
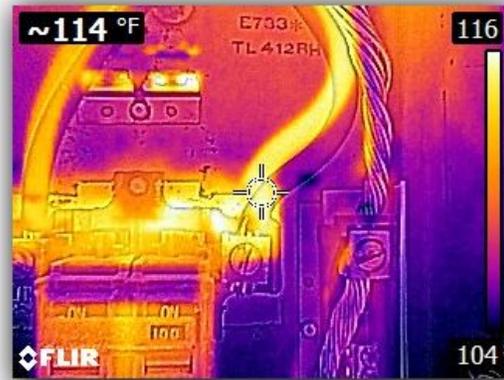
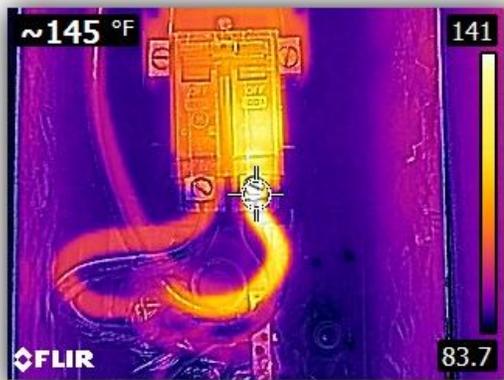
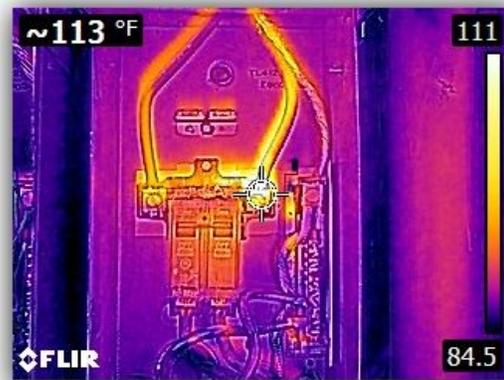
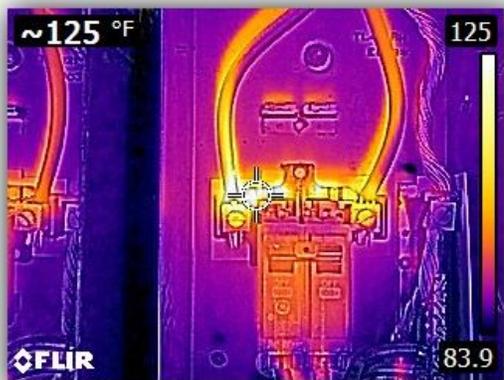
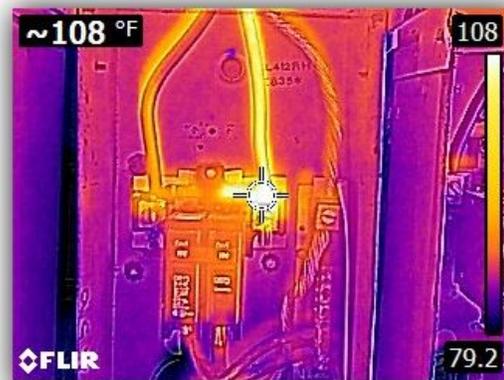
A thermal imbalance was measured at the main service conductors possibly indicating a loose connection. Recommend further evaluation and repair by a licensed electrician.

1. Bdle 2 Unit 312
2. Bdle 9 Unit (Not Labeled)
3. Bdle 15 Unit (Not Labeled)
4. Bdle 14 Unit 105
5. Bdle 13 Unit 210
6. Bdle 13 Unit 207
7. Bdle 13 Unit 202
8. Bdle 13 Unit 158
9. Bdle 19 Unit 185
10. Bdle 11 Unit 234
11. Bdle 11 Unit 231
12. Bdle 10 Unit 246
13. Bdle 8 Unit 267

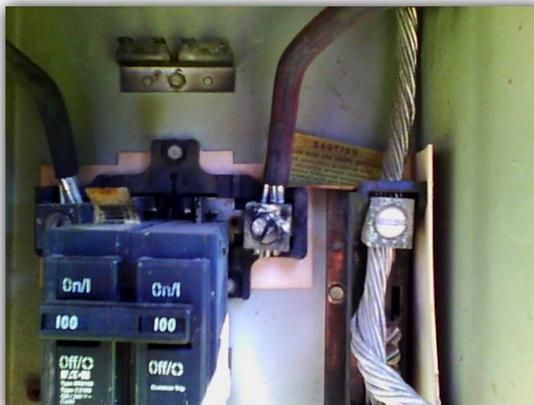
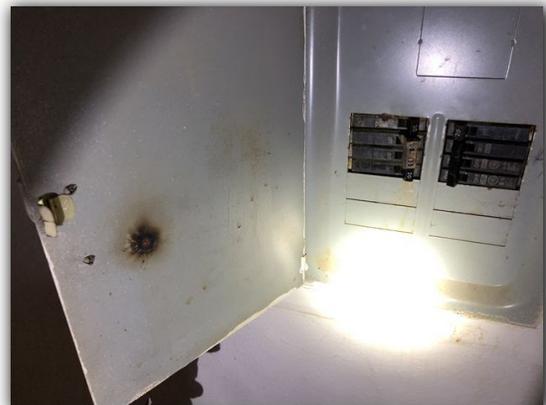
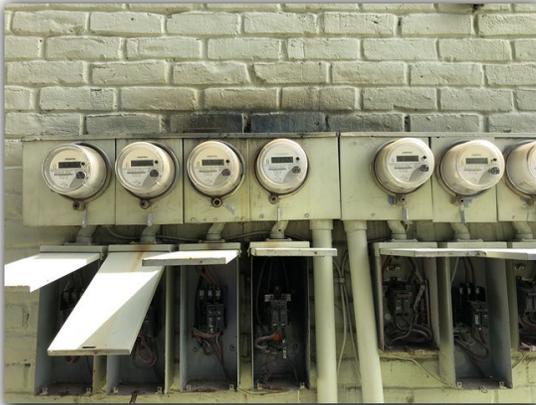
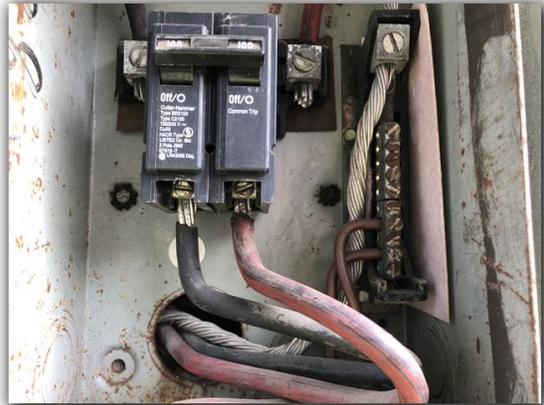
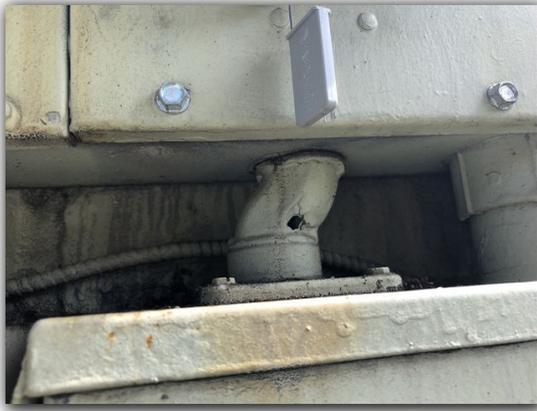
Evidence of previous overheating/arcng was noted within the panel as evident by discoloration on the interior of the box.

1. Bdle 9 Unit (not labeled)
2. Interior Sub panel Unit 143 and 277
3. Bdle 14 Washer Room
4. Bdle 17 Unit 175
5. Bdle 17 Unit 176
6. Bdle 17 Unit 174
7. Bdle 19 Unit not labeled

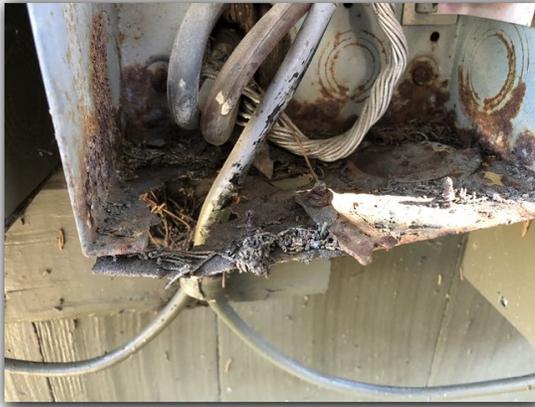
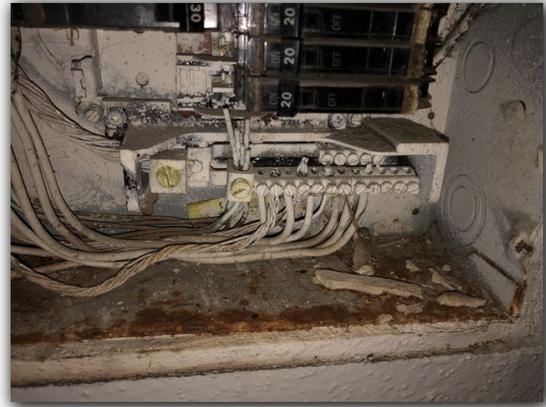
Most of the service box shows evidence of rusting, suggesting the presence of moisture. Many of the main electrical boxes are possible in need of replacement. Recommend further evaluation / replacement by a licensed electrician.

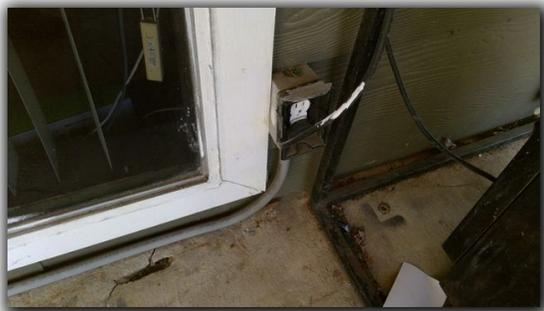
Missing cover plates should be replaced.

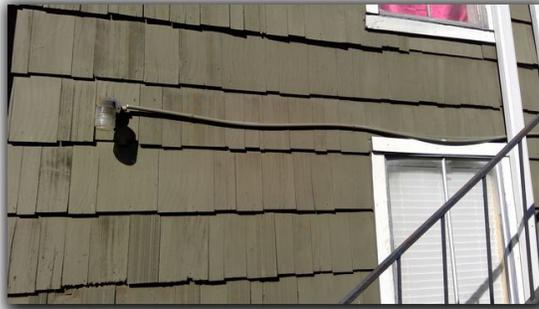
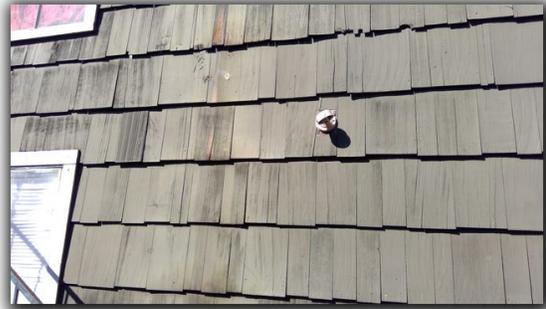
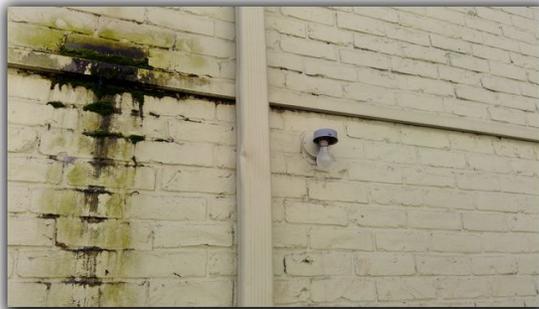
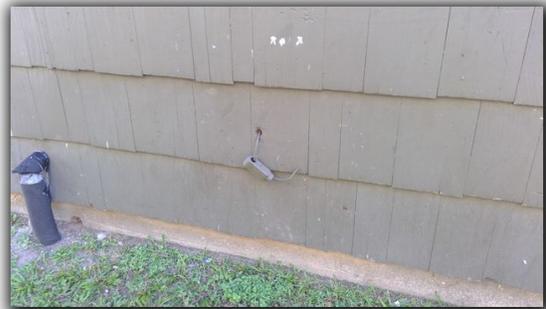
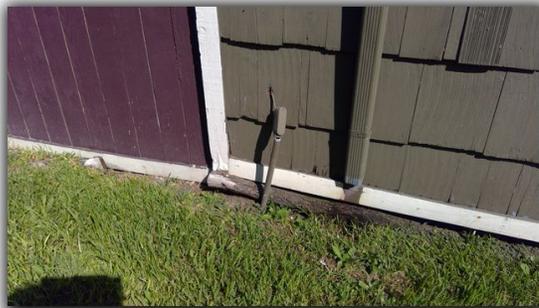
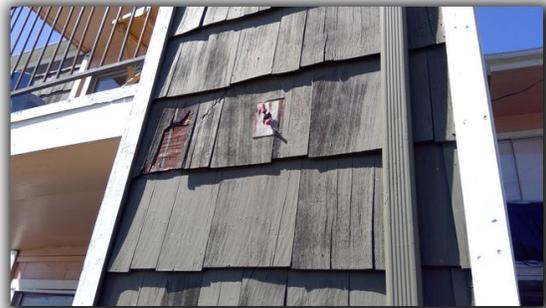
Missing globes, loose fixtures, and separated/loose conduit was found at many of the exterior lights/conductors.

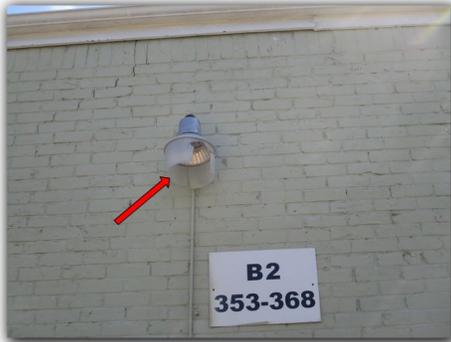
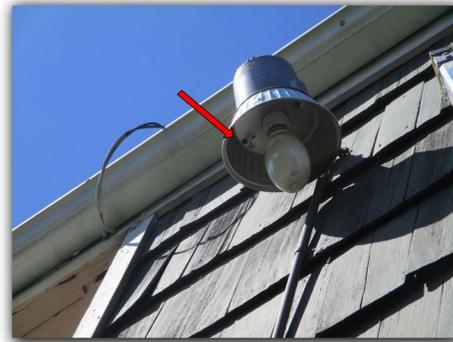
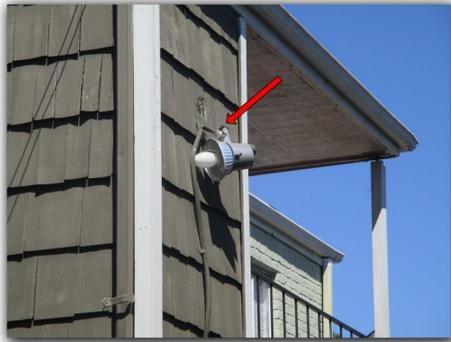
Improper electrical connections were noted on the roof of Building 6. Improper electrical connections should be improved. All electrical connections should be made inside junction boxes fitted with cover plates.

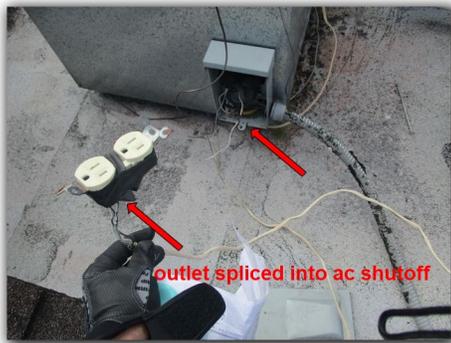
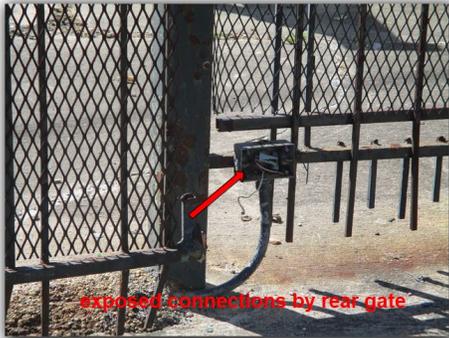
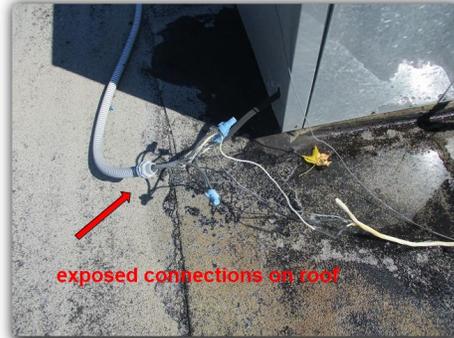
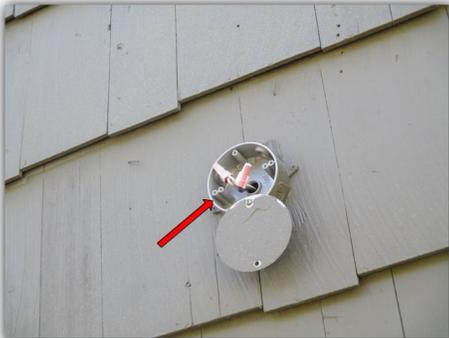
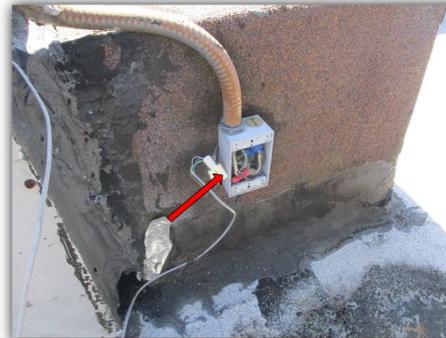
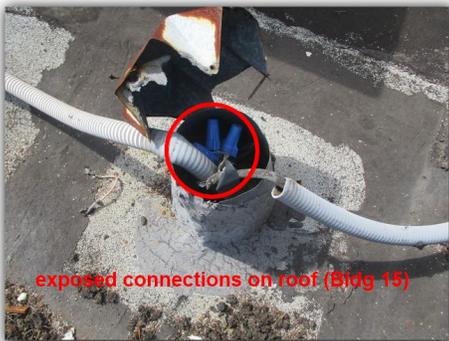
Exposed electrical connections were noted at various areas of the property. Improper electrical connections should be improved. All electrical connections should be made inside junction boxes fitted with cover plates.

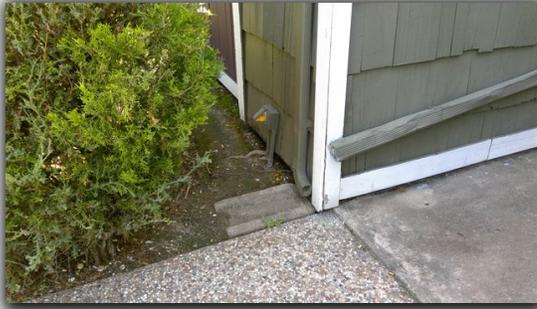
Receptacles at the exterior of unit # B13 are not functioning. Recommend further investigation and repairs by a licensed electrician.

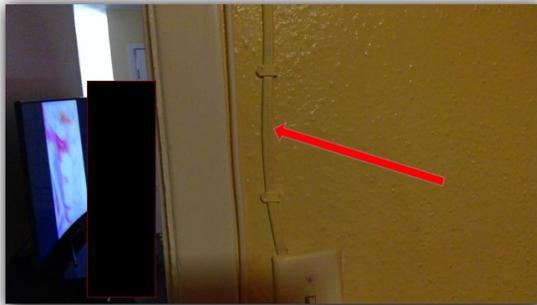
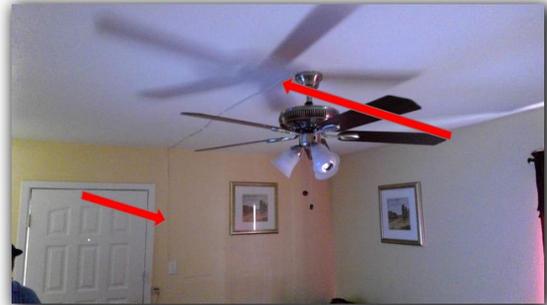
Missing conduit and improperly secured electrical conductors were noted in multiple units. Recommend evaluation for repair by a qualified tradesman

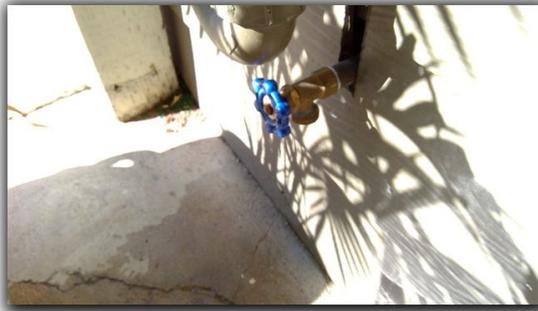
Anti-siphon devices not installed at all hose bibs

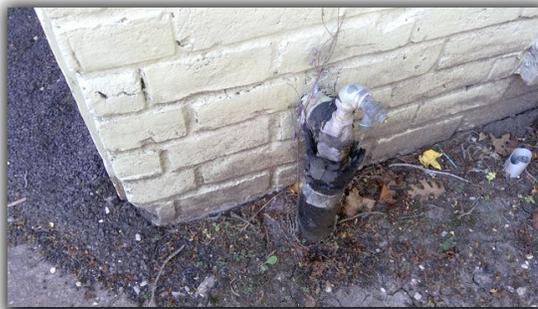
Missing hose bib / shutoff valve handles and leaking spouts were found at multiple areas.

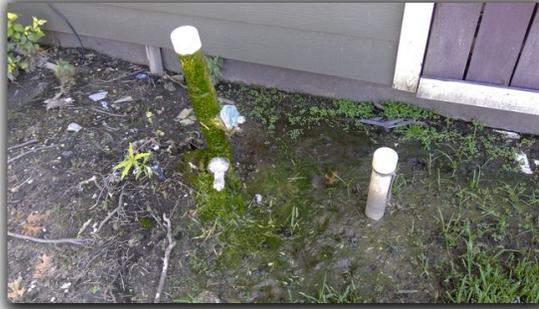
Active leaks should be repaired at the front right exterior of unit B15.

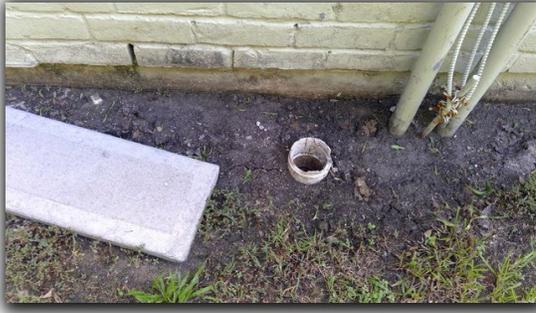
Missing drain covers should be replaced to prevent possible injury and obstruction from debris.

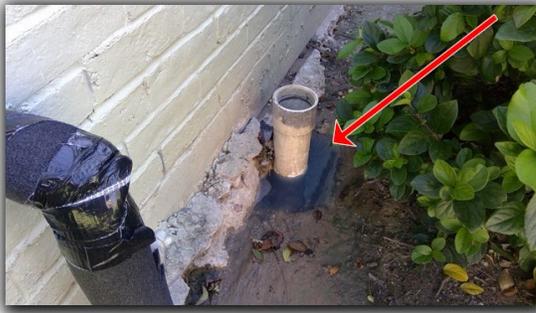
Standing water was found at the laundry room #2 exterior as evidence of improper plumbing drainage that may indicate underground breakage and or improper drainage. Repair by a licensed plumber is recommended.

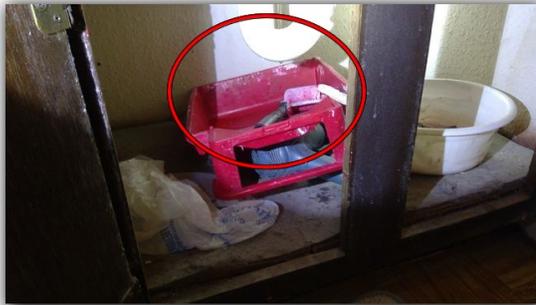
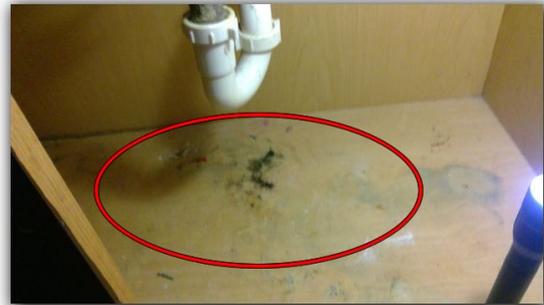
Active leaks were found at the sinks. in 286,338 Recommend repairs of the leaks by a licensed plumber and repairs of any damage caused by the leaks.

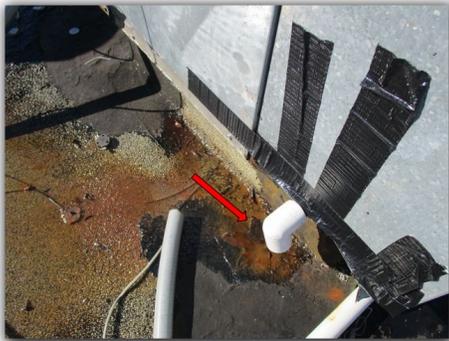
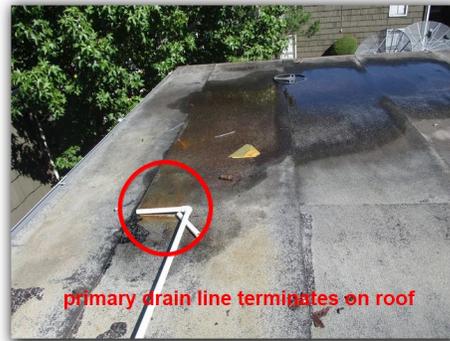
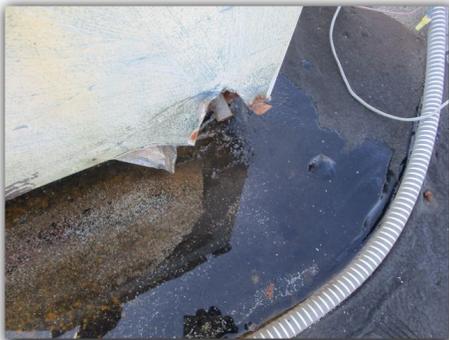
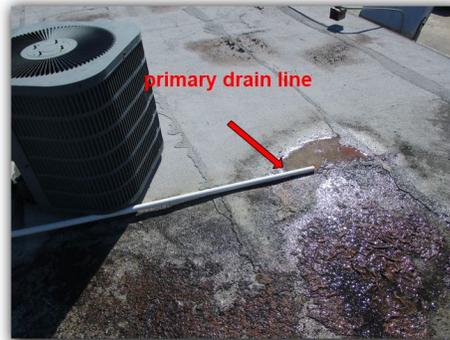
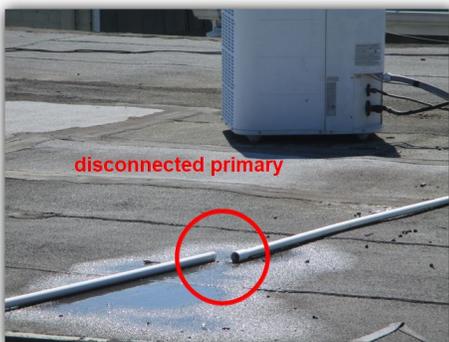
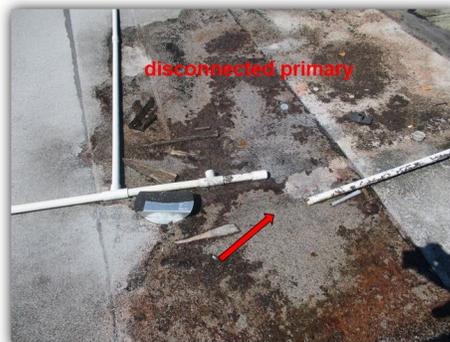
Several of the primary drain lines terminate on portions of the flat roof on most of the buildings . This can cause excessive moisture conditions on the roof which can eventually lead to roof leaks. Recommend improvements.

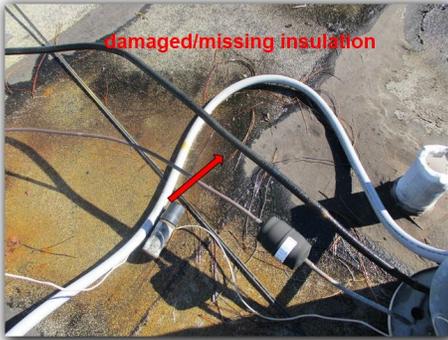
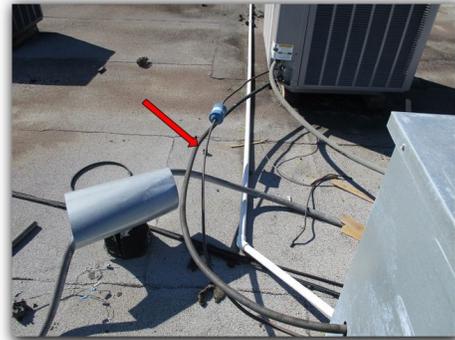
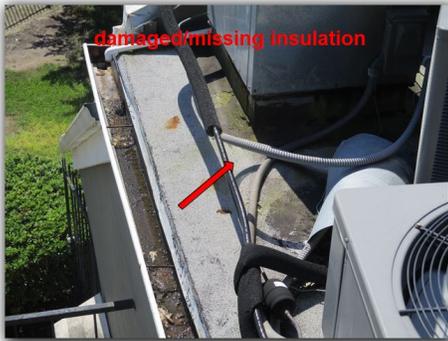
Damaged and missing insulation on the visible portions of the refrigerant lines should be repaired/replaced.

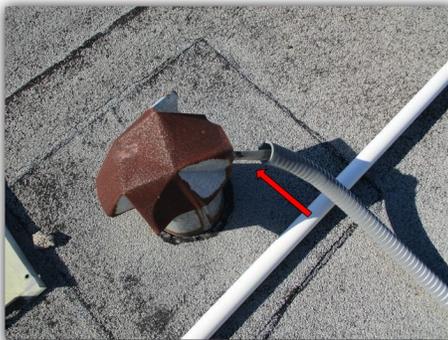
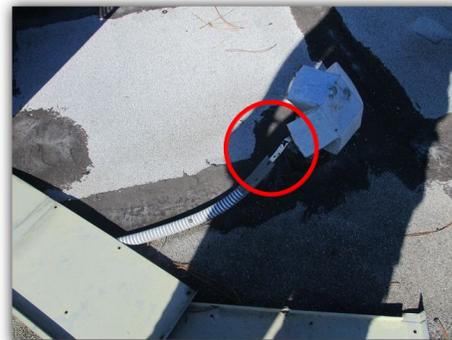
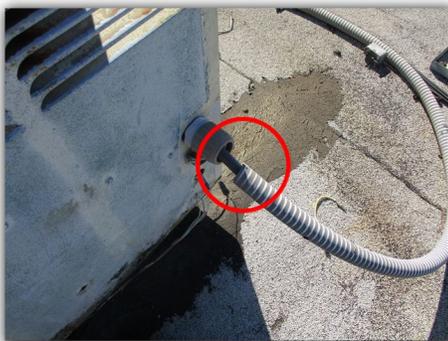
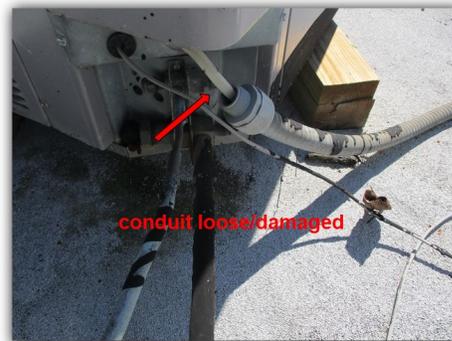
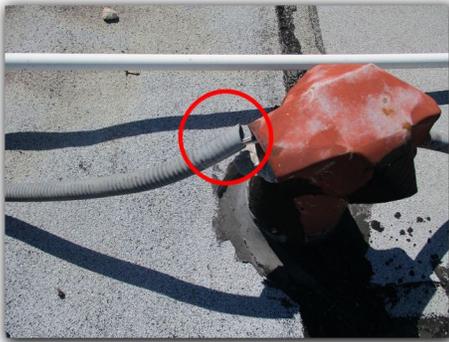
The conduit is loose at many locations of the exterior cooling unit(s) The conduit should be adjusted to completely cover/protect the conductors at this location.

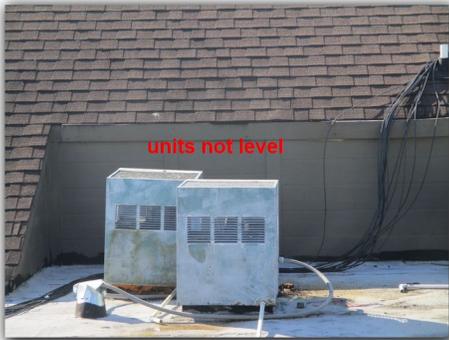
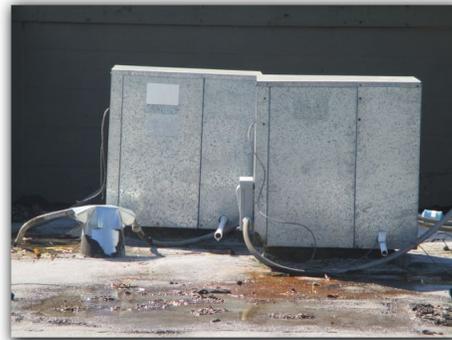
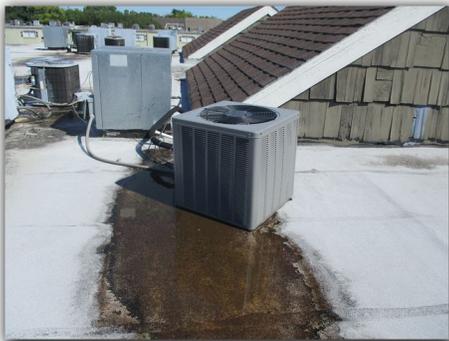
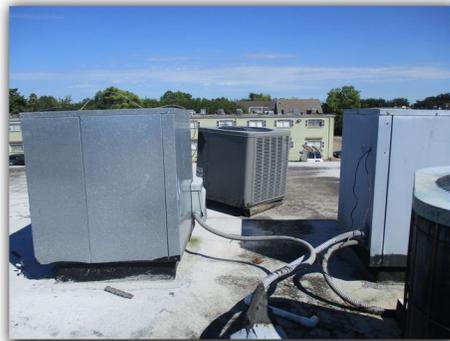
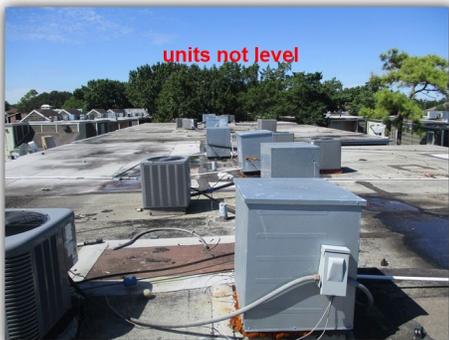
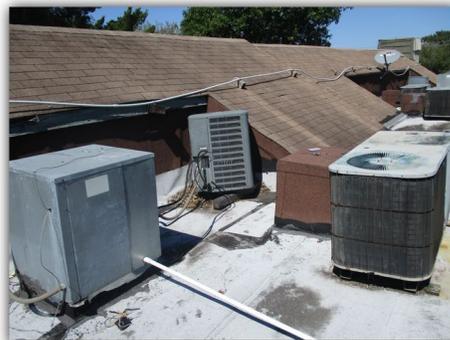
Several of the units of air conditioning system(s) are not level. This should be improved.

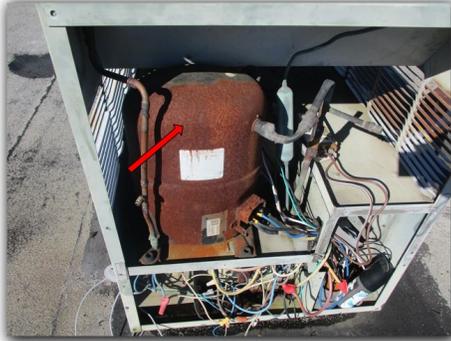
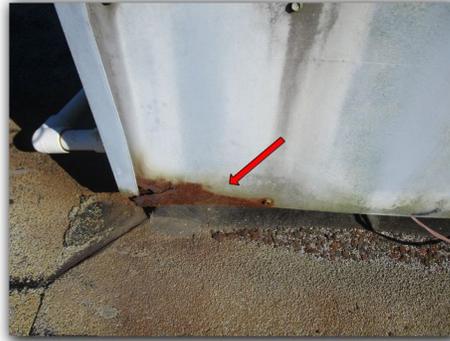
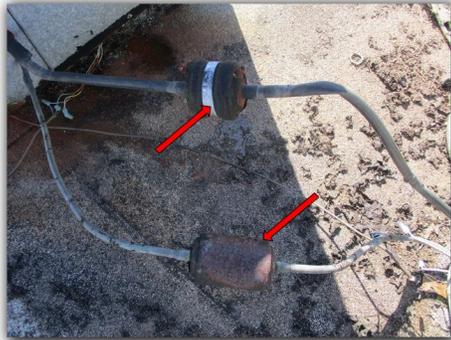
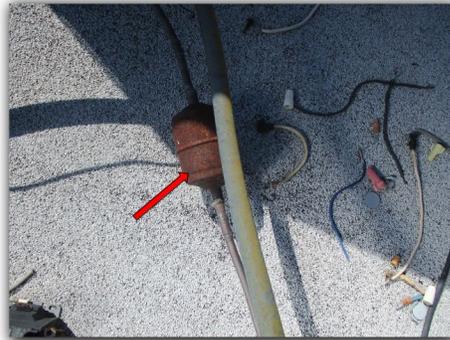
The refrigerant line dryer(s) at the exterior portion of the air conditioning system(s) are rusted at some units. These components should be inspected annually, cleaned and repainted to prevent leaks and other problems from developing. In addition, rust and corrosion was also noted on several of the units.

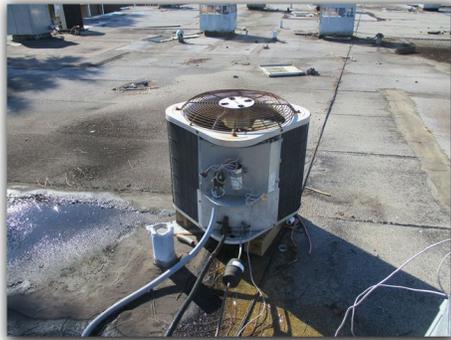
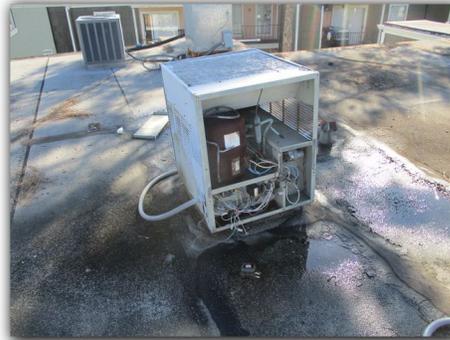
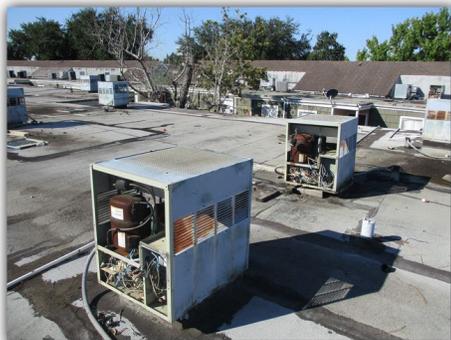
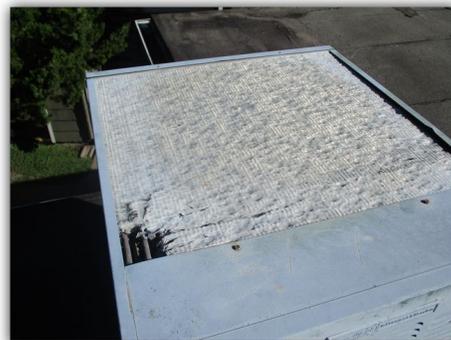
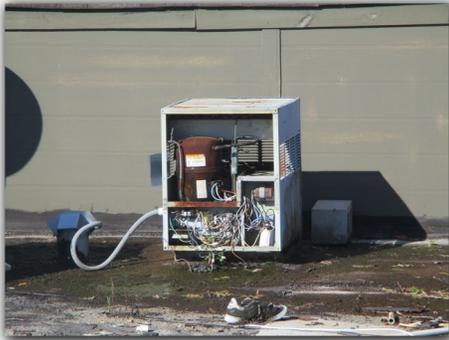
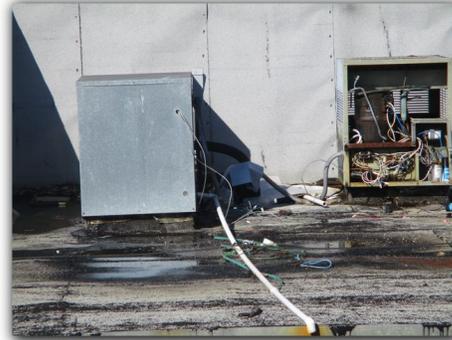
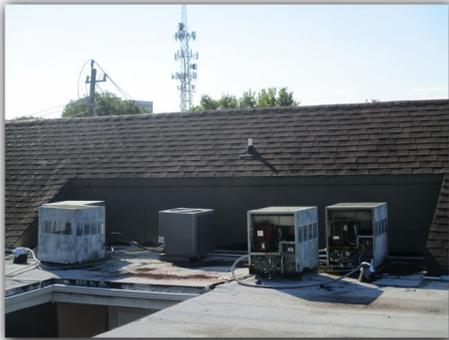
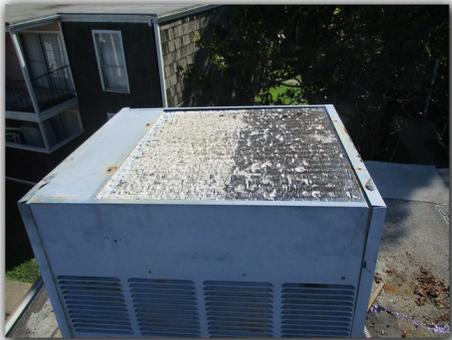
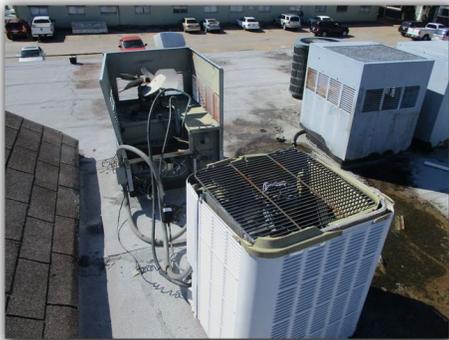
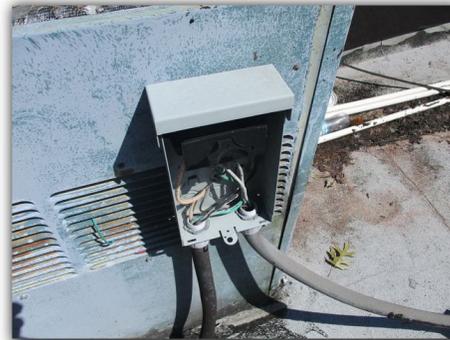
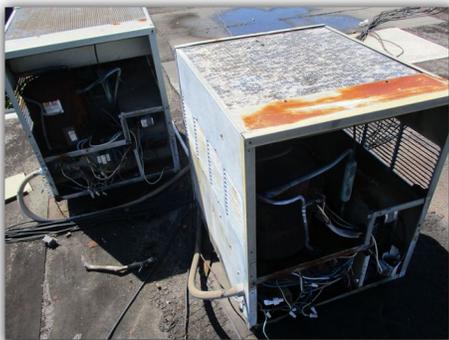
Missing and damaged panel covers were noted at most of the older systems. Recommend complete evaluation and repairs by a licensed HVAC technician.

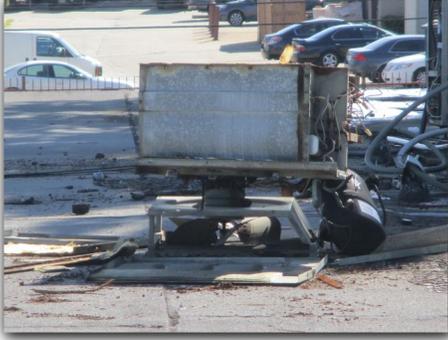
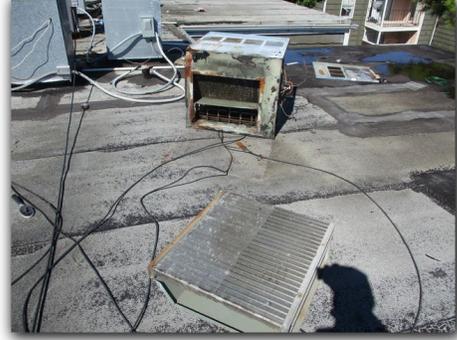
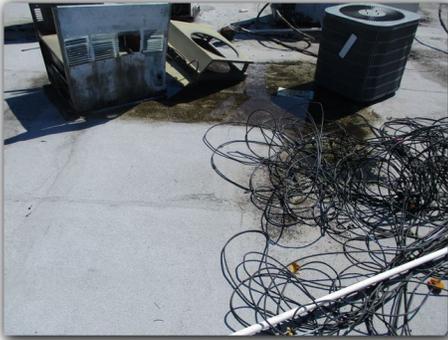
Recommend removal of all abandoned a/c units on the roofs.

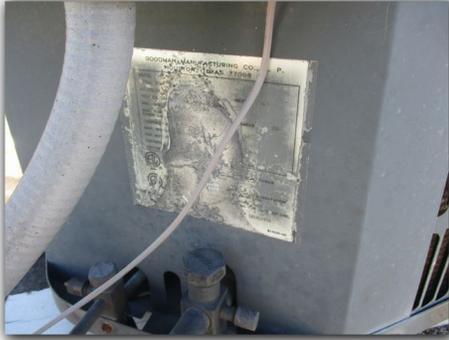
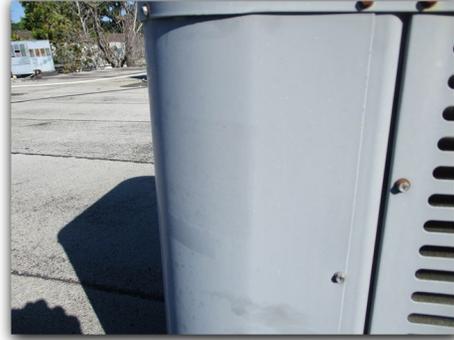
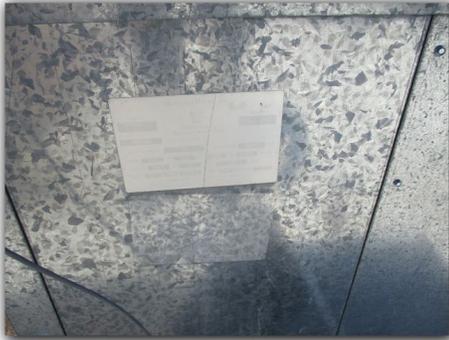
Most data plates on the older units are not legible/missing at time of the inspection.
